Profile/Photo Observation Report

Street:	Tanager	Flow Control:	Not Controlled
City:	Hobart, IN	Year Renewed:	
Location:	Sidewalk	Tape/Media #:	
Purpose:	Maintenance Related	Dia/Height:	8"
Use:	Sanitary	Material:	PVC
Drain Area:	NA	Lining:	
Category:	NA		
Comment:	Flow direction wrong.

Location Details:		Direction of Survey:	Upstream
US MH:	M-809-015	DS MH:	M-809-016
		Total Length Surveyed (ft):	117.4

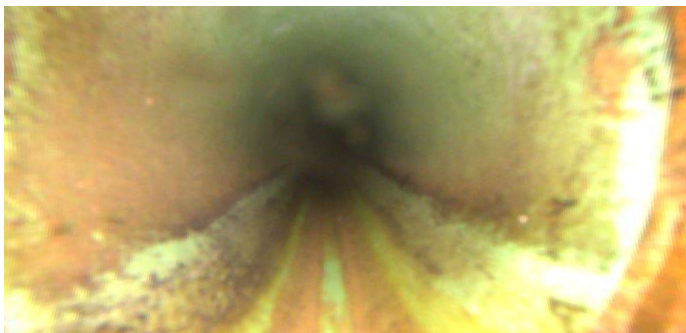
Code: **AMH**
Description: **Manhole**

Distance (ft): **.0**
Structural Grade: **0**
O&M Grade: **0**
Clock Start/From:
Clock To:
1st Value:
2nd Value:
Value Percent:
Continuous Index:
Within 8" of Joint: **NO**
Remarks: **M-809-016**

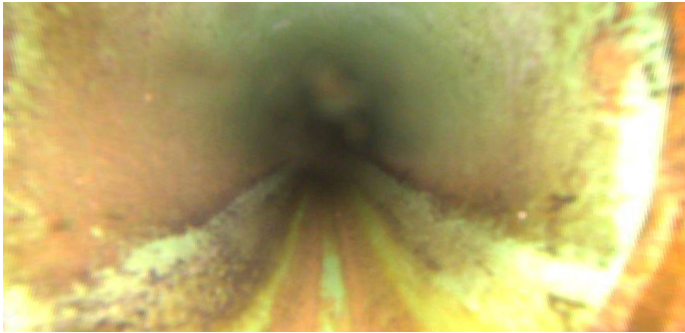
Code:	MWL
Description:	Water Level

Distance (ft):	.0
Structural Grade:	0
O&M Grade:	0
Clock Start/From:	
Clock To:	
1st Value:	
2nd Value:	
Value Percent:	5.000
Continuous Index:	
Within 8" of Joint:	NO
Remarks:

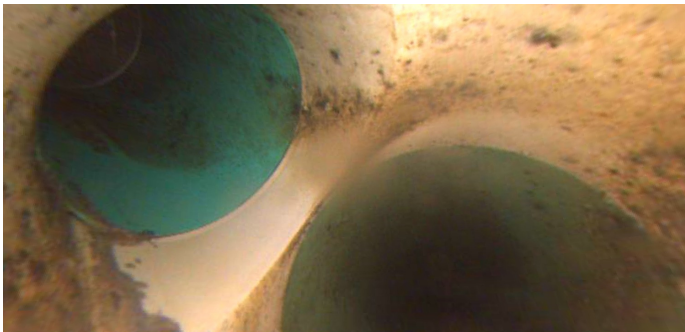
Code:	TF
Description:	Tap Factory

Distance (ft):	20.0
Structural Grade:	0
O&M Grade:	0
Clock Start/From:	2
Clock To:	
1st Value:	4.000
2nd Value:	
Value Percent:	
Continuous Index:	
Within 8" of Joint:	
Remarks:

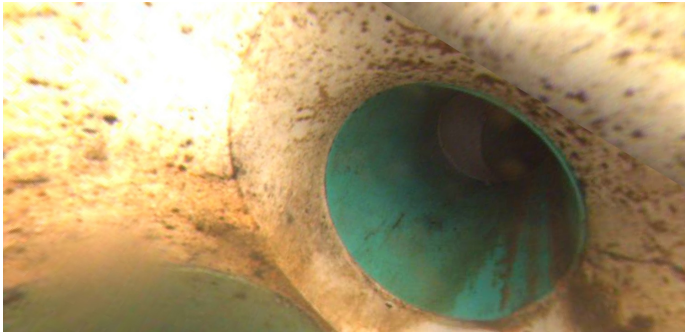
Code: **TF**
Description: **Tap Factory**

Distance (ft): **21.5**
Structural Grade: **0**
O&M Grade: **0**
Clock Start/From: **11**
Clock To:
1st Value: **4.000**
2nd Value:
Value Percent:
Continuous Index:
Within 8" of Joint:
Remarks:

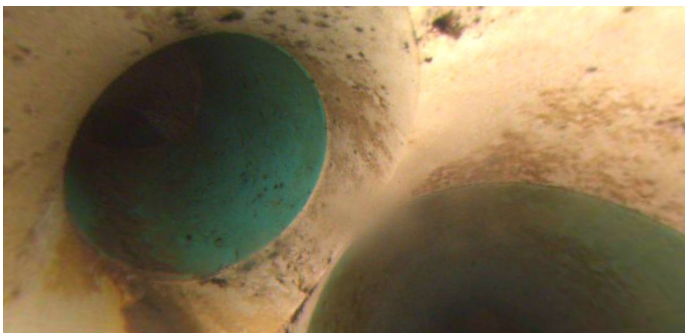
Code: **TF**
Description: **Tap Factory**

Distance (ft): **73.4**
Structural Grade: **0**
O&M Grade: **0**
Clock Start/From: **2**
Clock To:
1st Value: **4.000**
2nd Value:
Value Percent:
Continuous Index:
Within 8" of Joint:
Remarks:

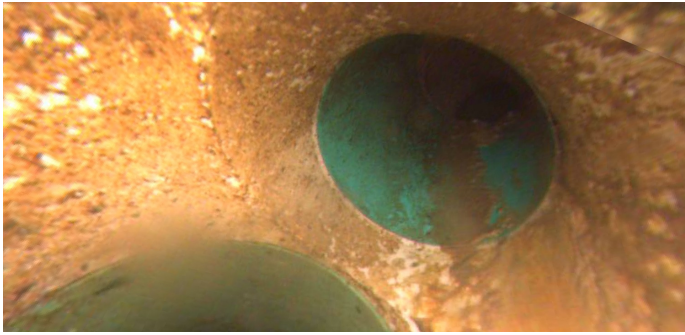
Code: **TF**
Description: **Tap Factory**

Distance (ft): **101.2**
Structural Grade: **0**
O&M Grade: **0**
Clock Start/From: **11**
Clock To:
1st Value: **4.000**
2nd Value:
Value Percent:
Continuous Index:
Within 8" of Joint:
Remarks:

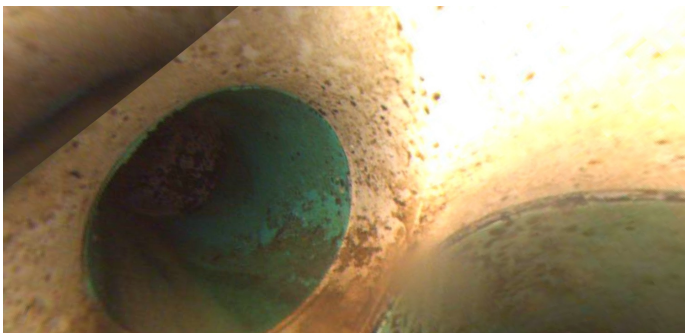
Code: **TF**
Description: **Tap Factory**

Distance (ft): **102.7**
Structural Grade: **0**
O&M Grade: **0**
Clock Start/From: **2**
Clock To:
1st Value: **4.000**
2nd Value:
Value Percent:
Continuous Index:
Within 8" of Joint:
Remarks:

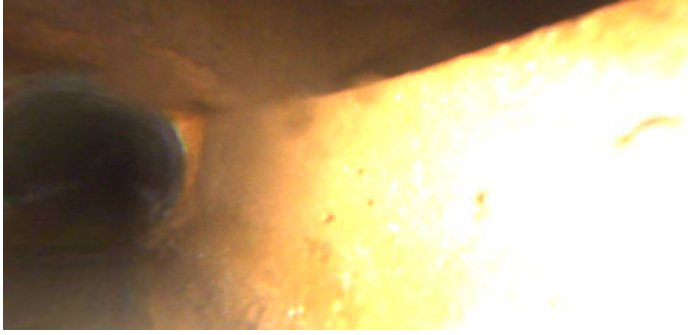
Code:	AMH
Description:	Manhole
Distance (ft):	117.4
Structural Grade:	0
O&M Grade:	0
Clock Start/From:	
Clock To:	
1st Value:	
2nd Value:	
Value Percent:	
Continuous Index:	
Within 8" of Joint:	NO
Remarks:	M-809-015
