Profile/Photo Observation Report

Street:	Tanager	Flow Control:	Not Controlled
City:	Hobart, IN	Year Renewed:	
Location:	Sidewalk	Tape/Media #:	
Purpose:	Maintenance Related	Dia/Height:	8"
Use:	Sanitary	Material:	PVC
Drain Area:	NA	Lining:	
Category:	NA		
Comment:	Flow direction wrong.

Location Details:		Direction of Survey:	Downstream
US MH:	M-809-016	DS MH:	M-809-017
		Total Length Surveyed (ft):	78.5

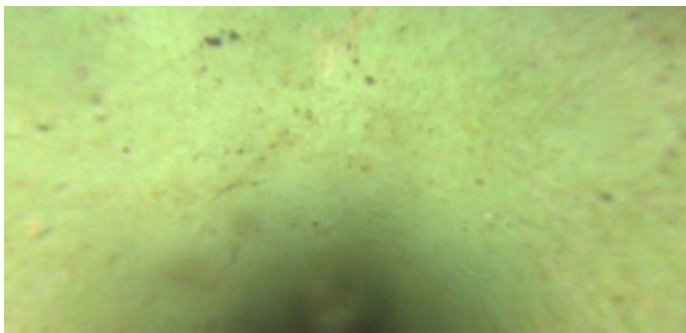
Code: **AMH**
Description: **Manhole**

Distance (ft): **.0**
Structural Grade: **0**
O&M Grade: **0**
Clock Start/From:
Clock To:
1st Value:
2nd Value:
Value Percent:
Continuous Index:
Within 8" of Joint: **NO**
Remarks: **M-809-016**

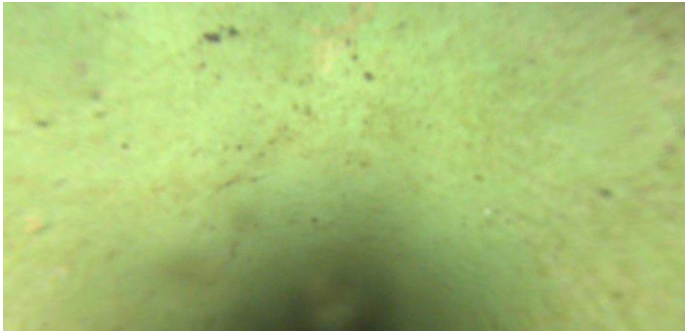
Code:	MWL
Description:	Water Level

Distance (ft):	.0
Structural Grade:	0
O&M Grade:	0
Clock Start/From:	
Clock To:	
1st Value:	
2nd Value:	
Value Percent:	5.000
Continuous Index:	
Within 8" of Joint:	NO
Remarks:

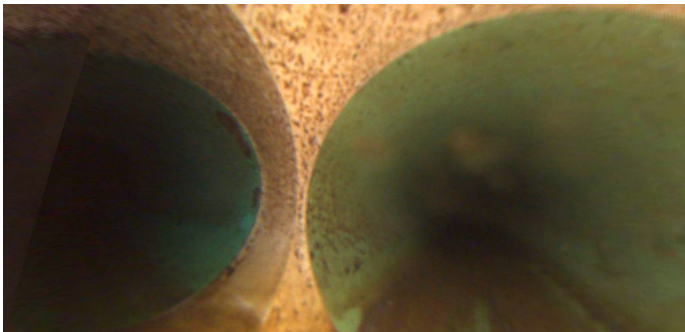
Code:	TF
Description:	Tap Factory

Distance (ft):	12.3
Structural Grade:	0
O&M Grade:	0
Clock Start/From:	9
Clock To:	
1st Value:	4.000
2nd Value:	
Value Percent:	
Continuous Index:	
Within 8" of Joint:	YES
Remarks:

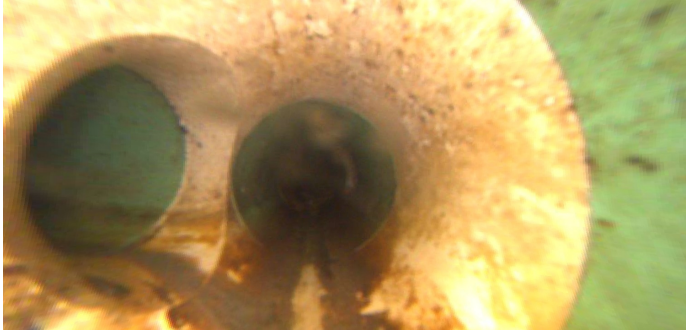
Code: **TF**
Description: **Tap Factory**

Distance (ft): **50.2**
Structural Grade: **0**
O&M Grade: **0**
Clock Start/From: **9**
Clock To:
1st Value: **4.000**
2nd Value:
Value Percent:
Continuous Index:
Within 8" of Joint: **YES**
Remarks:

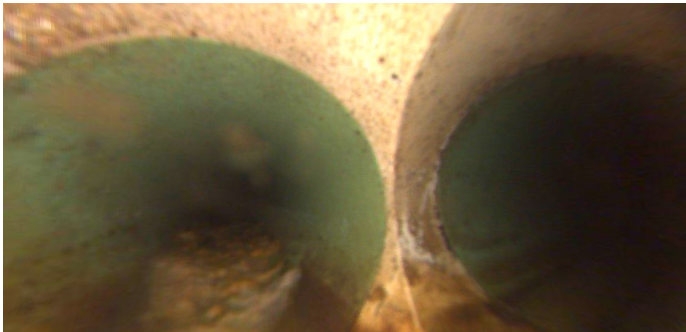
Code: **TF**
Description: **Tap Factory**

Distance (ft): **52.3**
Structural Grade: **0**
O&M Grade: **0**
Clock Start/From: **3**
Clock To:
1st Value: **4.000**
2nd Value:
Value Percent:
Continuous Index:
Within 8" of Joint: **YES**
Remarks:

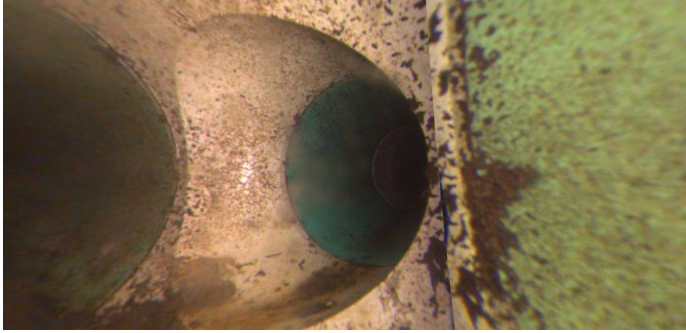
Code: **TF**
Description: **Tap Factory**

Distance (ft): **72.0**
Structural Grade: **0**
O&M Grade: **0**
Clock Start/From: **9**
Clock To:
1st Value: **4.000**
2nd Value:
Value Percent:
Continuous Index:
Within 8" of Joint:
Remarks:

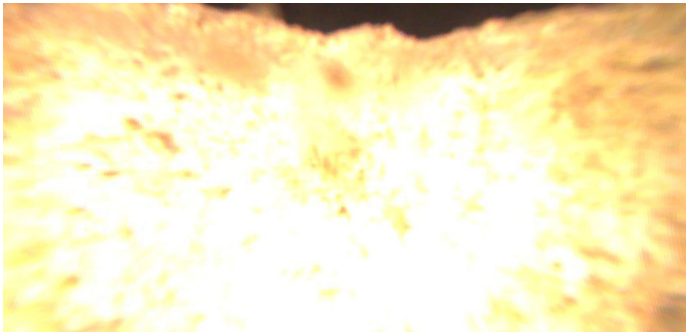
Code: **AMH**
Description: **Manhole**

Distance (ft): **78.5**
Structural Grade: **0**
O&M Grade: **0**
Clock Start/From:
Clock To:
1st Value:
2nd Value:
Value Percent:
Continuous Index:
Within 8" of Joint: **NO**
Remarks: **M-809-017**
