# Profile/Photo Observation Report

Date:	<b>03/23/2018</b>	Weather:		Coding:	<b>PACP 6.0</b>
Pipe Length (ft):	<b>374.3</b>	Owner:	<b>NA</b>	Pre Clean:	<b>Not Known</b>
P.O.#:		Surveyor:	<b>Jen Costello</b>	PSR:	<b>P-809-019-018</b>
Customer:		Clean Date:	<b>01/01/1900</b>	Shape:	<b>C</b>

Street:	<b>Oak</b>	Flow Control:	<b>Not Controlled</b>
City:	<b>Hobart, IN</b>	Year Renewed:	
Location:	<b>Sidewalk</b>	Tape/Media #:	
Purpose:	<b>Maintenance Related</b>	Dia/Height:	<b>10"</b>
Use:	<b>Sanitary</b>	Material:	<b>PVC</b>
Drain Area:	<b>NA</b>	Lining:	
Category:	<b>NA</b>		
Comment:	<b>debris pile at 3'.</b>		
Location Details:		Direction of Survey:	<b>Downstream</b>
US MH:	<b>M-809-019</b>	DS MH:	<b>M-809-018</b>
		Total Length Surveyed (ft):	<b>4.6</b>

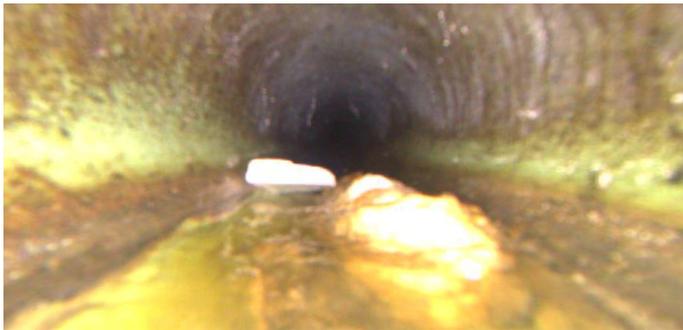
Code: **AMH**  
Description: **Manhole**

Distance (ft): **.0**  
Structural Grade: **0**  
O&M Grade: **0**  
Clock Start/From:  
Clock To:  
1st Value:  
2nd Value:  
Value Percent:  
Continuous Index:  
Within 8" of Joint: **NO**  
Remarks: **M-809-019**

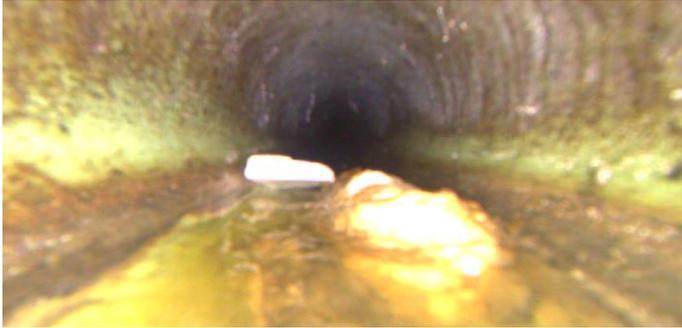
Code: **MWL**  
Description: **Water Level**

Distance (ft): **.0**  
Structural Grade: **0**  
O&M Grade: **0**  
Clock Start/From:  
Clock To:  
1st Value:  
2nd Value:  
Value Percent: **20.000**  
Continuous Index:  
Within 8" of Joint: **NO**  
Remarks:

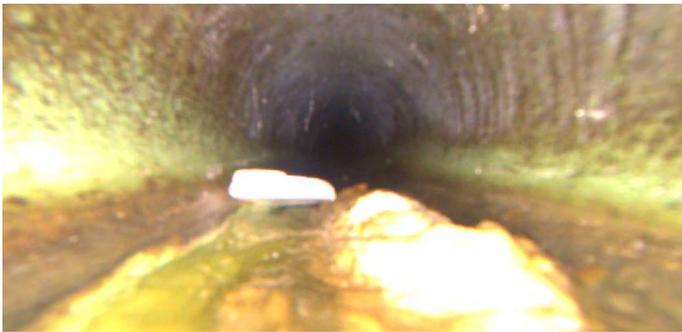
Code: **OBZ**  
Description: **Obstacle Other**

Distance (ft): **.3**  
Structural Grade: **0**  
O&M Grade: **3**  
Clock Start/From: **4**  
Clock To: **8**  
1st Value:  
2nd Value:  
Value Percent: **20.000**  
Continuous Index:  
Within 8" of Joint: **NO**  
Remarks: **MISC**

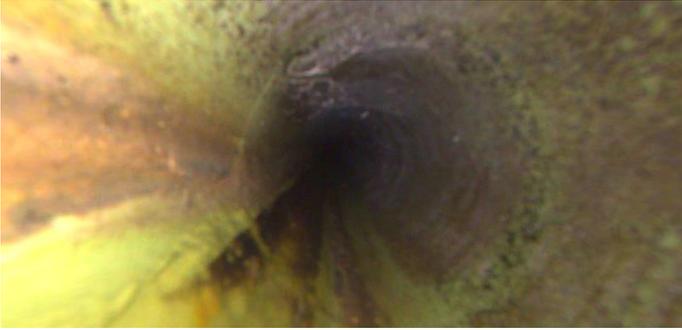
Code:	<b>MSA</b>
Description:	<b>Abandoned Survey</b>
Distance (ft):	<b>4.6</b>
Structural Grade:	<b>0</b>
O&M Grade:	<b>0</b>
Clock Start/From:	
Clock To:	
1st Value:	
2nd Value:	
Value Percent:	
Continuous Index:	
Within 8" of Joint:	<b>NO</b>
Remarks:	<b>OVERTURNED</b>
