Profile/Photo Observation Report

Street:	Oak	Flow Control:	Not Controlled
City:	Hobart, IN	Year Renewed:	
Location:	Sidewalk	Tape/Media #:	
Purpose:	Maintenance Related	Dia/Height:	10"
Use:	Sanitary	Material:	PVC
Drain Area:	NA	Lining:	
Category:	NA		
Comment:

Location Details:		Direction of Survey:	Downstream
US MH:	M-809-019	DS MH:	M-809-020
		Total Length Surveyed (ft):	84.2

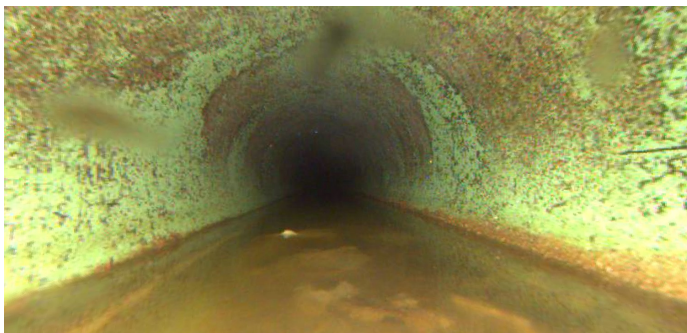
Code: **AMH**
 Description: **Manhole**

Distance (ft): **.0**
 Structural Grade: **0**
 O&M Grade: **0**
 Clock Start/From:
 Clock To:
 1st Value:
 2nd Value:
 Value Percent:
 Continuous Index:
 Within 8" of Joint: **NO**
 Remarks: **M-809-019**

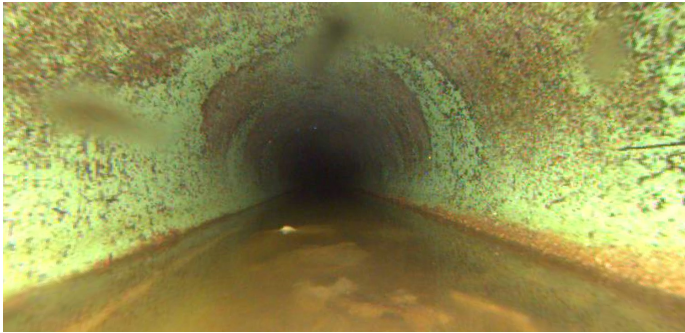
Code:	MWL
Description:	Water Level

Distance (ft):	.0
Structural Grade:	0
O&M Grade:	0
Clock Start/From:	
Clock To:	
1st Value:	
2nd Value:	
Value Percent:	30.000
Continuous Index:	
Within 8" of Joint:	NO
Remarks:

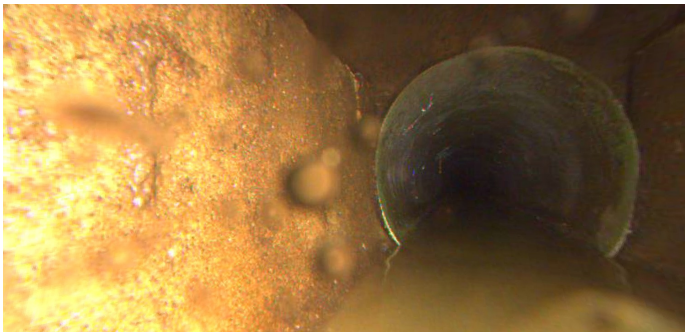
Code:	AMH
Description:	Manhole

Distance (ft):	84.2
Structural Grade:	0
O&M Grade:	0
Clock Start/From:	
Clock To:	
1st Value:	
2nd Value:	
Value Percent:	
Continuous Index:	
Within 8" of Joint:	NO
Remarks:	M-809-020
