Profile/Photo Observation Report

Street:	BRACKEN PKWY	Flow Control:	Not Controlled
City:	Hobart, IN	Year Renewed:	
Location:	Sidewalk	Tape/Media #:	
Purpose:	Maintenance Related	Dia/Height:	10"
Use:	Sanitary	Material:	PVC
Drain Area:	NA	Lining:	
Category:	NA		
Comment:

Location Details:		Direction of Survey:	Downstream
US MH:	M-809-021	DS MH:	M-809-022
		Total Length Surveyed (ft):	307.9

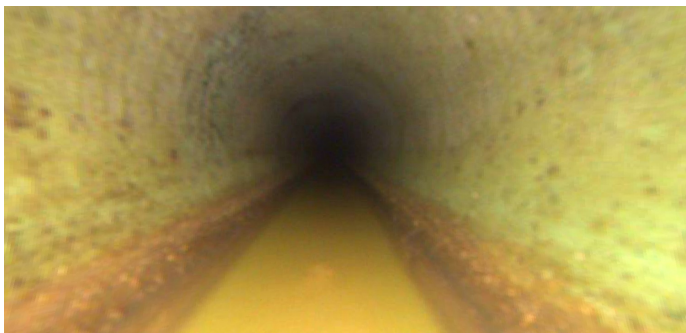
Code: **AMH**
Description: **Manhole**

Distance (ft): **.0**
Structural Grade: **0**
O&M Grade: **0**
Clock Start/From:
Clock To:
1st Value:
2nd Value:
Value Percent:
Continuous Index:
Within 8" of Joint: **NO**
Remarks: **M-809-021**

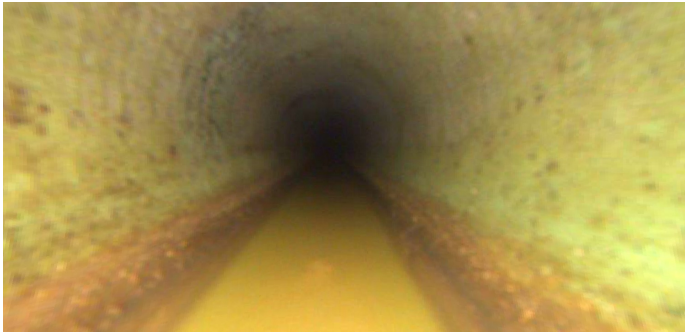
Code:	MWL
Description:	Water Level

Distance (ft):	.0
Structural Grade:	0
O&M Grade:	0
Clock Start/From:	
Clock To:	
1st Value:	
2nd Value:	
Value Percent:	5.000
Continuous Index:	
Within 8" of Joint:	NO
Remarks:

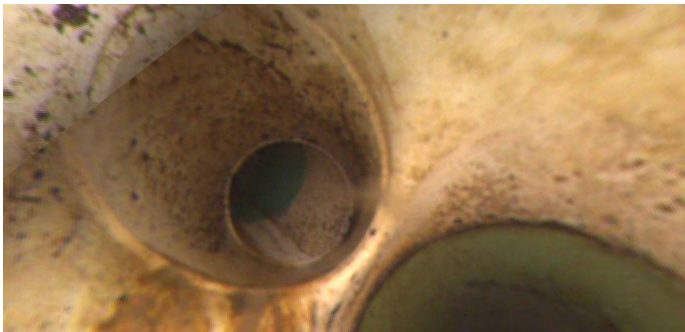
Code:	TF
Description:	Tap Factory

Distance (ft):	24.7
Structural Grade:	0
O&M Grade:	0
Clock Start/From:	10
Clock To:	
1st Value:	4.000
2nd Value:	
Value Percent:	
Continuous Index:	
Within 8" of Joint:	
Remarks:

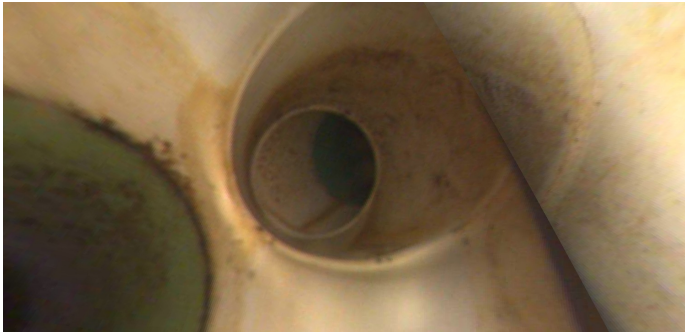
Code: **TF**
Description: **Tap Factory**

Distance (ft): **38.3**
Structural Grade: **0**
O&M Grade: **0**
Clock Start/From: **2**
Clock To:
1st Value: **4.000**
2nd Value:
Value Percent:
Continuous Index:
Within 8" of Joint:
Remarks:

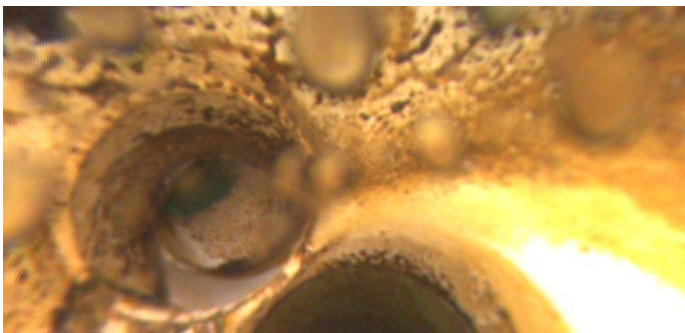
Code: **TF**
Description: **Tap Factory**

Distance (ft): **94.7**
Structural Grade: **0**
O&M Grade: **0**
Clock Start/From: **10**
Clock To:
1st Value: **4.000**
2nd Value:
Value Percent:
Continuous Index:
Within 8" of Joint:
Remarks:

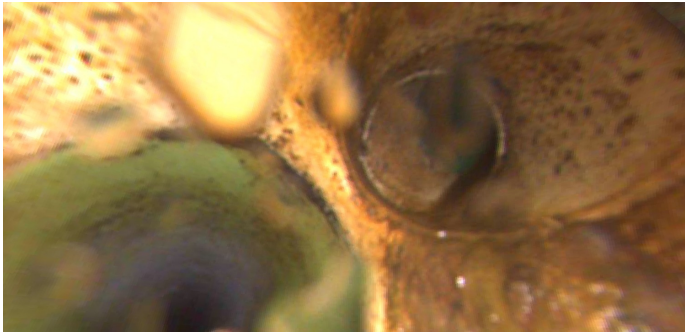
Code: **TF**
Description: **Tap Factory**

Distance (ft): **127.4**
Structural Grade: **0**
O&M Grade: **0**
Clock Start/From: **2**
Clock To:
1st Value: **4.000**
2nd Value:
Value Percent:
Continuous Index:
Within 8" of Joint:
Remarks:

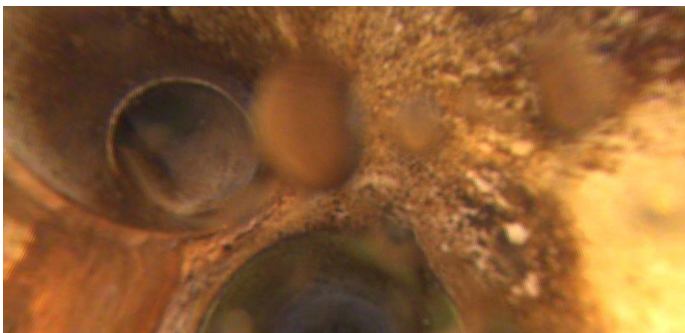
Code: **TF**
Description: **Tap Factory**

Distance (ft): **147.5**
Structural Grade: **0**
O&M Grade: **0**
Clock Start/From: **10**
Clock To:
1st Value: **4.000**
2nd Value:
Value Percent:
Continuous Index:
Within 8" of Joint:
Remarks:

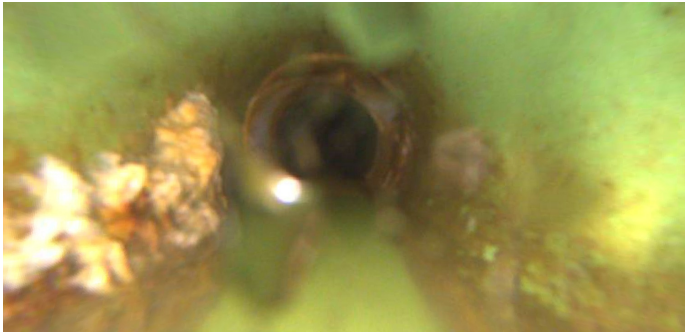
Code: **DAGS**
Description: **Deposits Attached Grease**

Distance (ft): **197.6**
Structural Grade: **0**
O&M Grade: **2**
Clock Start/From: **8**
Clock To: **10**
1st Value:
2nd Value:
Value Percent: **5.000**
Continuous Index:
Within 8" of Joint: **NO**
Remarks:

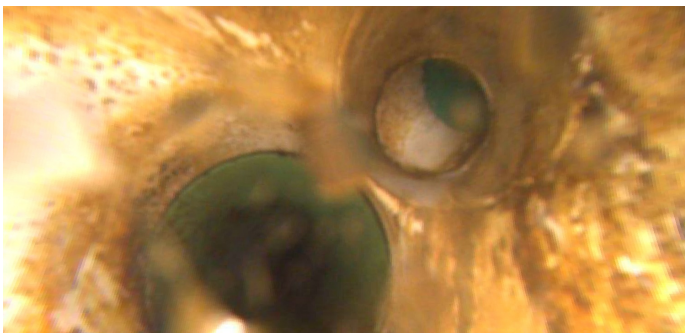
Code: **TF**
Description: **Tap Factory**

Distance (ft): **198.9**
Structural Grade: **0**
O&M Grade: **0**
Clock Start/From: **1**
Clock To:
1st Value: **4.000**
2nd Value:
Value Percent:
Continuous Index:
Within 8" of Joint:
Remarks:

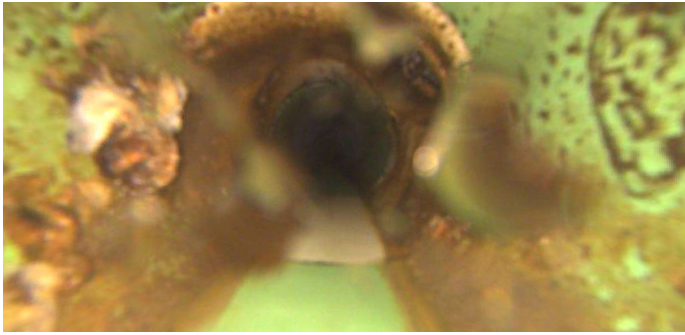
Code: **DAGS**
Description: **Deposits Attached Grease**

Distance (ft): **270.5**
Structural Grade: **0**
O&M Grade: **2**
Clock Start/From: **9**
Clock To:
1st Value:
2nd Value:
Value Percent: **5.000**
Continuous Index:
Within 8" of Joint: **NO**
Remarks:

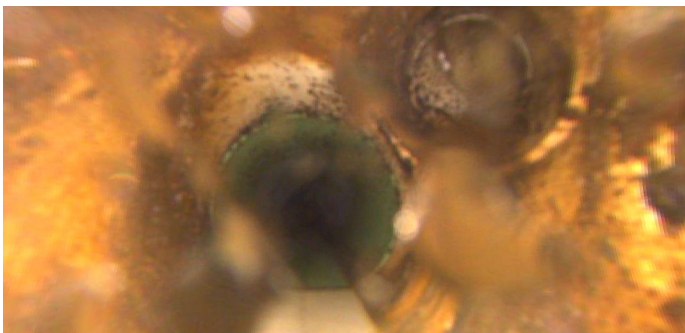
Code: **TF**
Description: **Tap Factory**

Distance (ft): **271.1**
Structural Grade: **0**
O&M Grade: **0**
Clock Start/From: **2**
Clock To:
1st Value: **4.000**
2nd Value:
Value Percent:
Continuous Index:
Within 8" of Joint:
Remarks:

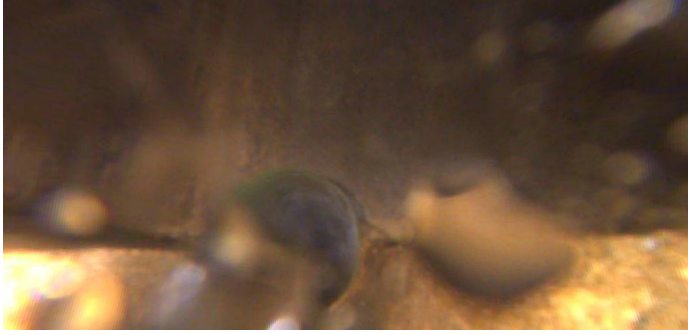
Code:	AMH
Description:	Manhole
Distance (ft):	307.9
Structural Grade:	0
O&M Grade:	0
Clock Start/From:	
Clock To:	
1st Value:	
2nd Value:	
Value Percent:	
Continuous Index:	
Within 8" of Joint:	NO
Remarks:	M-809-022
