Profile/Photo Observation Report

Street:	Oak	Flow Control:	Not Controlled
City:	Hobart, IN	Year Renewed:	
Location:	Sidewalk	Tape/Media #:	
Purpose:	Maintenance Related	Dia/Height:	10"
Use:	Sanitary	Material:	PVC
Drain Area:	NA	Lining:	
Category:	NA		
Comment:

Location Details:		Direction of Survey:	Downstream
US MH:	M-809-021	DS MH:	M-809-022
		Total Length Surveyed (ft):	307.9

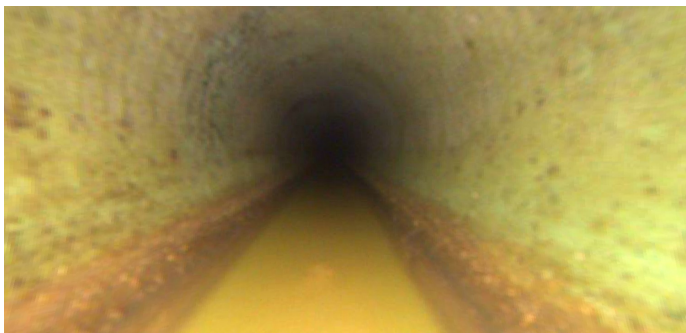
Code: **AMH**
Description: **Manhole**

Distance (ft): **.0**
Structural Grade: **0**
O&M Grade: **0**
Clock Start/From:
Clock To:
1st Value:
2nd Value:
Value Percent:
Continuous Index:
Within 8" of Joint: **NO**
Remarks: **M-809-021**

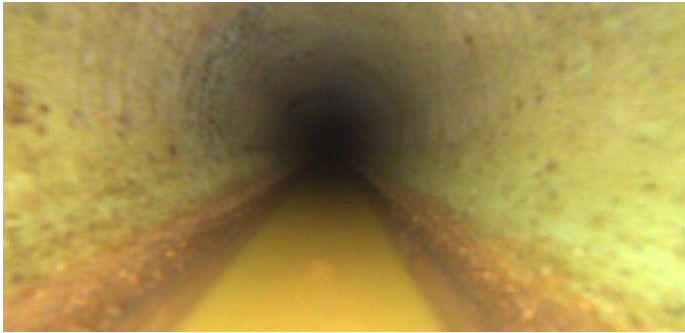
Code:	MWL
Description:	Water Level

Distance (ft):	.0
Structural Grade:	0
O&M Grade:	0
Clock Start/From:	
Clock To:	
1st Value:	
2nd Value:	
Value Percent:	5.000
Continuous Index:	
Within 8" of Joint:	NO
Remarks:

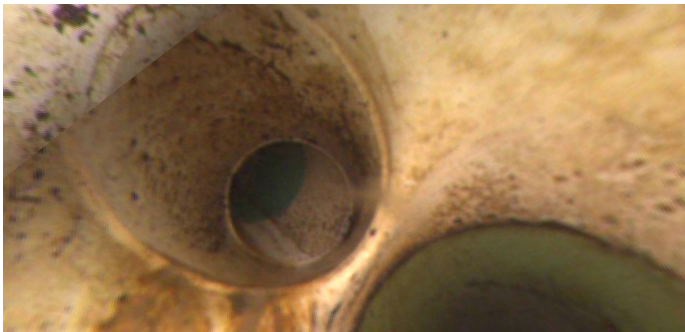
Code:	TF
Description:	Tap Factory

Distance (ft):	24.7
Structural Grade:	0
O&M Grade:	0
Clock Start/From:	10
Clock To:	
1st Value:	4.000
2nd Value:	
Value Percent:	
Continuous Index:	
Within 8" of Joint:	
Remarks:

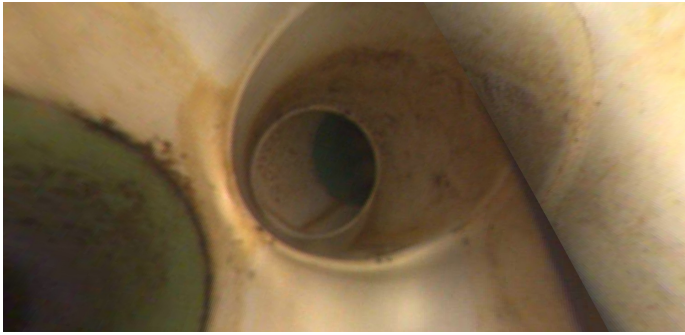
Code: **TF**
Description: **Tap Factory**

Distance (ft): **38.3**
Structural Grade: **0**
O&M Grade: **0**
Clock Start/From: **2**
Clock To:
1st Value: **4.000**
2nd Value:
Value Percent:
Continuous Index:
Within 8" of Joint:
Remarks:

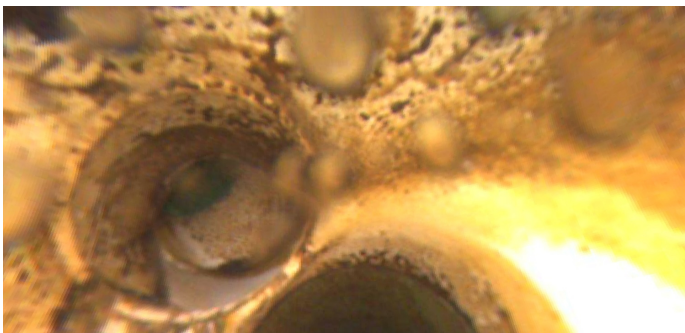
Code: **TF**
Description: **Tap Factory**

Distance (ft): **94.7**
Structural Grade: **0**
O&M Grade: **0**
Clock Start/From: **10**
Clock To:
1st Value: **4.000**
2nd Value:
Value Percent:
Continuous Index:
Within 8" of Joint:
Remarks:

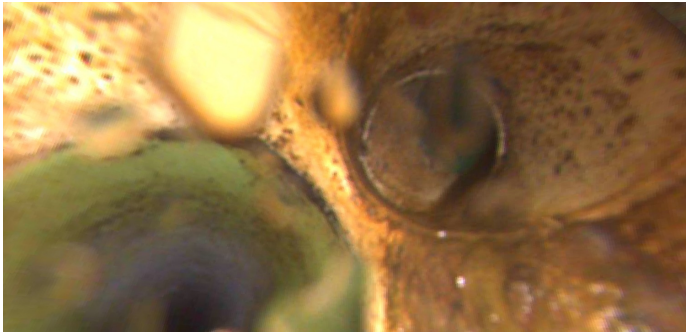
Code: **TF**
Description: **Tap Factory**

Distance (ft): **127.4**
Structural Grade: **0**
O&M Grade: **0**
Clock Start/From: **2**
Clock To:
1st Value: **4.000**
2nd Value:
Value Percent:
Continuous Index:
Within 8" of Joint:
Remarks:

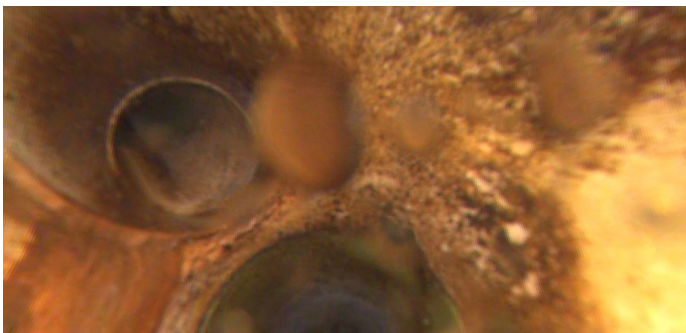
Code: **TF**
Description: **Tap Factory**

Distance (ft): **147.5**
Structural Grade: **0**
O&M Grade: **0**
Clock Start/From: **10**
Clock To:
1st Value: **4.000**
2nd Value:
Value Percent:
Continuous Index:
Within 8" of Joint:
Remarks:

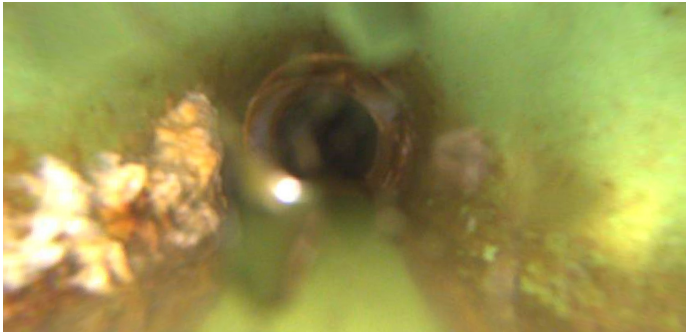
Code: **DAGS**
Description: **Deposits Attached Grease**

Distance (ft): **197.6**
Structural Grade: **0**
O&M Grade: **2**
Clock Start/From: **8**
Clock To: **10**
1st Value:
2nd Value:
Value Percent: **5.000**
Continuous Index:
Within 8" of Joint: **NO**
Remarks:

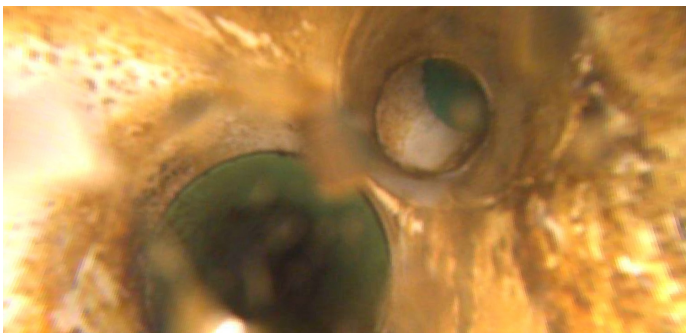
Code: **TF**
Description: **Tap Factory**

Distance (ft): **198.9**
Structural Grade: **0**
O&M Grade: **0**
Clock Start/From: **1**
Clock To:
1st Value: **4.000**
2nd Value:
Value Percent:
Continuous Index:
Within 8" of Joint:
Remarks:

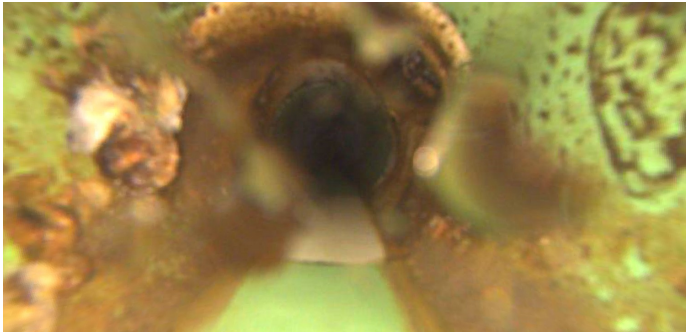
Code: **DAGS**
Description: **Deposits Attached Grease**

Distance (ft): **270.5**
Structural Grade: **0**
O&M Grade: **2**
Clock Start/From: **9**
Clock To:
1st Value:
2nd Value:
Value Percent: **5.000**
Continuous Index:
Within 8" of Joint: **NO**
Remarks:

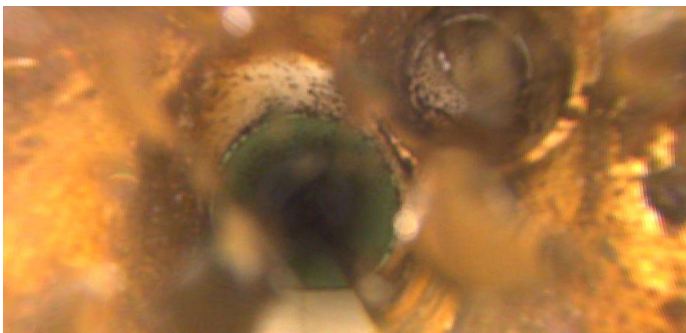
Code: **TF**
Description: **Tap Factory**

Distance (ft): **271.1**
Structural Grade: **0**
O&M Grade: **0**
Clock Start/From: **2**
Clock To:
1st Value: **4.000**
2nd Value:
Value Percent:
Continuous Index:
Within 8" of Joint:
Remarks:

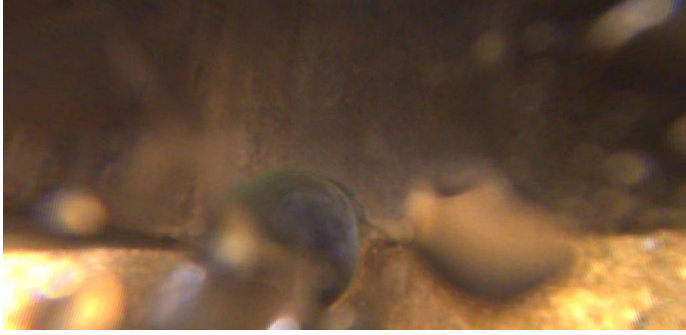
Code:	AMH
Description:	Manhole
Distance (ft):	307.9
Structural Grade:	0
O&M Grade:	0
Clock Start/From:	
Clock To:	
1st Value:	
2nd Value:	
Value Percent:	
Continuous Index:	
Within 8" of Joint:	NO
Remarks:	M-809-022
