Profile/Photo Observation Report

Street:	BRACKEN PKWY	Flow Control:	Not Controlled
City:	Hobart, IN	Year Renewed:	
Location:	Sidewalk	Tape/Media #:	
Purpose:	Maintenance Related	Dia/Height:	8"
Use:	Sanitary	Material:	PVC
Drain Area:	NA	Lining:	
Category:	NA		
Comment:	flow incorrect.

Location Details:		Direction of Survey:	Upstream
US MH:	M-809-022	DS MH:	M-809-023
		Total Length Surveyed (ft):	274.9

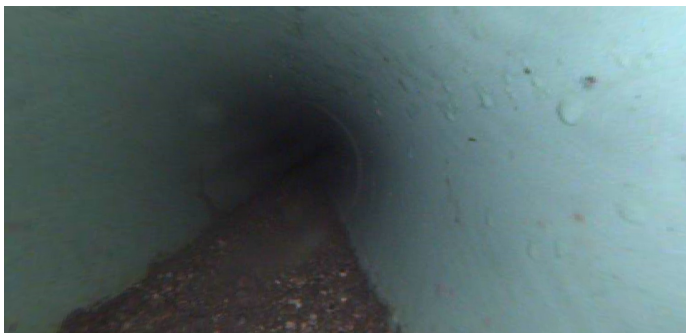
Code: **AMH**
Description: **Manhole**

Distance (ft): **.0**
Structural Grade: **0**
O&M Grade: **0**
Clock Start/From:
Clock To:
1st Value:
2nd Value:
Value Percent:
Continuous Index:
Within 8" of Joint: **NO**
Remarks: **M-809-023**

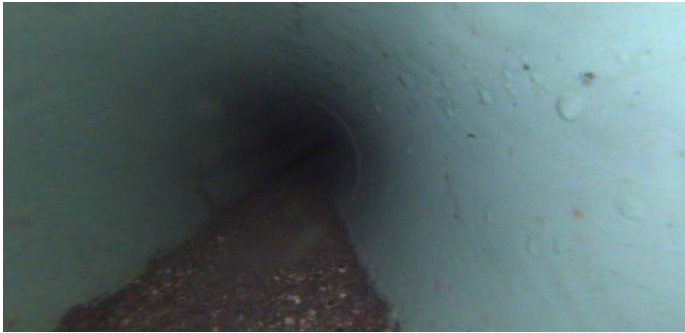
Code:	MWL
Description:	Water Level

Distance (ft):	.0
Structural Grade:	0
O&M Grade:	0
Clock Start/From:	
Clock To:	
1st Value:	
2nd Value:	
Value Percent:	0.000
Continuous Index:	
Within 8" of Joint:	NO
Remarks:

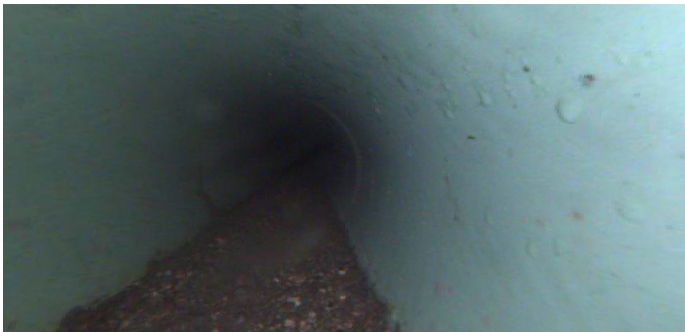
Code:	DSGV
Description:	Deposits Settled Gravel

Distance (ft):	.0
Structural Grade:	0
O&M Grade:	2
Clock Start/From:	5
Clock To:	7
1st Value:	
2nd Value:	
Value Percent:	10.000
Continuous Index:	S01
Within 8" of Joint:	YES
Remarks:

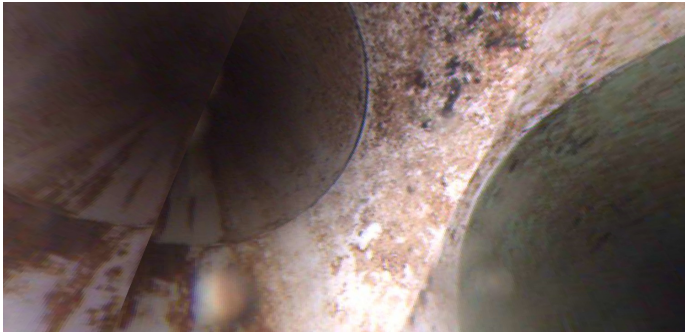
Code: **TF**
Description: **Tap Factory**

Distance (ft): **15.3**
Structural Grade: **0**
O&M Grade: **0**
Clock Start/From: **10**
Clock To:
1st Value: **4.000**
2nd Value:
Value Percent:
Continuous Index:
Within 8" of Joint:
Remarks:

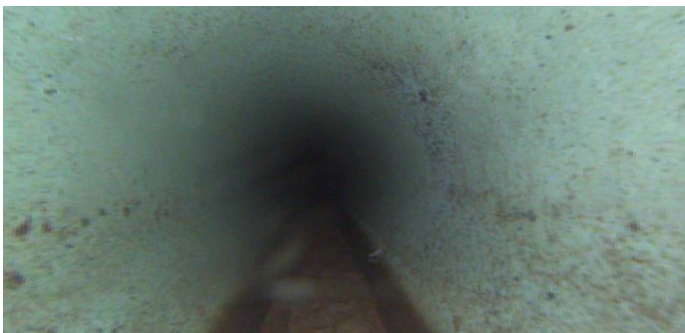
Code: **DSGV**
Description: **Deposits Settled Gravel**

Distance (ft): **18.4**
Structural Grade: **0**
O&M Grade: **2**
Clock Start/From: **5**
Clock To: **7**
1st Value:
2nd Value:
Value Percent: **10.000**
Continuous Index: **F01**
Within 8" of Joint: **YES**
Remarks:

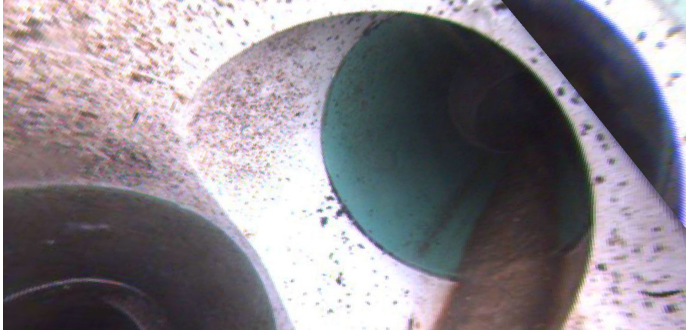
Code: **TF**
Description: **Tap Factory**

Distance (ft): **32.1**
Structural Grade: **0**
O&M Grade: **0**
Clock Start/From: **2**
Clock To:
1st Value: **4.000**
2nd Value:
Value Percent:
Continuous Index:
Within 8" of Joint:
Remarks:

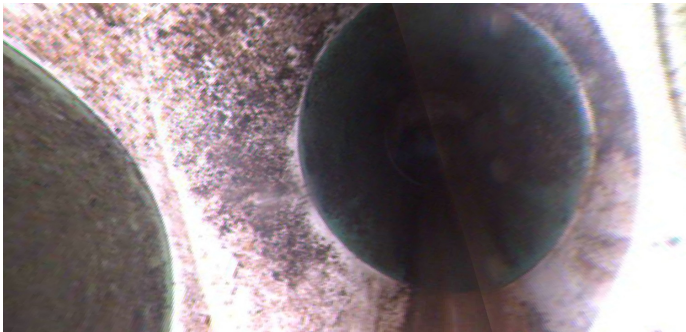
Code: **TF**
Description: **Tap Factory**

Distance (ft): **33.7**
Structural Grade: **0**
O&M Grade: **0**
Clock Start/From: **2**
Clock To:
1st Value: **4.000**
2nd Value:
Value Percent:
Continuous Index:
Within 8" of Joint:
Remarks:

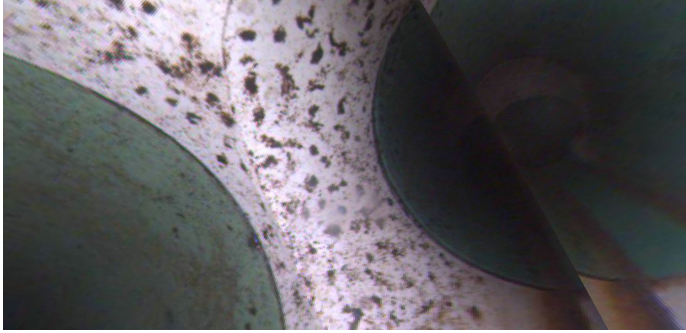
Code: **TF**
Description: **Tap Factory**

Distance (ft): **119.1**
Structural Grade: **0**
O&M Grade: **0**
Clock Start/From: **2**
Clock To:
1st Value: **4.000**
2nd Value:
Value Percent:
Continuous Index:
Within 8" of Joint:
Remarks:

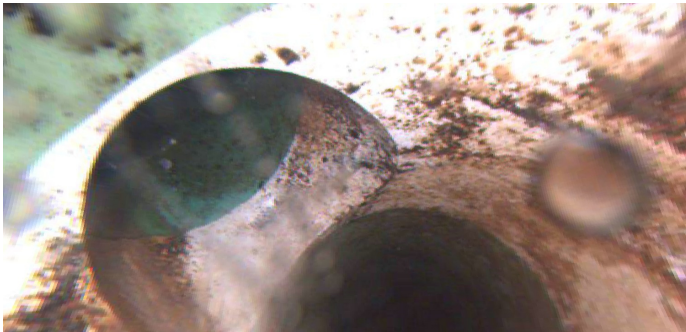
Code: **TF**
Description: **Tap Factory**

Distance (ft): **157.4**
Structural Grade: **0**
O&M Grade: **0**
Clock Start/From: **10**
Clock To:
1st Value: **4.000**
2nd Value:
Value Percent:
Continuous Index:
Within 8" of Joint:
Remarks:

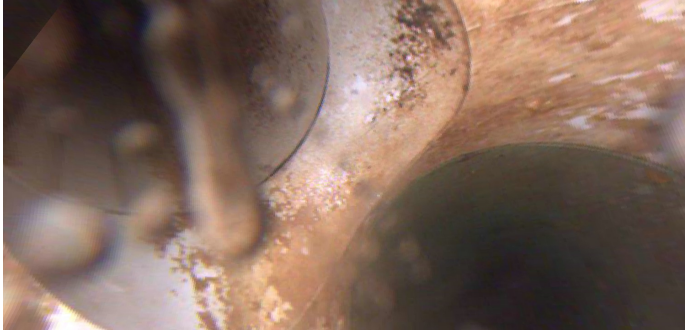
Code: **TF**
Description: **Tap Factory**

Distance (ft): **216.9**
Structural Grade: **0**
O&M Grade: **0**
Clock Start/From: **10**
Clock To:
1st Value: **4.000**
2nd Value:
Value Percent:
Continuous Index:
Within 8" of Joint:
Remarks:

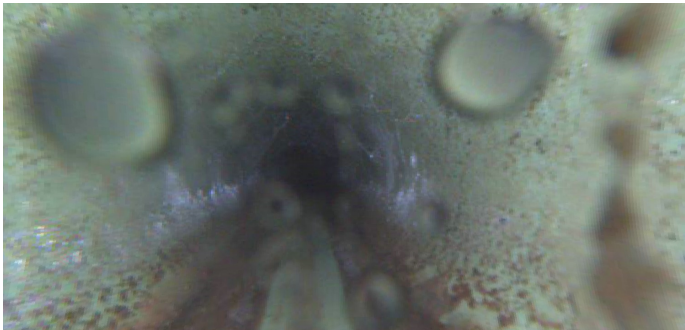
Code: **DAGS**
Description: **Deposits Attached Grease**

Distance (ft): **254.0**
Structural Grade: **0**
O&M Grade: **2**
Clock Start/From: **7**
Clock To: **5**
1st Value:
2nd Value:
Value Percent: **5.000**
Continuous Index: **S02**
Within 8" of Joint: **YES**
Remarks: **WANDER**

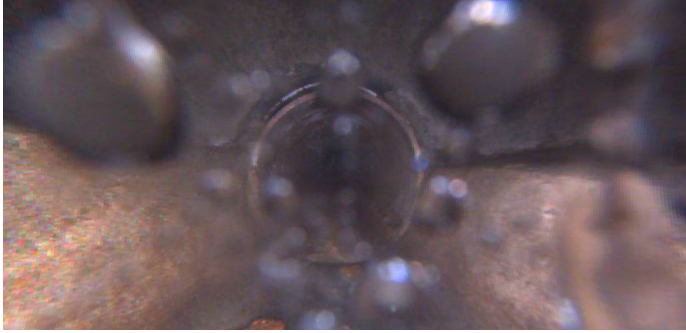
Code: **AMH**
Description: **Manhole**

Distance (ft): **274.9**
Structural Grade: **0**
O&M Grade: **0**
Clock Start/From:
Clock To:
1st Value:
2nd Value:
Value Percent:
Continuous Index:
Within 8" of Joint: **NO**
Remarks: **M-809-022**

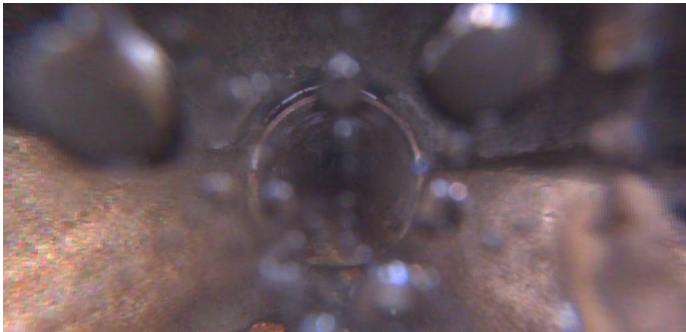
Code: **DAGS**
Description: **Deposits Attached Grease**

Distance (ft): **274.9**
Structural Grade: **0**
O&M Grade: **2**
Clock Start/From: **7**
Clock To: **5**
1st Value:
2nd Value:
Value Percent: **5.000**
Continuous Index: **F02**
Within 8" of Joint: **YES**
Remarks: **WANDER**
