Profile/Photo Observation Report

Date:	03/23/2018	Weather:		Coding:	PACP 6.0
Pipe Length (ft):	289.5	Owner:	NA	Pre Clean:	Not Known
P.O.#:		Surveyor:	Justin Gonzales	PSR:	P-809-023-022
Customer:		Clean Date:	01/01/1900	Shape:	C

Street:	Oak	Flow Control:	Not Controlled
City:	Hobart, IN	Year Renewed:	
Location:	Sidewalk	Tape/Media #:	
Purpose:	Maintenance Related	Dia/Height:	8"
Use:	Sanitary	Material:	PVC
Drain Area:	NA	Lining:	
Category:	NA		
Comment:	flow incorrect.

Location Details:		Direction of Survey:	Upstream
US MH:	M-809-022	DS MH:	M-809-023
		Total Length Surveyed (ft):	274.9

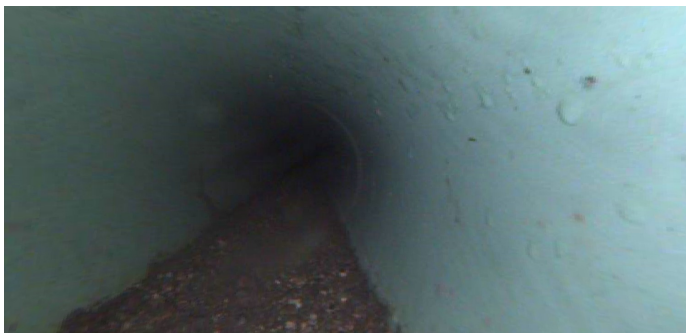
Code: **AMH**
Description: **Manhole**

Distance (ft): **.0**
Structural Grade: **0**
O&M Grade: **0**
Clock Start/From:
Clock To:
1st Value:
2nd Value:
Value Percent:
Continuous Index:
Within 8" of Joint: **NO**
Remarks: **M-809-023**

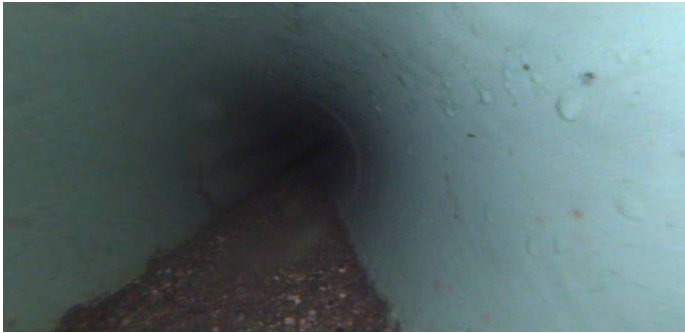
Code:	MWL
Description:	Water Level

Distance (ft):	.0
Structural Grade:	0
O&M Grade:	0
Clock Start/From:	
Clock To:	
1st Value:	
2nd Value:	
Value Percent:	0.000
Continuous Index:	
Within 8" of Joint:	NO
Remarks:

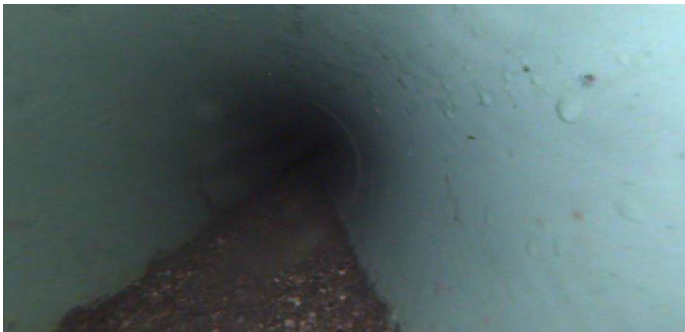
Code:	DSGV
Description:	Deposits Settled Gravel

Distance (ft):	.0
Structural Grade:	0
O&M Grade:	2
Clock Start/From:	5
Clock To:	7
1st Value:	
2nd Value:	
Value Percent:	10.000
Continuous Index:	S01
Within 8" of Joint:	YES
Remarks:

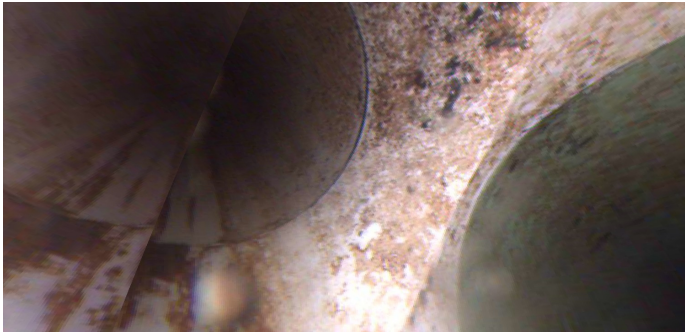
Code: **TF**
Description: **Tap Factory**

Distance (ft): **15.3**
Structural Grade: **0**
O&M Grade: **0**
Clock Start/From: **10**
Clock To:
1st Value: **4.000**
2nd Value:
Value Percent:
Continuous Index:
Within 8" of Joint:
Remarks:

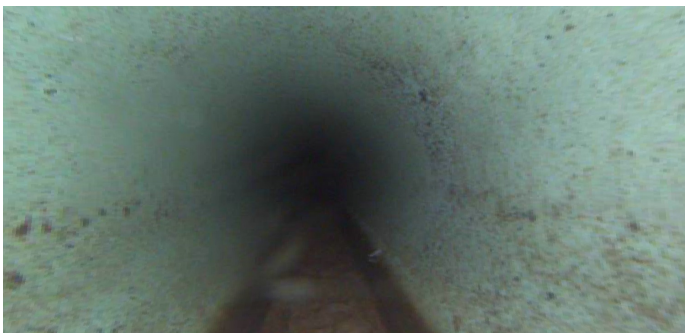
Code: **DSGV**
Description: **Deposits Settled Gravel**

Distance (ft): **18.4**
Structural Grade: **0**
O&M Grade: **2**
Clock Start/From: **5**
Clock To: **7**
1st Value:
2nd Value:
Value Percent: **10.000**
Continuous Index: **F01**
Within 8" of Joint: **YES**
Remarks:

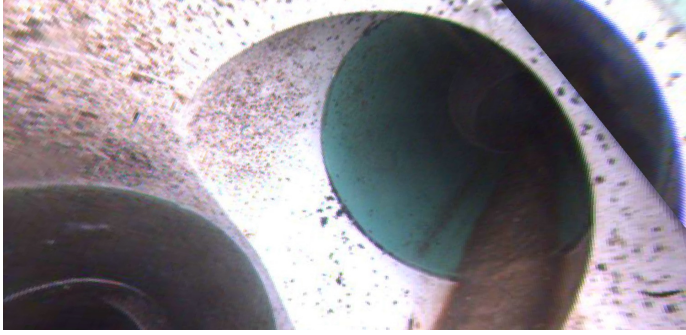
Code: **TF**
Description: **Tap Factory**

Distance (ft): **32.1**
Structural Grade: **0**
O&M Grade: **0**
Clock Start/From: **2**
Clock To:
1st Value: **4.000**
2nd Value:
Value Percent:
Continuous Index:
Within 8" of Joint:
Remarks:

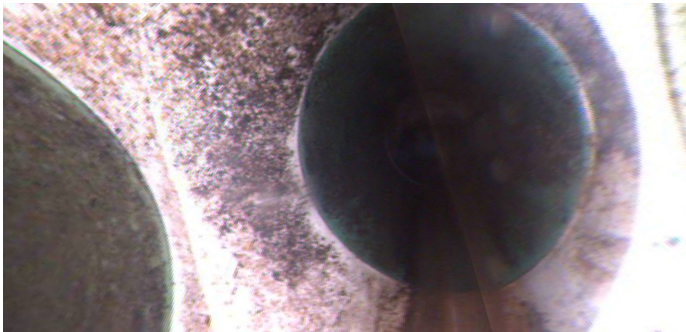
Code: **TF**
Description: **Tap Factory**

Distance (ft): **33.7**
Structural Grade: **0**
O&M Grade: **0**
Clock Start/From: **2**
Clock To:
1st Value: **4.000**
2nd Value:
Value Percent:
Continuous Index:
Within 8" of Joint:
Remarks:

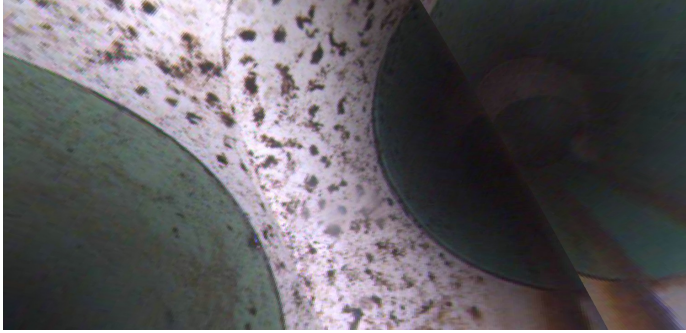
Code: **TF**
Description: **Tap Factory**

Distance (ft): **119.1**
Structural Grade: **0**
O&M Grade: **0**
Clock Start/From: **2**
Clock To:
1st Value: **4.000**
2nd Value:
Value Percent:
Continuous Index:
Within 8" of Joint:
Remarks:

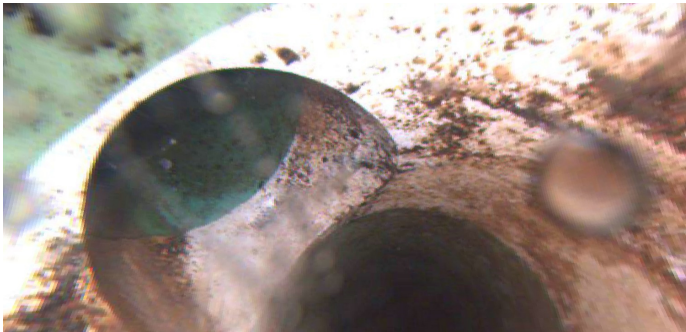
Code: **TF**
Description: **Tap Factory**

Distance (ft): **157.4**
Structural Grade: **0**
O&M Grade: **0**
Clock Start/From: **10**
Clock To:
1st Value: **4.000**
2nd Value:
Value Percent:
Continuous Index:
Within 8" of Joint:
Remarks:

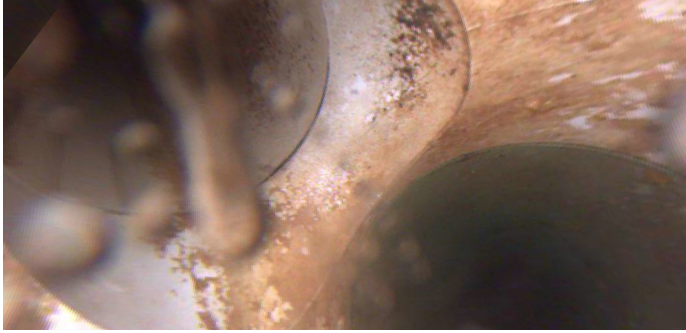
Code: **TF**
Description: **Tap Factory**

Distance (ft): **216.9**
Structural Grade: **0**
O&M Grade: **0**
Clock Start/From: **10**
Clock To:
1st Value: **4.000**
2nd Value:
Value Percent:
Continuous Index:
Within 8" of Joint:
Remarks:

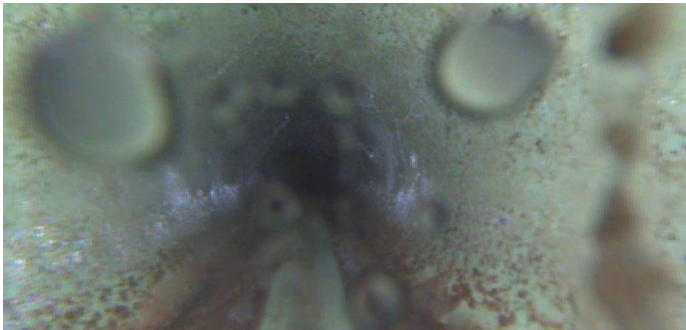
Code: **DAGS**
Description: **Deposits Attached Grease**

Distance (ft): **254.0**
Structural Grade: **0**
O&M Grade: **2**
Clock Start/From: **7**
Clock To: **5**
1st Value:
2nd Value:
Value Percent: **5.000**
Continuous Index: **S02**
Within 8" of Joint: **YES**
Remarks: **WANDER**

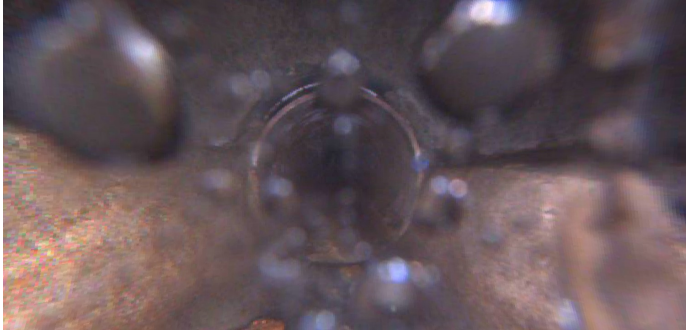
Code: **AMH**
Description: **Manhole**

Distance (ft): **274.9**
Structural Grade: **0**
O&M Grade: **0**
Clock Start/From:
Clock To:
1st Value:
2nd Value:
Value Percent:
Continuous Index:
Within 8" of Joint: **NO**
Remarks: **M-809-022**

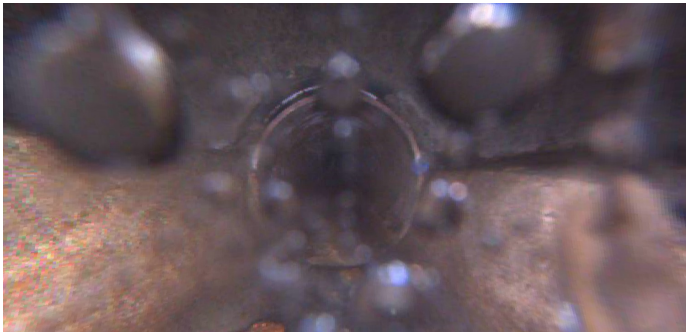
Code: **DAGS**
Description: **Deposits Attached Grease**

Distance (ft): **274.9**
Structural Grade: **0**
O&M Grade: **2**
Clock Start/From: **7**
Clock To: **5**
1st Value:
2nd Value:
Value Percent: **5.000**
Continuous Index: **F02**
Within 8" of Joint: **YES**
Remarks: **WANDER**
