Profile/Photo Observation Report

Date:	03/28/2018	Weather:		Coding:	PACP 6.0
Pipe Length (ft):	289.5	Owner:	NA	Pre Clean:	Not Known
P.O.#:		Surveyor:	Selasie Honu	PSR:	P-809-023-022
Customer:		Clean Date:	01/01/1900	Shape:	C

Street:	BRACKEN PKWY	Flow Control:	Not Controlled
City:	Hobart, IN	Year Renewed:	
Location:	Sidewalk	Tape/Media #:	
Purpose:	Maintenance Related	Dia/Height:	8"
Use:	Sanitary	Material:	PVC
Drain Area:	NA	Lining:	
Category:	NA		
Comment:	Flow direction wrong. Redeployment.		
Location Details:		Direction of Survey:	Upstream
US MH:	M-809-022	DS MH:	M-809-023
		Total Length Surveyed (ft):	93.0

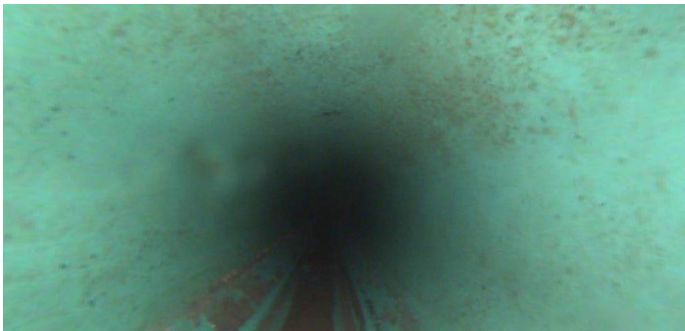
Code: **AMH**
Description: **Manhole**

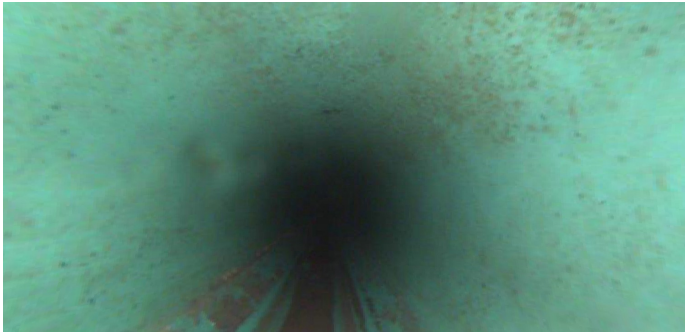
Code:	MWL
Description:	Water Level

Distance (ft):	.0
Structural Grade:	0
O&M Grade:	0
Clock Start/From:	
Clock To:	
1st Value:	
2nd Value:	
Value Percent:	5.000
Continuous Index:	
Within 8" of Joint:	NO
Remarks:

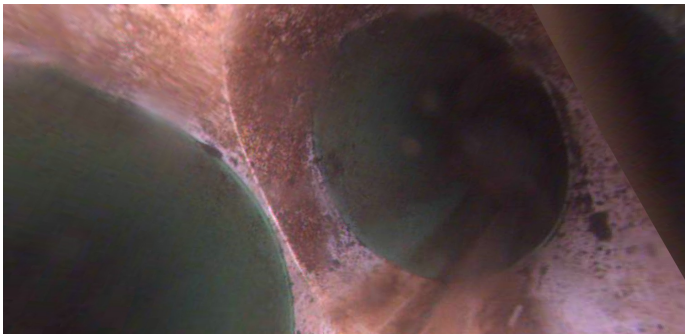
Code:	TF
Description:	Tap Factory

Distance (ft):	9.0
Structural Grade:	0
O&M Grade:	0
Clock Start/From:	10
Clock To:	
1st Value:	4.000
2nd Value:	
Value Percent:	
Continuous Index:	
Within 8" of Joint:	
Remarks:

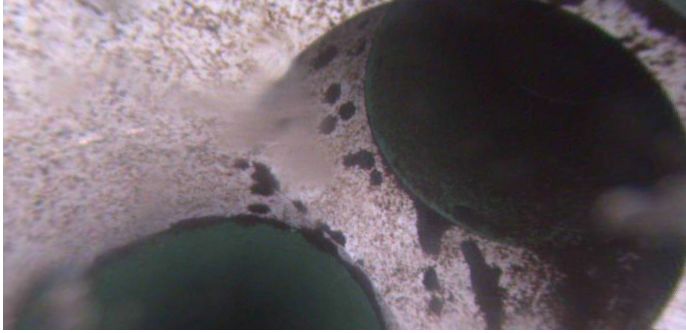
Code: **TF**
Description: **Tap Factory**

Distance (ft): **58.5**
Structural Grade: **0**
O&M Grade: **0**
Clock Start/From: **2**
Clock To:
1st Value: **4.000**
2nd Value:
Value Percent:
Continuous Index:
Within 8" of Joint:
Remarks:

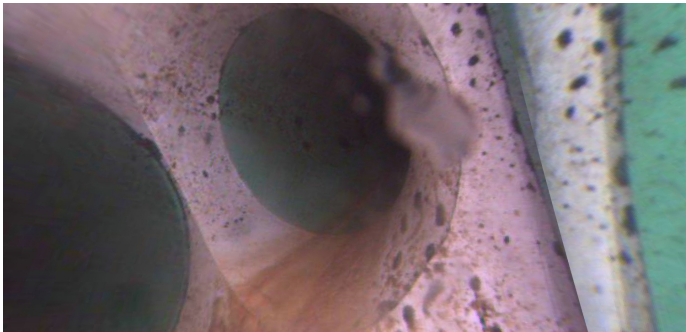
Code: **TF**
Description: **Tap Factory**

Distance (ft): **84.9**
Structural Grade: **0**
O&M Grade: **0**
Clock Start/From: **10**
Clock To:
1st Value: **4.000**
2nd Value:
Value Percent:
Continuous Index:
Within 8" of Joint:
Remarks:

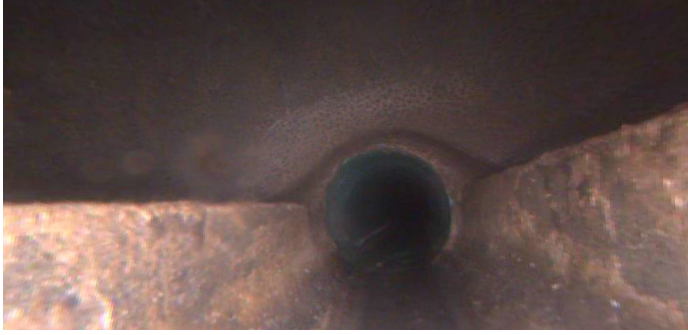
Code:	AMH
Description:	Manhole
Distance (ft):	93.0
Structural Grade:	0
O&M Grade:	0
Clock Start/From:	
Clock To:	
1st Value:	
2nd Value:	
Value Percent:	
Continuous Index:	
Within 8" of Joint:	NO
Remarks:	M-809-022
