Profile/Photo Observation Report

Date:	03/28/2018	Weather:		Coding:	PACP 6.0
Pipe Length (ft):	289.5	Owner:	NA	Pre Clean:	Not Known
P.O.#:		Surveyor:	Selasie Honu	PSR:	P-809-023-022
Customer:		Clean Date:	01/01/1900	Shape:	C

Location Details:		Direction of Survey:	Upstream
US MH:	M-809-022	DS MH:	M-809-023
		Total Length Surveyed (ft):	93.0

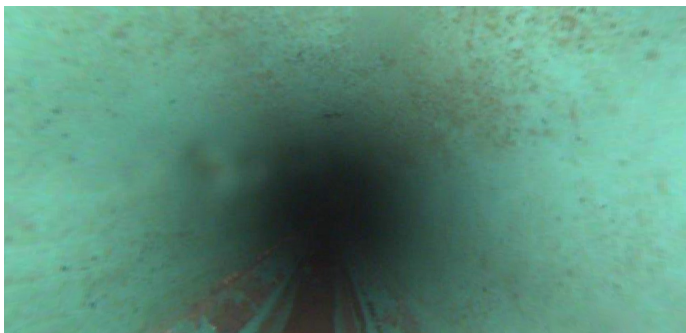
Code: **AMH**
Description: **Manhole**

Distance (ft): **.0**
Structural Grade: **0**
O&M Grade: **0**
Clock Start/From:
Clock To:
1st Value:
2nd Value:
Value Percent:
Continuous Index:
Within 8" of Joint: **NO**
Remarks: **M-809-023**

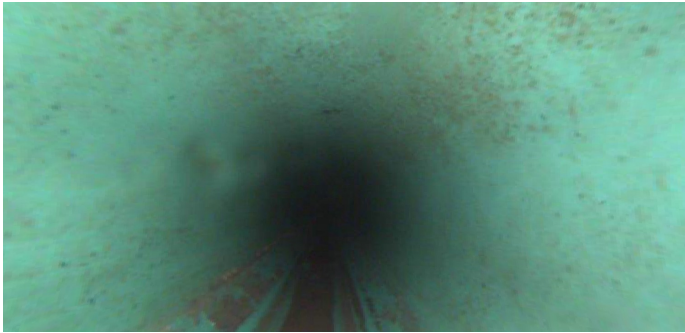
Code:	MWL
Description:	Water Level

Distance (ft):	.0
Structural Grade:	0
O&M Grade:	0
Clock Start/From:	
Clock To:	
1st Value:	
2nd Value:	
Value Percent:	5.000
Continuous Index:	
Within 8" of Joint:	NO
Remarks:

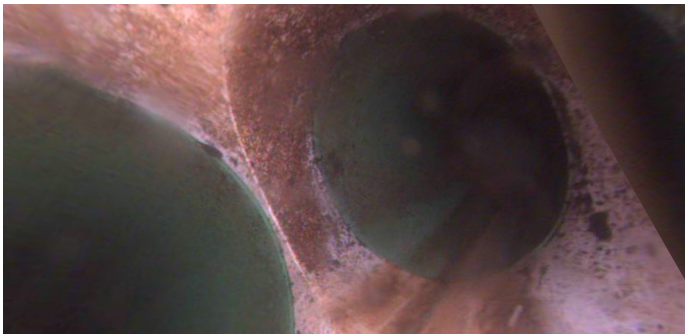
Code:	TF
Description:	Tap Factory

Distance (ft):	9.0
Structural Grade:	0
O&M Grade:	0
Clock Start/From:	10
Clock To:	
1st Value:	4.000
2nd Value:	
Value Percent:	
Continuous Index:	
Within 8" of Joint:	
Remarks:

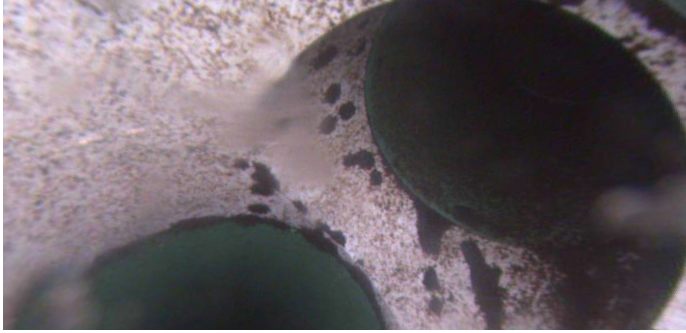
Code: **TF**
Description: **Tap Factory**

Distance (ft): **58.5**
Structural Grade: **0**
O&M Grade: **0**
Clock Start/From: **2**
Clock To:
1st Value: **4.000**
2nd Value:
Value Percent:
Continuous Index:
Within 8" of Joint:
Remarks:

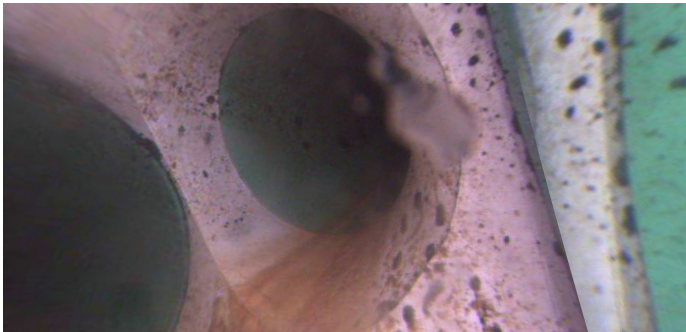
Code: **TF**
Description: **Tap Factory**

Distance (ft): **84.9**
Structural Grade: **0**
O&M Grade: **0**
Clock Start/From: **10**
Clock To:
1st Value: **4.000**
2nd Value:
Value Percent:
Continuous Index:
Within 8" of Joint:
Remarks:

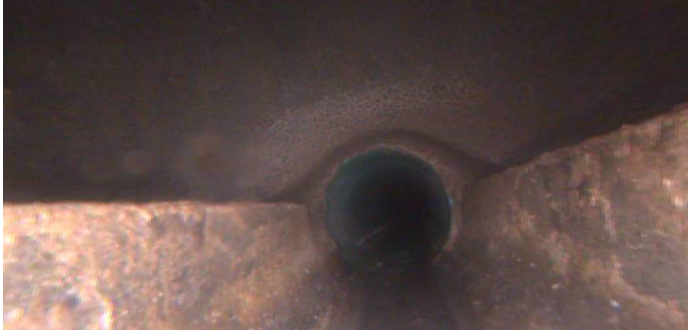
Code:	AMH
Description:	Manhole
Distance (ft):	93.0
Structural Grade:	0
O&M Grade:	0
Clock Start/From:	
Clock To:	
1st Value:	
2nd Value:	
Value Percent:	
Continuous Index:	
Within 8" of Joint:	NO
Remarks:	M-809-022
