Profile/Photo Observation Report

Street:	Oak	Flow Control:	Not Controlled
City:	Hobart, IN	Year Renewed:	
Location:	Sidewalk	Tape/Media #:	
Purpose:	Maintenance Related	Dia/Height:	8"
Use:	Sanitary	Material:	PVC
Drain Area:	NA	Lining:	
Category:	NA		
Comment:	mh confirmed. flow direction incorrect.

Location Details:		Direction of Survey:	Downstream
US MH:	M-809-025	DS MH:	M-809-024
		Total Length Surveyed (ft):	214.5

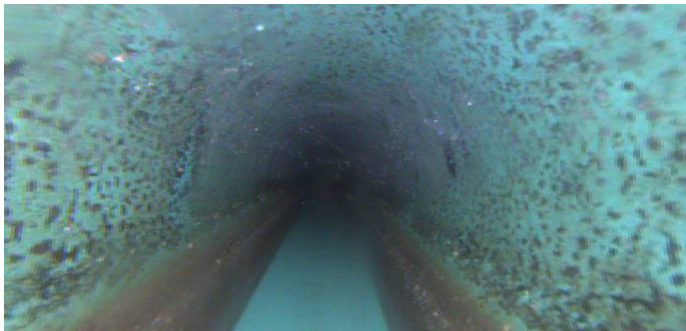
Code: **AMH**
Description: **Manhole**

Distance (ft): **.0**
Structural Grade: **0**
O&M Grade: **0**
Clock Start/From:
Clock To:
1st Value:
2nd Value:
Value Percent:
Continuous Index:
Within 8" of Joint: **NO**
Remarks: **M-809-025**

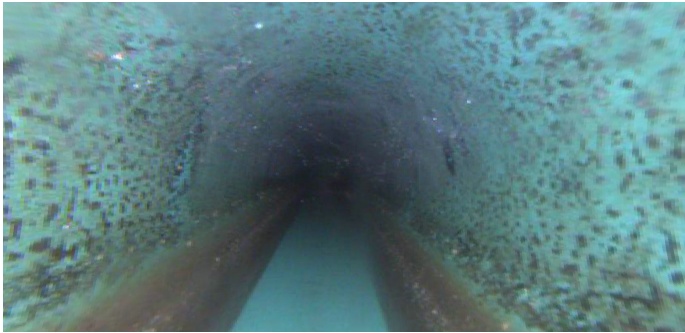
Code:	MWL
Description:	Water Level

Distance (ft):	.0
Structural Grade:	0
O&M Grade:	0
Clock Start/From:	
Clock To:	
1st Value:	
2nd Value:	
Value Percent:	5.000
Continuous Index:	
Within 8" of Joint:	NO
Remarks:

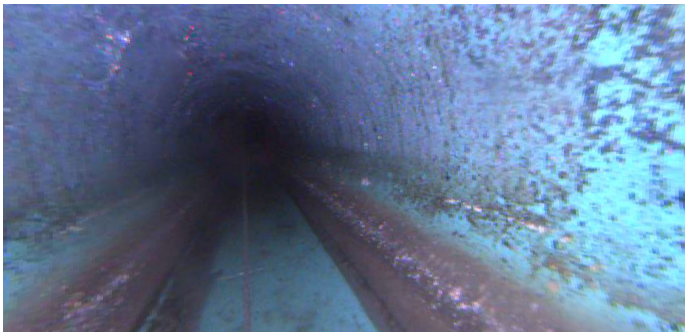
Code:	MGO
Description:	General Observation

Distance (ft):	3.3
Structural Grade:	0
O&M Grade:	0
Clock Start/From:	
Clock To:	
1st Value:	
2nd Value:	
Value Percent:	
Continuous Index:	
Within 8" of Joint:	NO
Remarks:	switching to rear view

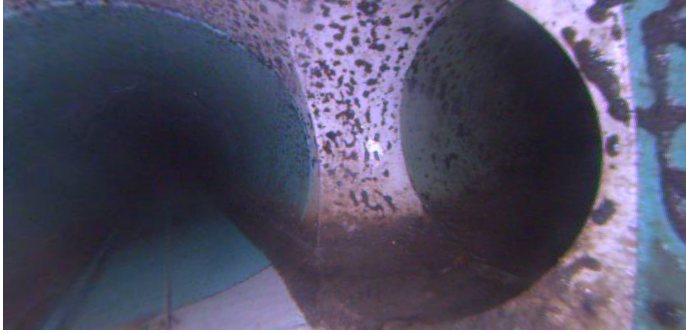
Code: **TFA**
Description: **Tap Factory Active**

Distance (ft): **78.0**
Structural Grade: **0**
O&M Grade: **0**
Clock Start/From: **9**
Clock To:
1st Value: **4.000**
2nd Value:
Value Percent:
Continuous Index:
Within 8" of Joint:
Remarks:

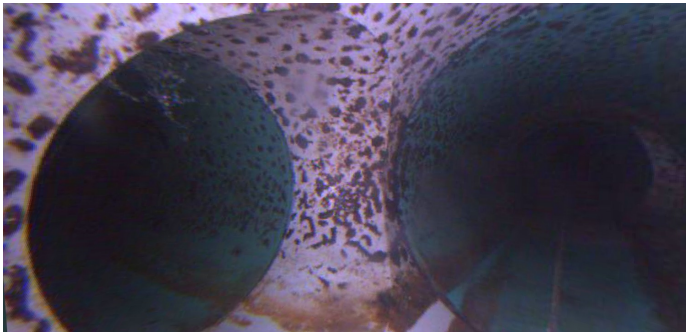
Code: **TF**
Description: **Tap Factory**

Distance (ft): **79.6**
Structural Grade: **0**
O&M Grade: **0**
Clock Start/From: **3**
Clock To:
1st Value: **4.000**
2nd Value:
Value Percent:
Continuous Index:
Within 8" of Joint:
Remarks:

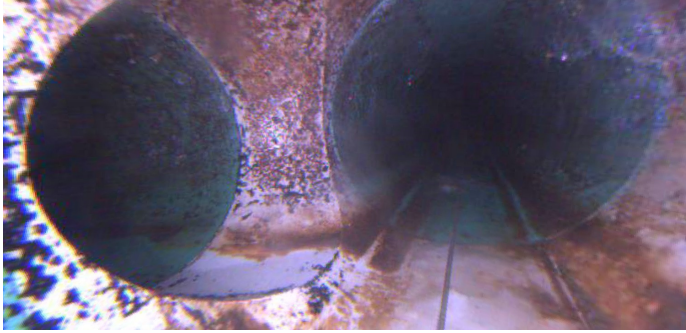
Code: **TF**
Description: **Tap Factory**

Distance (ft): **137.2**
Structural Grade: **0**
O&M Grade: **0**
Clock Start/From: **3**
Clock To:
1st Value: **4.000**
2nd Value:
Value Percent:
Continuous Index:
Within 8" of Joint:
Remarks:

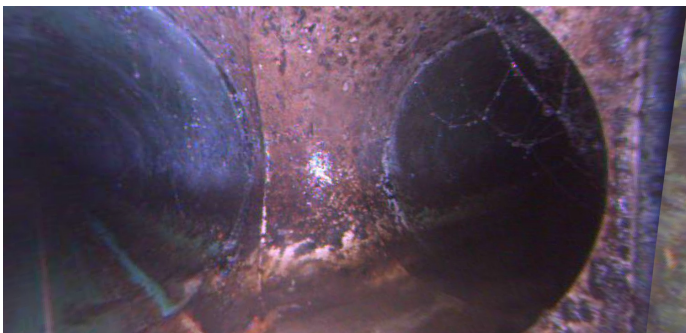
Code: **TFA**
Description: **Tap Factory Active**

Distance (ft): **157.6**
Structural Grade: **0**
O&M Grade: **0**
Clock Start/From: **9**
Clock To:
1st Value: **4.000**
2nd Value:
Value Percent:
Continuous Index:
Within 8" of Joint:
Remarks:

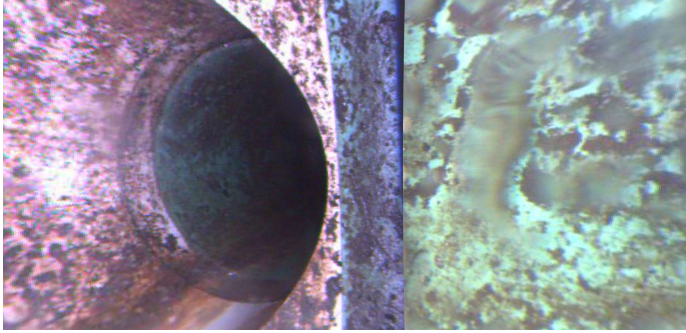
Code: **TF**
Description: **Tap Factory**

Distance (ft): **197.0**
Structural Grade: **0**
O&M Grade: **0**
Clock Start/From: **9**
Clock To:
1st Value: **4.000**
2nd Value:
Value Percent:
Continuous Index:
Within 8" of Joint:
Remarks:

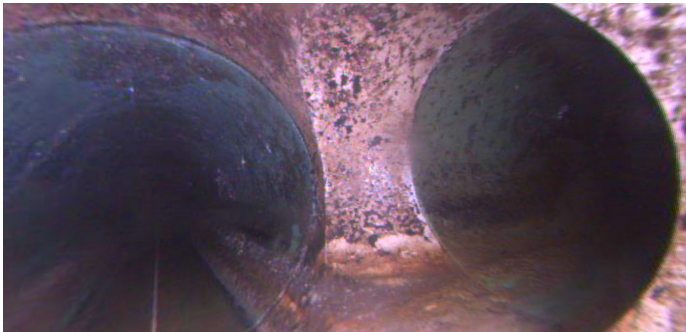
Code: **TFA**
Description: **Tap Factory Active**

Distance (ft): **206.7**
Structural Grade: **0**
O&M Grade: **0**
Clock Start/From: **9**
Clock To:
1st Value: **4.000**
2nd Value:
Value Percent:
Continuous Index:
Within 8" of Joint:
Remarks:

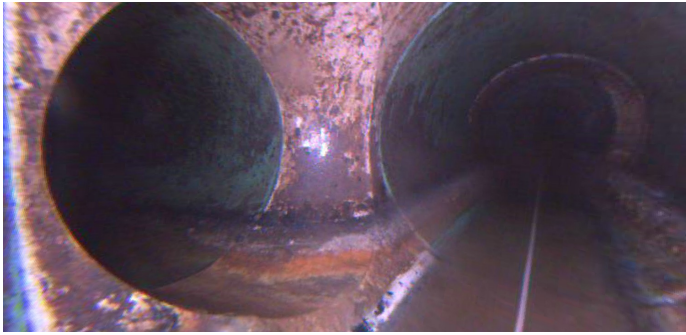
Code: **TF**
Description: **Tap Factory**

Distance (ft): **208.5**
Structural Grade: **0**
O&M Grade: **0**
Clock Start/From: **3**
Clock To:
1st Value: **4.000**
2nd Value:
Value Percent:
Continuous Index:
Within 8" of Joint:
Remarks:

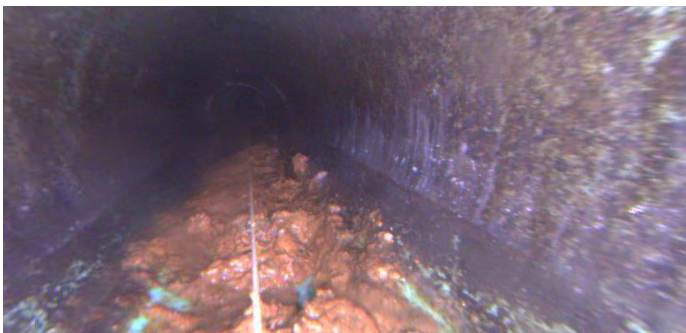
Code: **DSZ**
Description: **Deposits Settled Other**

Distance (ft): **211.7**
Structural Grade: **0**
O&M Grade: **2**
Clock Start/From: **5**
Clock To: **7**
1st Value:
2nd Value:
Value Percent: **10.000**
Continuous Index:
Within 8" of Joint: **NO**
Remarks: **misc**

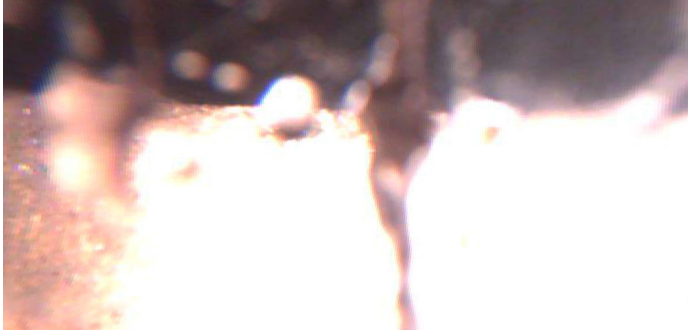
Code:	AMH
Description:	Manhole
Distance (ft):	214.5
Structural Grade:	0
O&M Grade:	0
Clock Start/From:	
Clock To:	
1st Value:	
2nd Value:	
Value Percent:	
Continuous Index:	
Within 8" of Joint:	NO
Remarks:	M-809-024
