Profile/Photo Observation Report

Street:	MURRELET ST	Flow Control:	Not Controlled
City:	Hobart, IN	Year Renewed:	
Location:	Sidewalk	Tape/Media #:	
Purpose:	Maintenance Related	Dia/Height:	8"
Use:	Sanitary	Material:	PVC
Drain Area:	NA	Lining:	
Category:	NA		
Comment:

Location Details:		Direction of Survey:	Upstream
US MH:	M-809-026	DS MH:	M-809-025
		Total Length Surveyed (ft):	226.3

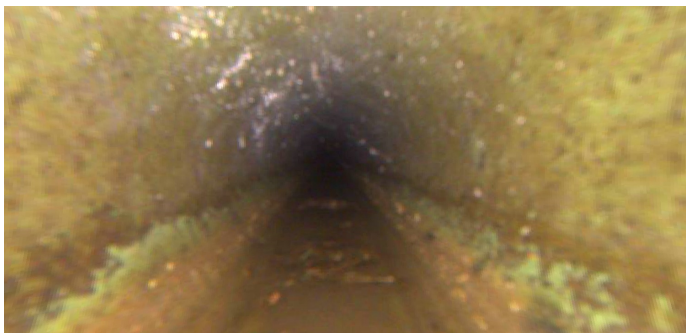
Code: **AMH**
Description: **Manhole**

Distance (ft): **.0**
Structural Grade: **0**
O&M Grade: **0**
Clock Start/From:
Clock To:
1st Value:
2nd Value:
Value Percent:
Continuous Index:
Within 8" of Joint: **NO**
Remarks: **M-809-025**

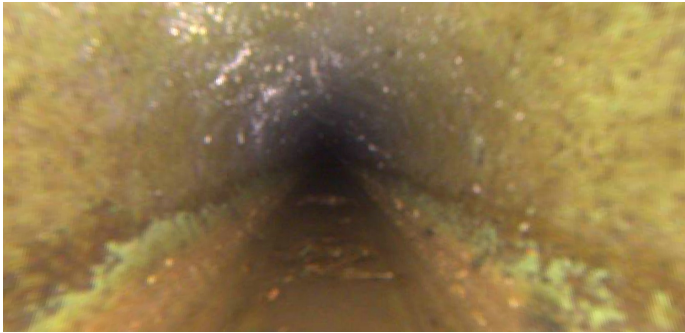
Code:	MWL
Description:	Water Level

Distance (ft):	.0
Structural Grade:	0
O&M Grade:	0
Clock Start/From:	
Clock To:	
1st Value:	
2nd Value:	
Value Percent:	5.000
Continuous Index:	
Within 8" of Joint:	NO
Remarks:

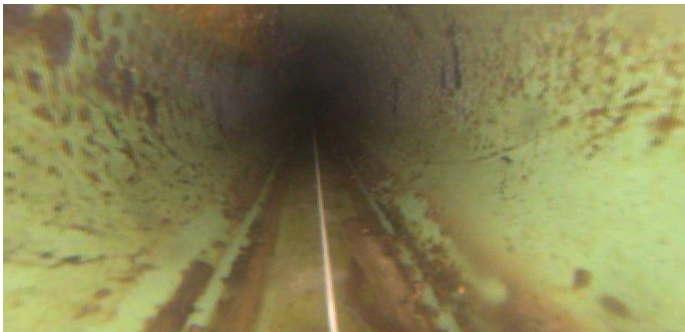
Code:	MGO
Description:	General Observation

Distance (ft):	30.2
Structural Grade:	0
O&M Grade:	0
Clock Start/From:	
Clock To:	
1st Value:	
2nd Value:	
Value Percent:	
Continuous Index:	
Within 8" of Joint:	NO
Remarks:	switching to rear view

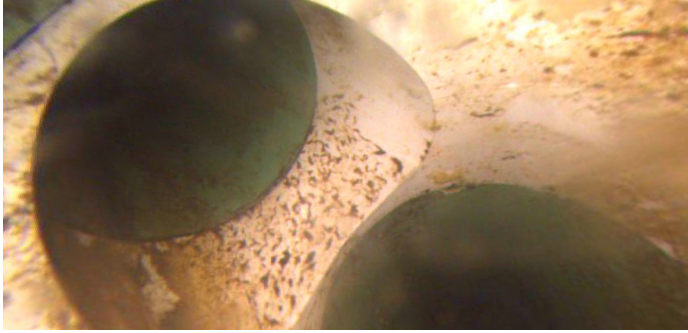
Code: **TF**
Description: **Tap Factory**

Distance (ft): **32.4**
Structural Grade: **0**
O&M Grade: **0**
Clock Start/From: **2**
Clock To:
1st Value: **4.000**
2nd Value:
Value Percent:
Continuous Index:
Within 8" of Joint:
Remarks:

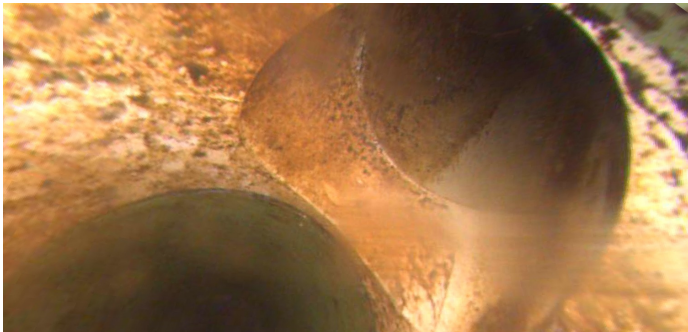
Code: **TF**
Description: **Tap Factory**

Distance (ft): **51.1**
Structural Grade: **0**
O&M Grade: **0**
Clock Start/From: **10**
Clock To:
1st Value: **4.000**
2nd Value:
Value Percent:
Continuous Index:
Within 8" of Joint:
Remarks:

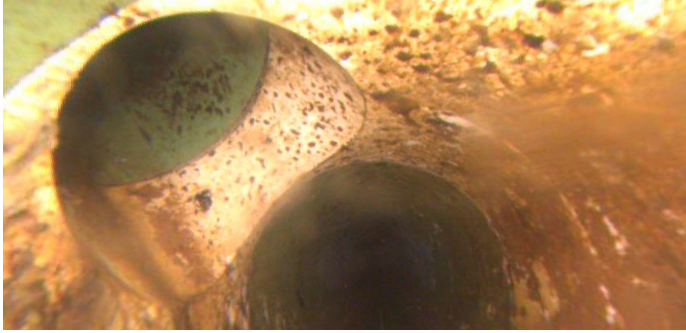
Code: **TF**
Description: **Tap Factory**

Distance (ft): **115.0**
Structural Grade: **0**
O&M Grade: **0**
Clock Start/From: **2**
Clock To:
1st Value: **4.000**
2nd Value:
Value Percent:
Continuous Index:
Within 8" of Joint:
Remarks:

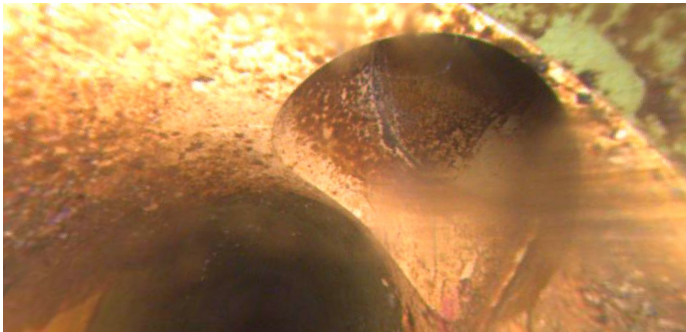
Code: **TF**
Description: **Tap Factory**

Distance (ft): **127.9**
Structural Grade: **0**
O&M Grade: **0**
Clock Start/From: **10**
Clock To:
1st Value: **4.000**
2nd Value:
Value Percent:
Continuous Index:
Within 8" of Joint:
Remarks:

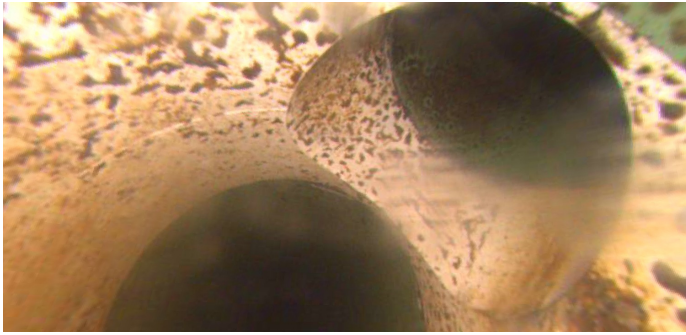
Code: **TFA**
Description: **Tap Factory Active**

Distance (ft): **184.1**
Structural Grade: **0**
O&M Grade: **0**
Clock Start/From: **10**
Clock To:
1st Value: **4.000**
2nd Value:
Value Percent:
Continuous Index:
Within 8" of Joint:
Remarks:

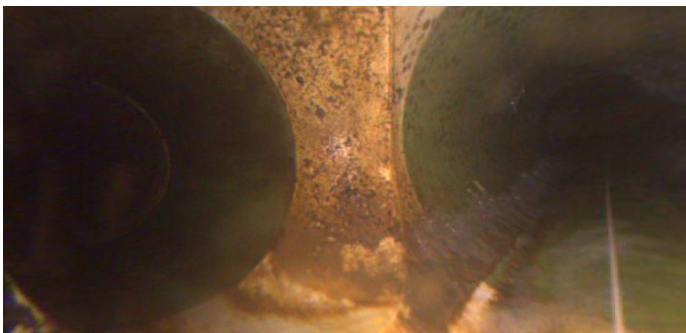
Code: **TFA**
Description: **Tap Factory Active**

Distance (ft): **199.2**
Structural Grade: **0**
O&M Grade: **0**
Clock Start/From: **3**
Clock To:
1st Value: **4.000**
2nd Value:
Value Percent:
Continuous Index:
Within 8" of Joint:
Remarks:

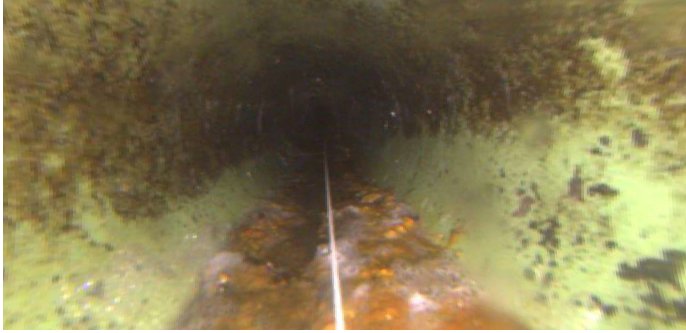
Code: **DSGV**
Description: **Deposits Settled Gravel**

Distance (ft): **209.8**
Structural Grade: **0**
O&M Grade: **2**
Clock Start/From: **5**
Clock To: **7**
1st Value:
2nd Value:
Value Percent: **5.000**
Continuous Index: **S01**
Within 8" of Joint: **NO**
Remarks:

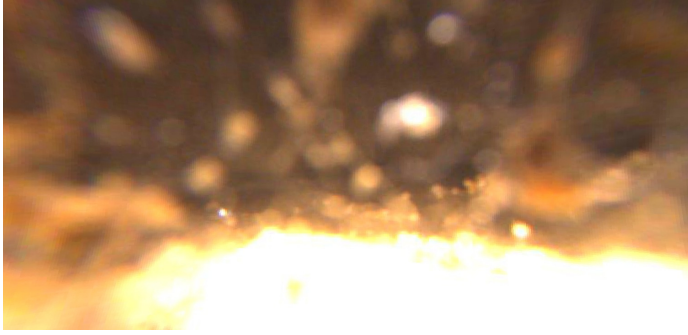
Code:	AMH
Description:	Manhole
Distance (ft):	226.3
Structural Grade:	0
O&M Grade:	0
Clock Start/From:	
Clock To:	
1st Value:	
2nd Value:	
Value Percent:	
Continuous Index:	
Within 8" of Joint:	NO
Remarks:	M-809-026
