Profile/Photo Observation Report

Street:	Oak	Flow Control:	Not Controlled
City:	Hobart, IN	Year Renewed:	
Location:	Sidewalk	Tape/Media #:	
Purpose:	Maintenance Related	Dia/Height:	8"
Use:	Sanitary	Material:	PVC
Drain Area:	NA	Lining:	
Category:	NA		
Comment:

Location Details:		Direction of Survey:	Upstream
US MH:	M-809-026	DS MH:	M-809-025
		Total Length Surveyed (ft):	226.3

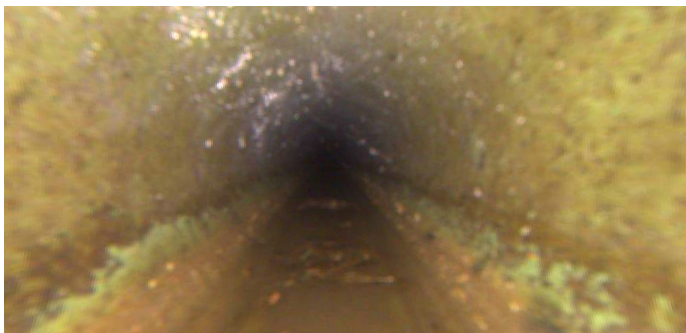
Code: **AMH**
Description: **Manhole**

Distance (ft): **.0**
Structural Grade: **0**
O&M Grade: **0**
Clock Start/From:
Clock To:
1st Value:
2nd Value:
Value Percent:
Continuous Index:
Within 8" of Joint: **NO**
Remarks: **M-809-025**

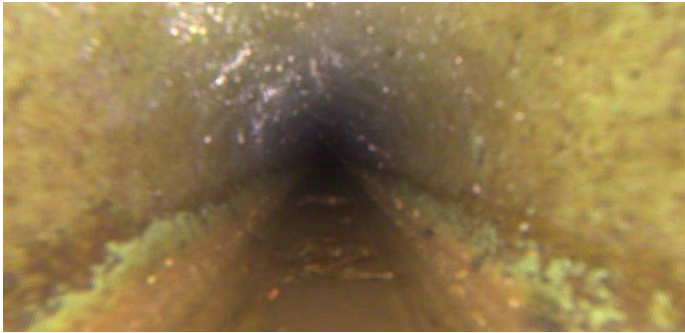
Code:	MWL
Description:	Water Level

Distance (ft):	.0
Structural Grade:	0
O&M Grade:	0
Clock Start/From:	
Clock To:	
1st Value:	
2nd Value:	
Value Percent:	5.000
Continuous Index:	
Within 8" of Joint:	NO
Remarks:

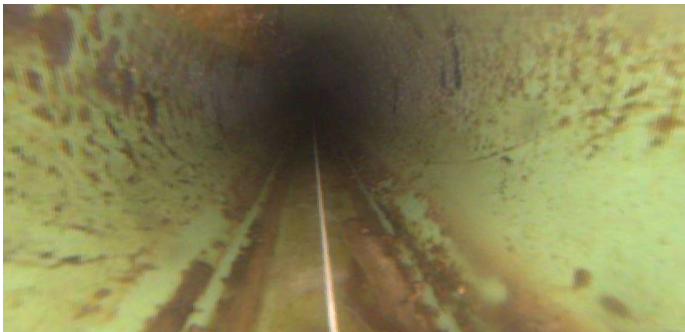
Code:	MGO
Description:	General Observation

Distance (ft):	30.2
Structural Grade:	0
O&M Grade:	0
Clock Start/From:	
Clock To:	
1st Value:	
2nd Value:	
Value Percent:	
Continuous Index:	
Within 8" of Joint:	NO
Remarks:	switching to rear view

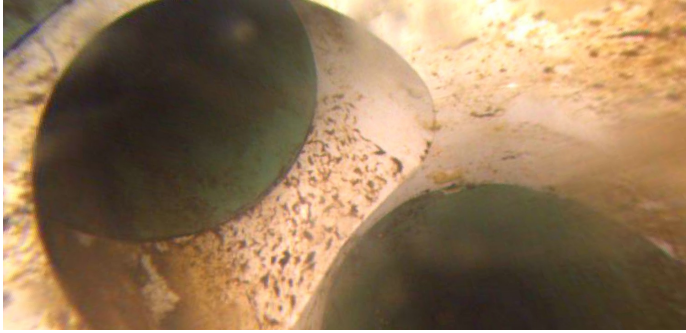
Code: **TF**
Description: **Tap Factory**

Distance (ft): **32.4**
Structural Grade: **0**
O&M Grade: **0**
Clock Start/From: **2**
Clock To:
1st Value: **4.000**
2nd Value:
Value Percent:
Continuous Index:
Within 8" of Joint:
Remarks:

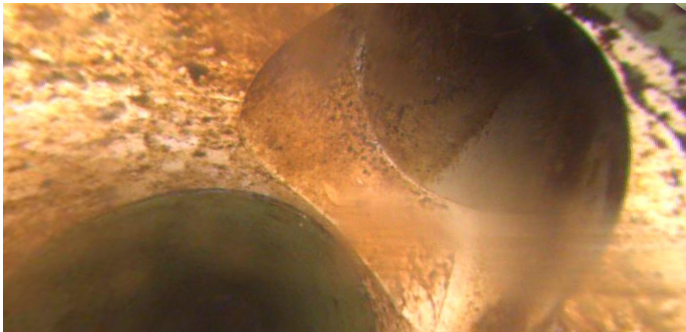
Code: **TF**
Description: **Tap Factory**

Distance (ft): **51.1**
Structural Grade: **0**
O&M Grade: **0**
Clock Start/From: **10**
Clock To:
1st Value: **4.000**
2nd Value:
Value Percent:
Continuous Index:
Within 8" of Joint:
Remarks:

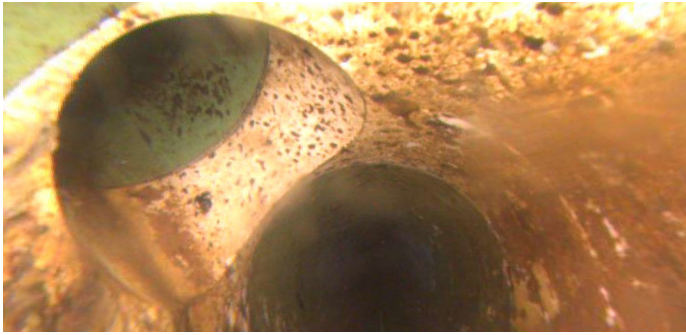
Code: **TF**
Description: **Tap Factory**

Distance (ft): **115.0**
Structural Grade: **0**
O&M Grade: **0**
Clock Start/From: **2**
Clock To:
1st Value: **4.000**
2nd Value:
Value Percent:
Continuous Index:
Within 8" of Joint:
Remarks:

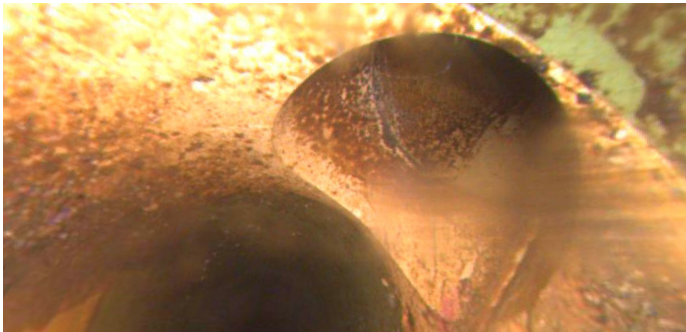
Code: **TF**
Description: **Tap Factory**

Distance (ft): **127.9**
Structural Grade: **0**
O&M Grade: **0**
Clock Start/From: **10**
Clock To:
1st Value: **4.000**
2nd Value:
Value Percent:
Continuous Index:
Within 8" of Joint:
Remarks:

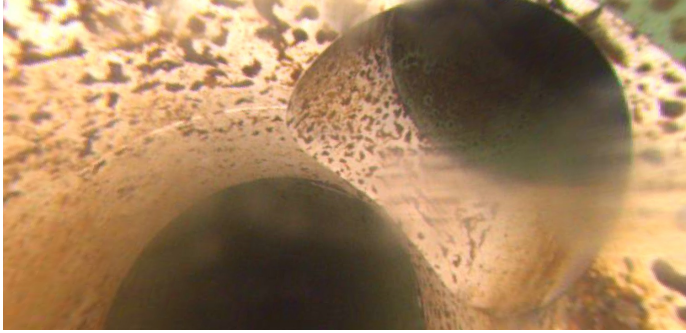
Code: **TFA**
Description: **Tap Factory Active**

Distance (ft): **184.1**
Structural Grade: **0**
O&M Grade: **0**
Clock Start/From: **10**
Clock To:
1st Value: **4.000**
2nd Value:
Value Percent:
Continuous Index:
Within 8" of Joint:
Remarks:

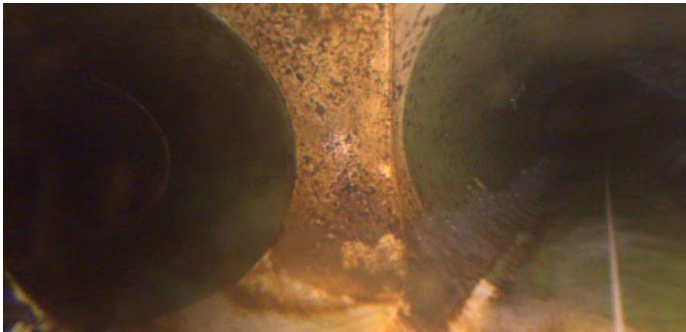
Code: **TFA**
Description: **Tap Factory Active**

Distance (ft): **199.2**
Structural Grade: **0**
O&M Grade: **0**
Clock Start/From: **3**
Clock To:
1st Value: **4.000**
2nd Value:
Value Percent:
Continuous Index:
Within 8" of Joint:
Remarks:

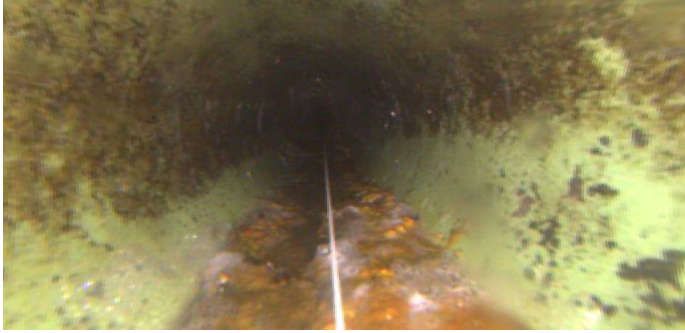
Code: **DSGV**
Description: **Deposits Settled Gravel**

Distance (ft): **209.8**
Structural Grade: **0**
O&M Grade: **2**
Clock Start/From: **5**
Clock To: **7**
1st Value:
2nd Value:
Value Percent: **5.000**
Continuous Index: **S01**
Within 8" of Joint: **NO**
Remarks:

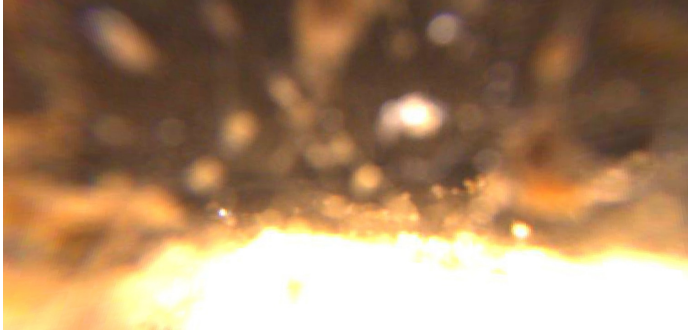
Code:	AMH
Description:	Manhole
Distance (ft):	226.3
Structural Grade:	0
O&M Grade:	0
Clock Start/From:	
Clock To:	
1st Value:	
2nd Value:	
Value Percent:	
Continuous Index:	
Within 8" of Joint:	NO
Remarks:	M-809-026
