Profile/Photo Observation Report

Date:	03/22/2018	Weather:		Coding:	PACP 6.0
Pipe Length (ft):	318.8	Owner:	NA	Pre Clean:	Not Known
P.O.#:		Surveyor:	Selasie Honu	PSR:	P-809-027-028
Customer:		Clean Date:	01/01/1900	Shape:	C

Street:	MURRELET ST	Flow Control:	Not Controlled
City:	Hobart, IN	Year Renewed:	
Location:	Sidewalk	Tape/Media #:	
Purpose:	Maintenance Related	Dia/Height:	8"
Use:	Sanitary	Material:	PVC
Drain Area:	NA	Lining:	
Category:	NA		
Comment:	flow incorrect.

Location Details:		Direction of Survey:	Downstream
US MH:	M-809-028	DS MH:	M-809-027
		Total Length Surveyed (ft):	303.4

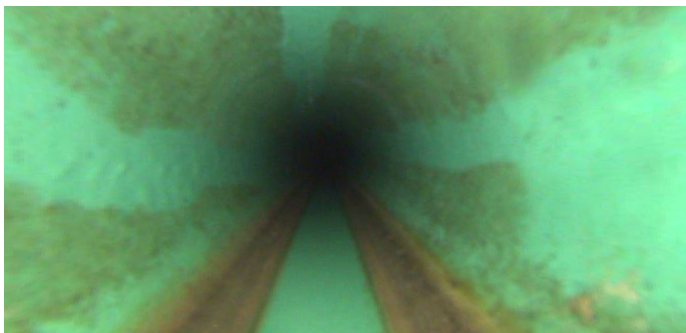
Code: **AMH**
Description: **Manhole**

Distance (ft): **.0**
Structural Grade: **0**
O&M Grade: **0**
Clock Start/From:
Clock To:
1st Value:
2nd Value:
Value Percent:
Continuous Index:
Within 8" of Joint: **NO**
Remarks: **M-809-028**

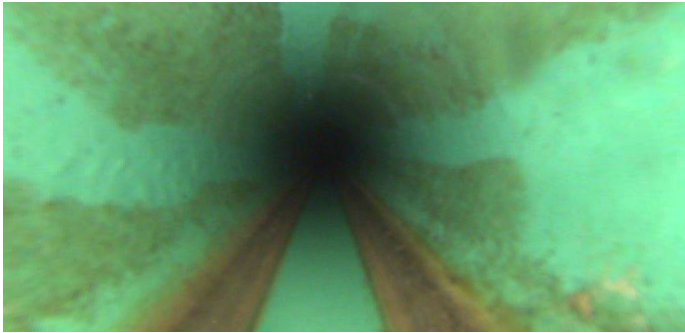
Code:	MWL
Description:	Water Level

Distance (ft):	.0
Structural Grade:	0
O&M Grade:	0
Clock Start/From:	
Clock To:	
1st Value:	
2nd Value:	
Value Percent:	5.000
Continuous Index:	
Within 8" of Joint:	NO
Remarks:

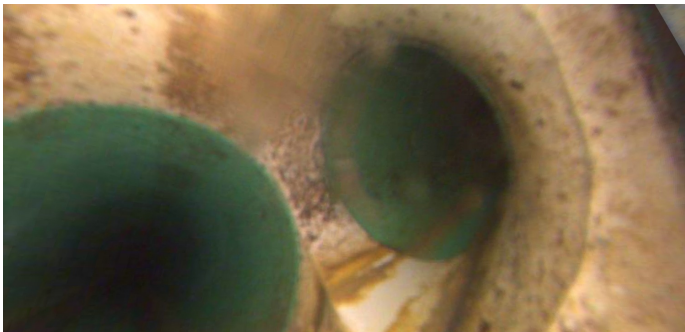
Code:	TF
Description:	Tap Factory

Distance (ft):	37.0
Structural Grade:	0
O&M Grade:	0
Clock Start/From:	2
Clock To:	
1st Value:	4.000
2nd Value:	
Value Percent:	
Continuous Index:	
Within 8" of Joint:	
Remarks:

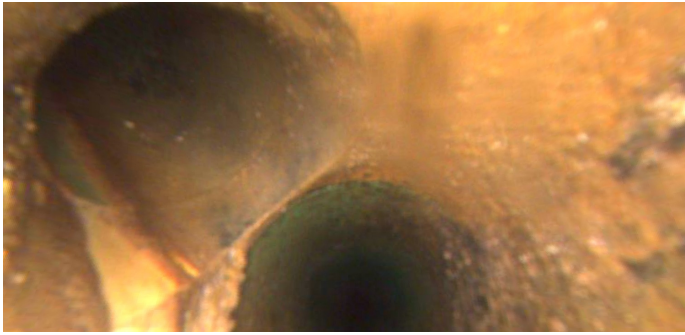
Code: **TF**
Description: **Tap Factory**

Distance (ft): **68.8**
Structural Grade: **0**
O&M Grade: **0**
Clock Start/From: **10**
Clock To:
1st Value: **4.000**
2nd Value:
Value Percent:
Continuous Index:
Within 8" of Joint:
Remarks:

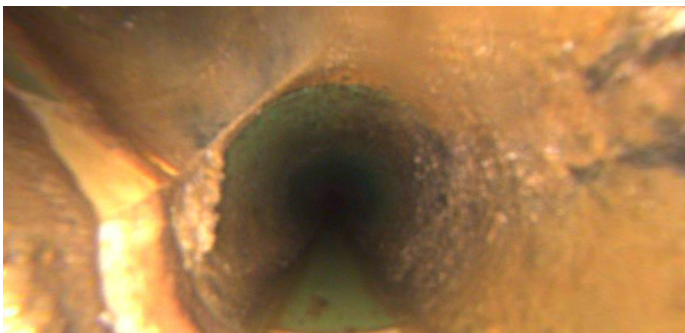
Code: **DAGS**
Description: **Deposits Attached Grease**

Distance (ft): **68.8**
Structural Grade: **0**
O&M Grade: **2**
Clock Start/From: **8**
Clock To: **4**
1st Value:
2nd Value:
Value Percent: **5.000**
Continuous Index:
Within 8" of Joint: **NO**
Remarks:

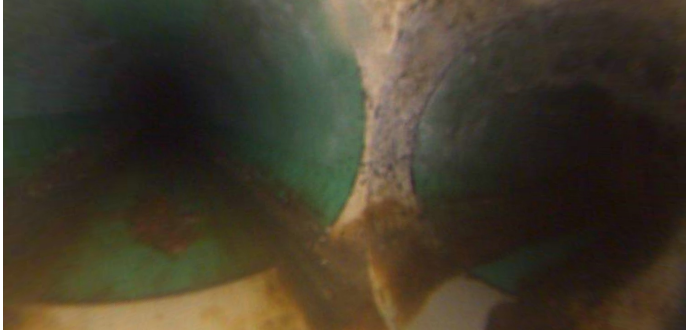
Code: **TFA**
Description: **Tap Factory Active**

Distance (ft): **105.6**
Structural Grade: **0**
O&M Grade: **0**
Clock Start/From: **3**
Clock To:
1st Value: **4.000**
2nd Value:
Value Percent:
Continuous Index:
Within 8" of Joint:
Remarks:

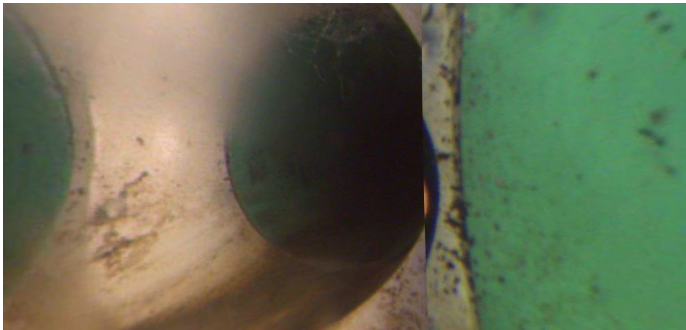
Code: **TFA**
Description: **Tap Factory Active**

Distance (ft): **144.2**
Structural Grade: **0**
O&M Grade: **0**
Clock Start/From: **9**
Clock To:
1st Value: **4.000**
2nd Value:
Value Percent:
Continuous Index:
Within 8" of Joint:
Remarks:

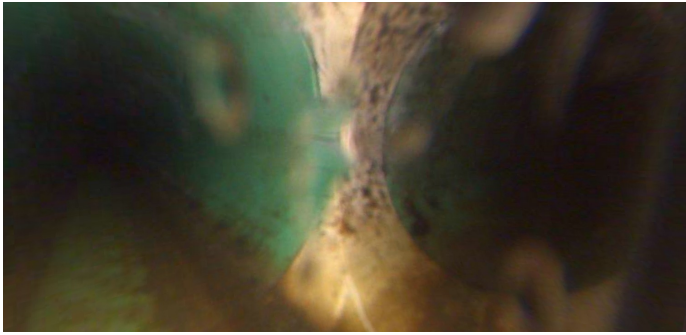
Code: **TF**
Description: **Tap Factory**

Distance (ft): **182.1**
Structural Grade: **0**
O&M Grade: **0**
Clock Start/From: **3**
Clock To:
1st Value: **4.000**
2nd Value:
Value Percent:
Continuous Index:
Within 8" of Joint:
Remarks:

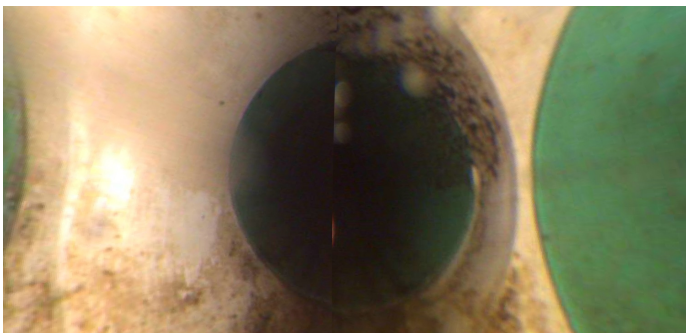
Code: **TF**
Description: **Tap Factory**

Distance (ft): **220.2**
Structural Grade: **0**
O&M Grade: **0**
Clock Start/From: **9**
Clock To:
1st Value: **4.000**
2nd Value:
Value Percent:
Continuous Index:
Within 8" of Joint:
Remarks:

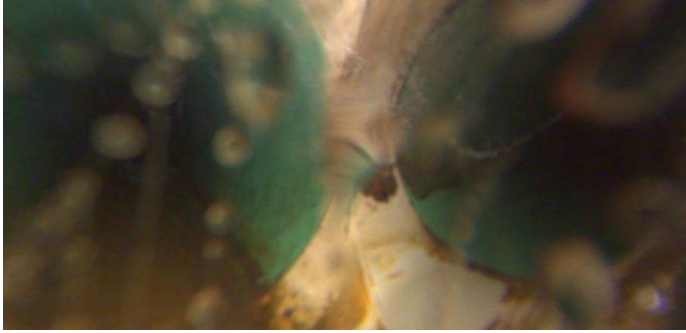
Code: **TF**
Description: **Tap Factory**

Distance (ft): **254.8**
Structural Grade: **0**
O&M Grade: **0**
Clock Start/From: **3**
Clock To:
1st Value: **4.000**
2nd Value:
Value Percent:
Continuous Index:
Within 8" of Joint:
Remarks:

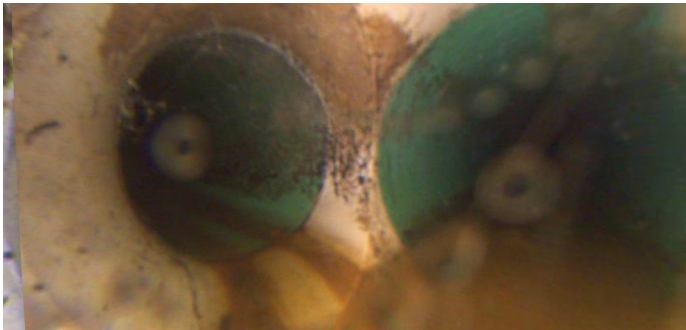
Code: **TFA**
Description: **Tap Factory Active**

Distance (ft): **277.6**
Structural Grade: **0**
O&M Grade: **0**
Clock Start/From: **9**
Clock To:
1st Value: **4.000**
2nd Value:
Value Percent:
Continuous Index:
Within 8" of Joint:
Remarks:

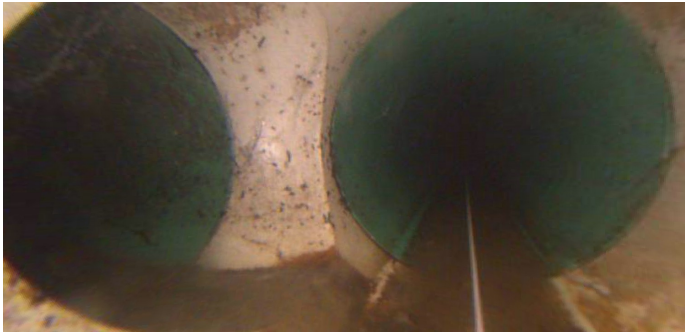
Code: **TFA**
Description: **Tap Factory Active**

Distance (ft): **297.5**
Structural Grade: **0**
O&M Grade: **0**
Clock Start/From: **3**
Clock To:
1st Value: **4.000**
2nd Value:
Value Percent:
Continuous Index:
Within 8" of Joint:
Remarks:

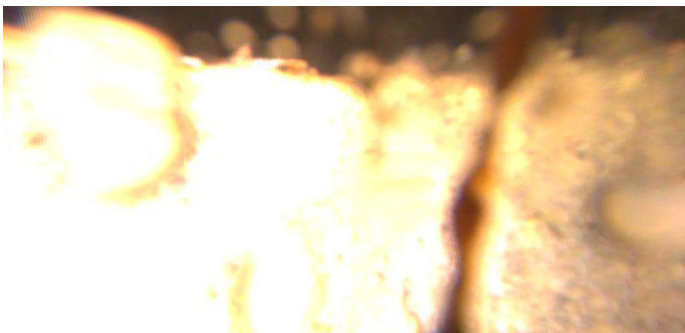
Code: **AMH**
Description: **Manhole**

Distance (ft): **303.4**
Structural Grade: **0**
O&M Grade: **0**
Clock Start/From:
Clock To:
1st Value:
2nd Value:
Value Percent:
Continuous Index:
Within 8" of Joint: **NO**
Remarks: **M-809-027**
