Profile/Photo Observation Report

Date:	03/22/2018	Weather:		Coding:	PACP 6.0
Pipe Length (ft):	318.8	Owner:	NA	Pre Clean:	Not Known
P.O.#:		Surveyor:	Selasie Honu	PSR:	P-809-027-028
Customer:		Clean Date:	01/01/1900	Shape:	C

Street:	Oak	Flow Control:	Not Controlled
City:	Hobart, IN	Year Renewed:	
Location:	Sidewalk	Tape/Media #:	
Purpose:	Maintenance Related	Dia/Height:	8"
Use:	Sanitary	Material:	PVC
Drain Area:	NA	Lining:	
Category:	NA		
Comment:	flow incorrect.

Location Details:		Direction of Survey:	Downstream
US MH:	M-809-028	DS MH:	M-809-027
		Total Length Surveyed (ft):	303.4

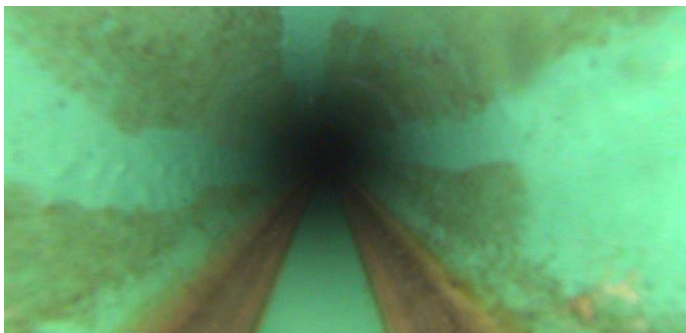
Code: **AMH**
Description: **Manhole**

Distance (ft): **.0**
Structural Grade: **0**
O&M Grade: **0**
Clock Start/From:
Clock To:
1st Value:
2nd Value:
Value Percent:
Continuous Index:
Within 8" of Joint: **NO**
Remarks: **M-809-028**

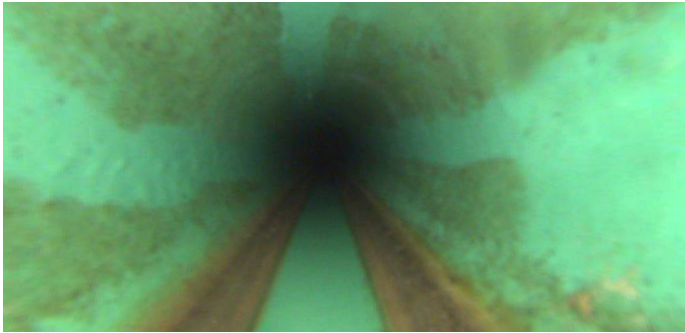
Code:	MWL
Description:	Water Level

Distance (ft):	.0
Structural Grade:	0
O&M Grade:	0
Clock Start/From:	
Clock To:	
1st Value:	
2nd Value:	
Value Percent:	5.000
Continuous Index:	
Within 8" of Joint:	NO
Remarks:

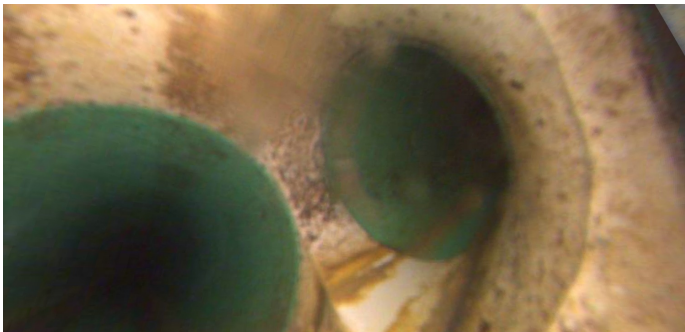
Code:	TF
Description:	Tap Factory

Distance (ft):	37.0
Structural Grade:	0
O&M Grade:	0
Clock Start/From:	2
Clock To:	
1st Value:	4.000
2nd Value:	
Value Percent:	
Continuous Index:	
Within 8" of Joint:	
Remarks:

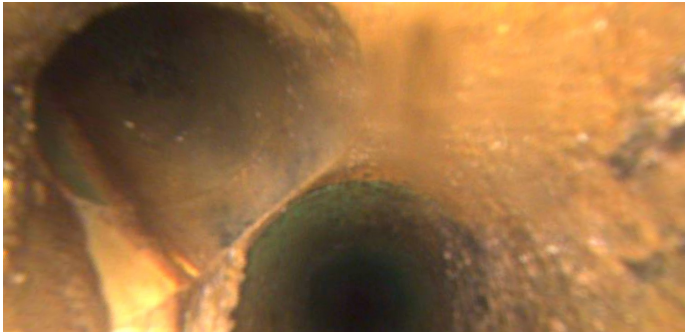
Code: **TF**
Description: **Tap Factory**

Distance (ft): **68.8**
Structural Grade: **0**
O&M Grade: **0**
Clock Start/From: **10**
Clock To:
1st Value: **4.000**
2nd Value:
Value Percent:
Continuous Index:
Within 8" of Joint:
Remarks:

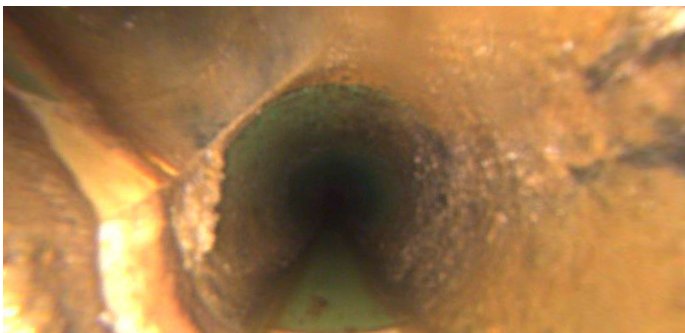
Code: **DAGS**
Description: **Deposits Attached Grease**

Distance (ft): **68.8**
Structural Grade: **0**
O&M Grade: **2**
Clock Start/From: **8**
Clock To: **4**
1st Value:
2nd Value:
Value Percent: **5.000**
Continuous Index:
Within 8" of Joint: **NO**
Remarks:

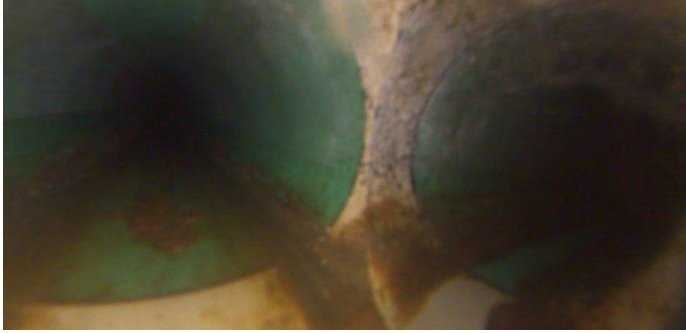
Code: **TFA**
Description: **Tap Factory Active**

Distance (ft): **105.6**
Structural Grade: **0**
O&M Grade: **0**
Clock Start/From: **3**
Clock To:
1st Value: **4.000**
2nd Value:
Value Percent:
Continuous Index:
Within 8" of Joint:
Remarks:

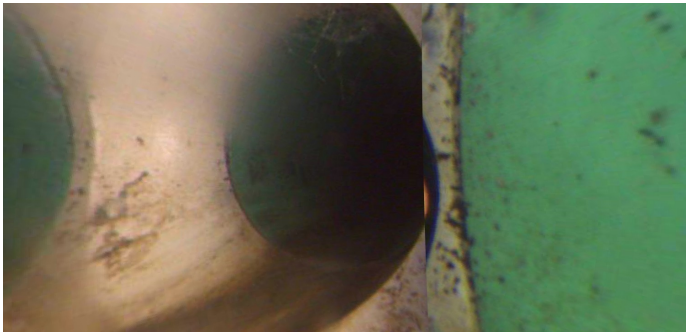
Code: **TFA**
Description: **Tap Factory Active**

Distance (ft): **144.2**
Structural Grade: **0**
O&M Grade: **0**
Clock Start/From: **9**
Clock To:
1st Value: **4.000**
2nd Value:
Value Percent:
Continuous Index:
Within 8" of Joint:
Remarks:

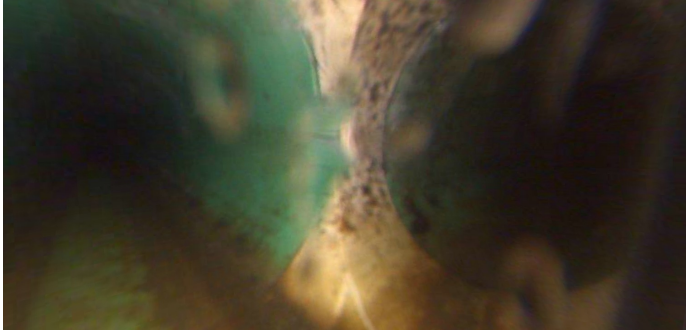
Code: **TF**
Description: **Tap Factory**

Distance (ft): **182.1**
Structural Grade: **0**
O&M Grade: **0**
Clock Start/From: **3**
Clock To:
1st Value: **4.000**
2nd Value:
Value Percent:
Continuous Index:
Within 8" of Joint:
Remarks:

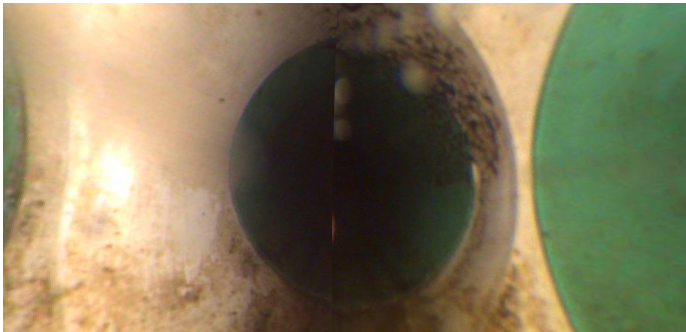
Code: **TF**
Description: **Tap Factory**

Distance (ft): **220.2**
Structural Grade: **0**
O&M Grade: **0**
Clock Start/From: **9**
Clock To:
1st Value: **4.000**
2nd Value:
Value Percent:
Continuous Index:
Within 8" of Joint:
Remarks:

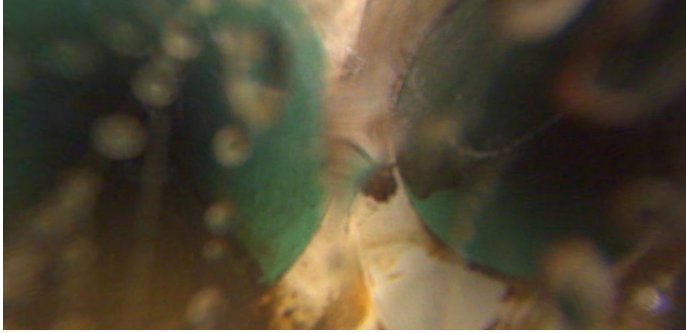
Code: **TF**
Description: **Tap Factory**

Distance (ft): **254.8**
Structural Grade: **0**
O&M Grade: **0**
Clock Start/From: **3**
Clock To:
1st Value: **4.000**
2nd Value:
Value Percent:
Continuous Index:
Within 8" of Joint:
Remarks:

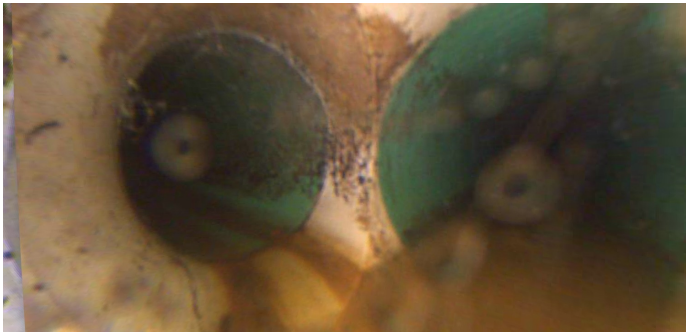
Code: **TFA**
Description: **Tap Factory Active**

Distance (ft): **277.6**
Structural Grade: **0**
O&M Grade: **0**
Clock Start/From: **9**
Clock To:
1st Value: **4.000**
2nd Value:
Value Percent:
Continuous Index:
Within 8" of Joint:
Remarks:

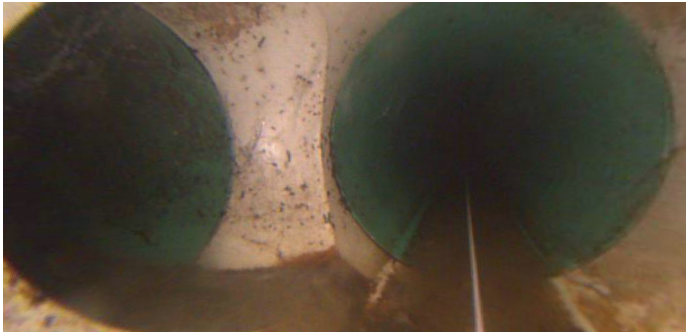
Code: **TFA**
Description: **Tap Factory Active**

Distance (ft): **297.5**
Structural Grade: **0**
O&M Grade: **0**
Clock Start/From: **3**
Clock To:
1st Value: **4.000**
2nd Value:
Value Percent:
Continuous Index:
Within 8" of Joint:
Remarks:

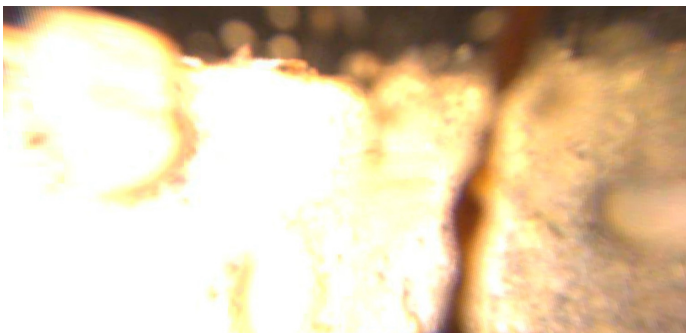
Code: **AMH**
Description: **Manhole**

Distance (ft): **303.4**
Structural Grade: **0**
O&M Grade: **0**
Clock Start/From:
Clock To:
1st Value:
2nd Value:
Value Percent:
Continuous Index:
Within 8" of Joint: **NO**
Remarks: **M-809-027**
