## Profile/Photo Observation Report

Street:	<b>MURRELET ST</b>	Flow Control:	<b>Not Controlled</b>
City:	<b>Hobart, IN</b>	Year Renewed:	
Location:	<b>Sidewalk</b>	Tape/Media #:	
Purpose:	<b>Maintenance Related</b>	Dia/Height:	<b>8"</b>
Use:	<b>Sanitary</b>	Material:	<b>PVC</b>
Drain Area:	<b>NA</b>	Lining:	
Category:	<b>NA</b>		
Comment:	<b>mh confirmed-flow incorrect.</b>

Location Details:		Direction of Survey:	<b>Upstream</b>
US MH:	<b>M-809-029</b>	DS MH:	<b>M-809-028</b>
		Total Length Surveyed (ft):	<b>227.9</b>

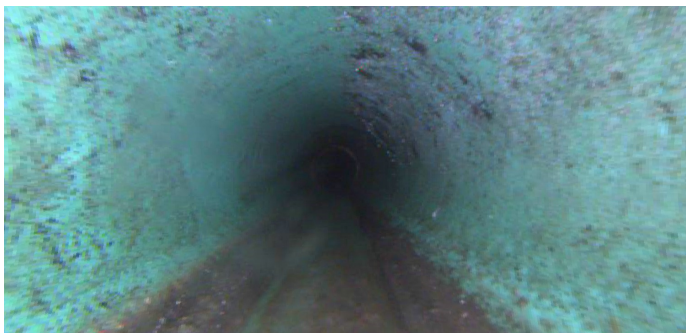
Code: **AMH**  
Description: **Manhole**

Distance (ft): **.0**  
Structural Grade: **0**  
O&M Grade: **0**  
Clock Start/From:  
Clock To:  
1st Value:  
2nd Value:  
Value Percent:  
Continuous Index:  
Within 8" of Joint: **NO**  
Remarks: **M-809-028**

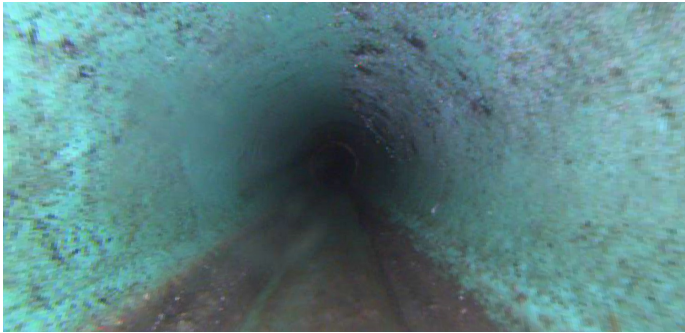
Code:	<b>MWL</b>
Description:	<b>Water Level</b>

Distance (ft):	<b>.0</b>
Structural Grade:	<b>0</b>
O&M Grade:	<b>0</b>
Clock Start/From:	
Clock To:	
1st Value:	
2nd Value:	
Value Percent:	<b>5.000</b>
Continuous Index:	
Within 8" of Joint:	<b>NO</b>
Remarks:

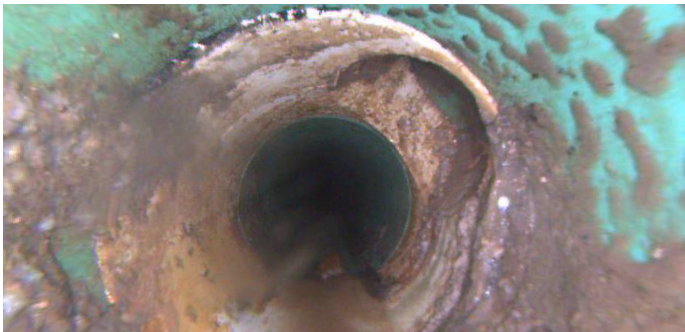
Code:	<b>DAGS</b>
Description:	<b>Deposits Attached Grease</b>

Distance (ft):	<b>4.5</b>
Structural Grade:	<b>0</b>
O&M Grade:	<b>2</b>
Clock Start/From:	<b>8</b>
Clock To:	<b>4</b>
1st Value:	
2nd Value:	
Value Percent:	<b>5.000</b>
Continuous Index:	
Within 8" of Joint:	<b>NO</b>
Remarks:

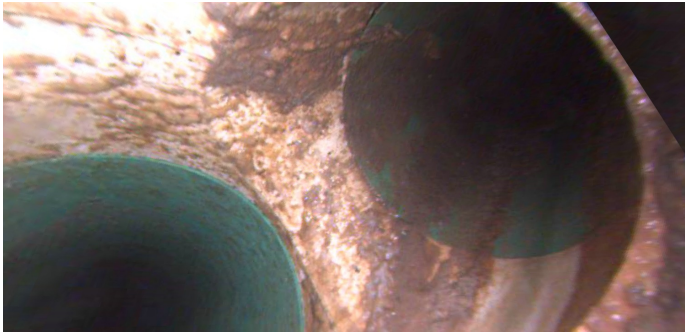
Code: **TF**  
Description: **Tap Factory**

Distance (ft): **5.0**  
Structural Grade: **0**  
O&M Grade: **0**  
Clock Start/From: **2**  
Clock To:  
1st Value: **4.000**  
2nd Value:  
Value Percent:  
Continuous Index:  
Within 8" of Joint:  
Remarks:

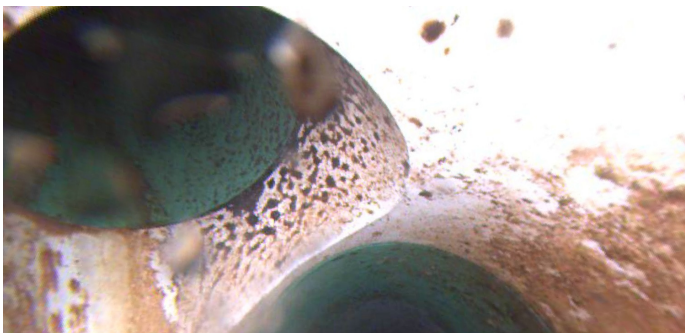
Code: **TF**  
Description: **Tap Factory**

Distance (ft): **38.6**  
Structural Grade: **0**  
O&M Grade: **0**  
Clock Start/From: **10**  
Clock To:  
1st Value: **4.000**  
2nd Value:  
Value Percent:  
Continuous Index:  
Within 8" of Joint:  
Remarks:

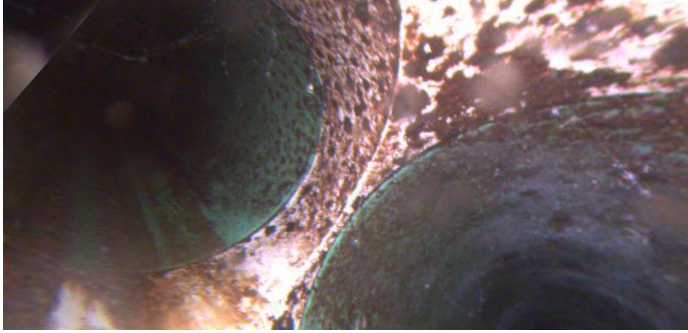
Code: **TF**  
Description: **Tap Factory**

Distance (ft): **73.0**  
Structural Grade: **0**  
O&M Grade: **0**  
Clock Start/From: **2**  
Clock To:  
1st Value: **4.000**  
2nd Value:  
Value Percent:  
Continuous Index:  
Within 8" of Joint:  
Remarks:

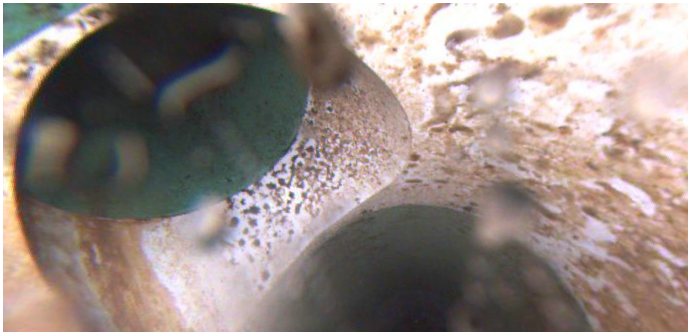
Code: **TF**  
Description: **Tap Factory**

Distance (ft): **110.9**  
Structural Grade: **0**  
O&M Grade: **0**  
Clock Start/From: **11**  
Clock To:  
1st Value: **4.000**  
2nd Value:  
Value Percent:  
Continuous Index:  
Within 8" of Joint:  
Remarks:

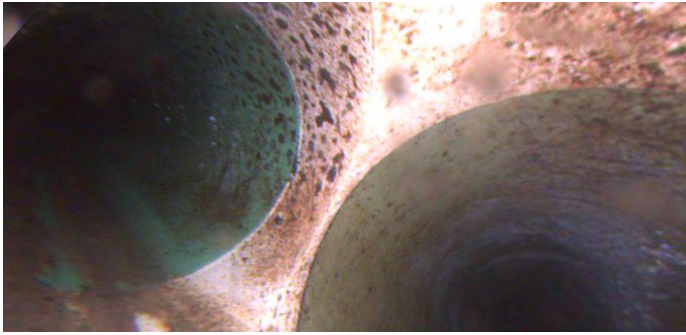
Code: **TF**  
Description: **Tap Factory**

Distance (ft): **137.1**  
Structural Grade: **0**  
O&M Grade: **0**  
Clock Start/From: **2**  
Clock To:  
1st Value: **4.000**  
2nd Value:  
Value Percent:  
Continuous Index:  
Within 8" of Joint:  
Remarks:

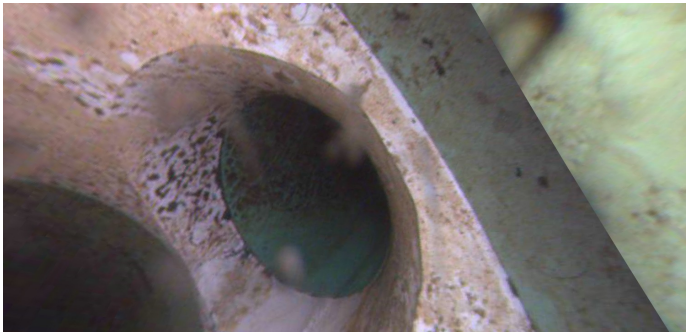
Code: **TF**  
Description: **Tap Factory**

Distance (ft): **183.6**  
Structural Grade: **0**  
O&M Grade: **0**  
Clock Start/From: **10**  
Clock To:  
1st Value: **4.000**  
2nd Value:  
Value Percent:  
Continuous Index:  
Within 8" of Joint:  
Remarks:

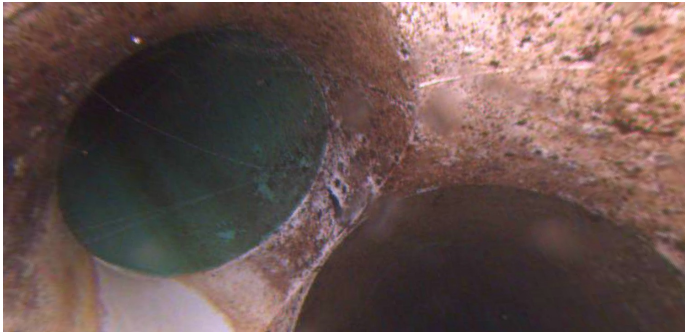
Code: **TF**  
Description: **Tap Factory**

Distance (ft): **201.7**  
Structural Grade: **0**  
O&M Grade: **0**  
Clock Start/From: **2**  
Clock To:  
1st Value: **4.000**  
2nd Value:  
Value Percent:  
Continuous Index:  
Within 8" of Joint:  
Remarks:

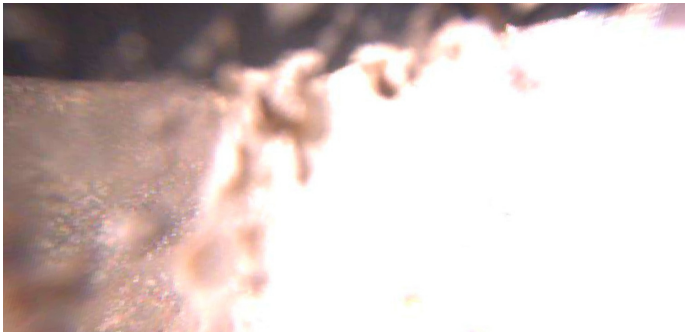
Code: **AMH**  
Description: **Manhole**

Distance (ft): **227.9**  
Structural Grade: **0**  
O&M Grade: **0**  
Clock Start/From:  
Clock To:  
1st Value:  
2nd Value:  
Value Percent:  
Continuous Index:  
Within 8" of Joint: **NO**  
Remarks: **M-809-029**
