Profile/Photo Observation Report

Street:	MURRELET ST	Flow Control:	Not Controlled
City:	Hobart, IN	Year Renewed:	
Location:	Yard	Tape/Media #:	
Purpose:	Maintenance Related	Dia/Height:	8"
Use:	Sanitary	Material:	PVC
Drain Area:	NA	Lining:	
Category:	NA		
Comment:

Location Details:		Direction of Survey:	Downstream
US MH:	M-809-030	DS MH:	M-809-029
		Total Length Surveyed (ft):	126.5

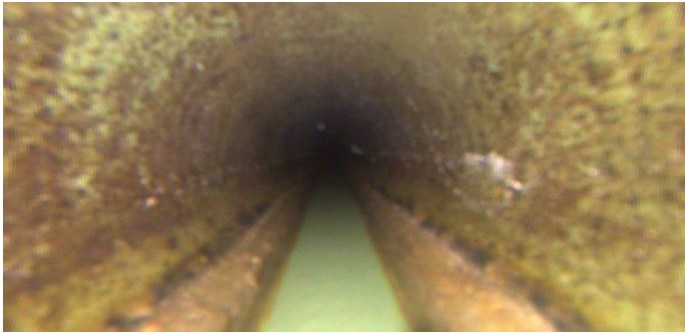
Code:	MWL
Description:	Water Level

Distance (ft):	.0
Structural Grade:	0
O&M Grade:	0
Clock Start/From:	
Clock To:	
1st Value:	
2nd Value:	
Value Percent:	5.000
Continuous Index:	
Within 8" of Joint:	NO
Remarks:

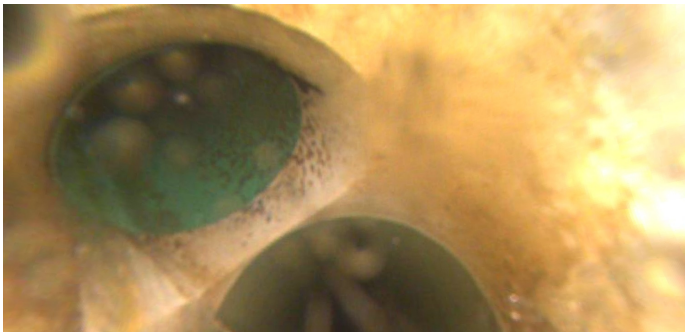
Code:	TFA
Description:	Tap Factory Active

Distance (ft):	50.2
Structural Grade:	0
O&M Grade:	0
Clock Start/From:	10
Clock To:	
1st Value:	4.000
2nd Value:	
Value Percent:	
Continuous Index:	
Within 8" of Joint:	
Remarks:

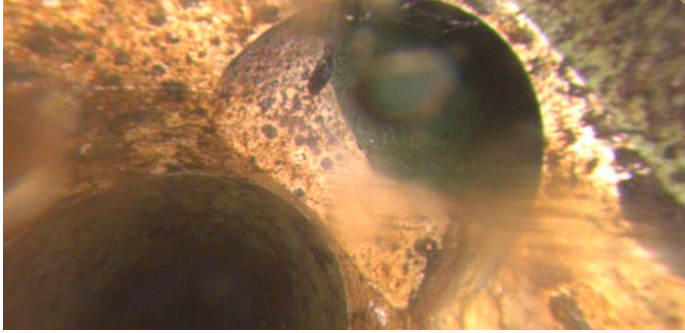
Code: **TF**
Description: **Tap Factory**

Distance (ft): **118.8**
Structural Grade: **0**
O&M Grade: **0**
Clock Start/From: **10**
Clock To:
1st Value: **4.000**
2nd Value:
Value Percent:
Continuous Index:
Within 8" of Joint:
Remarks:

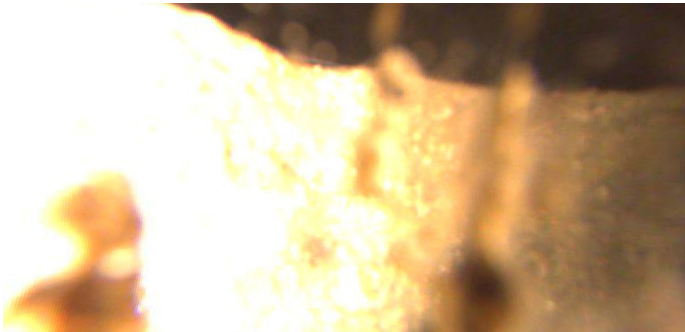
Code: **AMH**
Description: **Manhole**

Distance (ft): **126.5**
Structural Grade: **0**
O&M Grade: **0**
Clock Start/From:
Clock To:
1st Value:
2nd Value:
Value Percent:
Continuous Index:
Within 8" of Joint: **NO**
Remarks: **M-809-029**
