Profile/Photo Observation Report

Street:	BRACKEN PKWY & EIDER AVE	Flow Control:	Not Controlled
City:	Hobart, IN	Year Renewed:	
Location:	Sidewalk	Tape/Media #:	
Purpose:	Maintenance Related	Dia/Height:	8"
Use:	Sanitary	Material:	PVC
Drain Area:	NA	Lining:	
Category:	NA		
Comment:

Location Details:		Direction of Survey:	Downstream
US MH:	M-809-032	DS MH:	M-809-019
		Total Length Surveyed (ft):	263.2

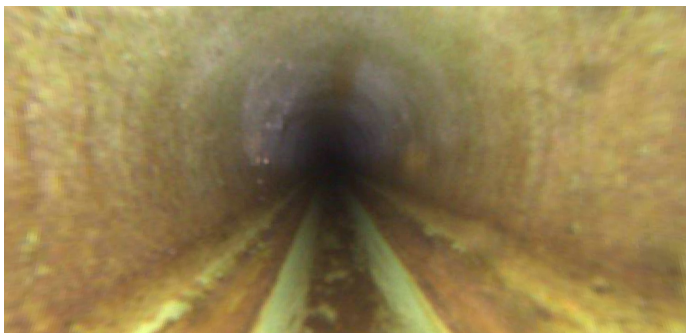
Code: **AMH**
Description: **Manhole**

Distance (ft): **.0**
Structural Grade: **0**
O&M Grade: **0**
Clock Start/From:
Clock To:
1st Value:
2nd Value:
Value Percent:
Continuous Index:
Within 8" of Joint: **NO**
Remarks: **M-809-032**

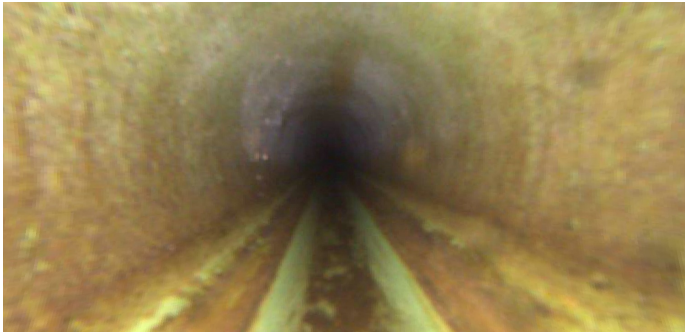
Code:	MWL
Description:	Water Level

Distance (ft):	.0
Structural Grade:	0
O&M Grade:	0
Clock Start/From:	
Clock To:	
1st Value:	
2nd Value:	
Value Percent:	5.000
Continuous Index:	
Within 8" of Joint:	NO
Remarks:

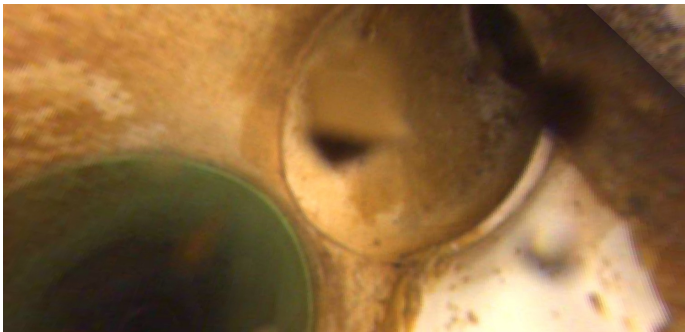
Code:	TF
Description:	Tap Factory

Distance (ft):	42.4
Structural Grade:	0
O&M Grade:	0
Clock Start/From:	2
Clock To:	
1st Value:	4.000
2nd Value:	
Value Percent:	
Continuous Index:	
Within 8" of Joint:	
Remarks:

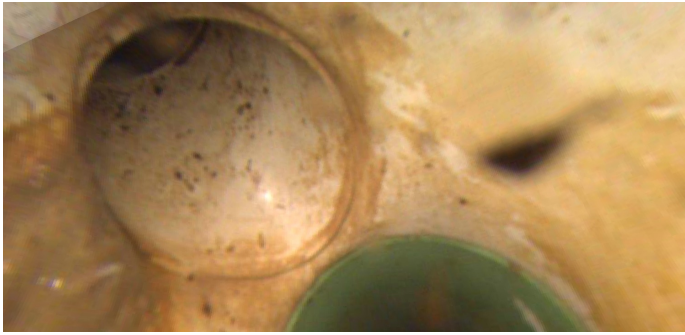
Code: **TF**
Description: **Tap Factory**

Distance (ft): **47.8**
Structural Grade: **0**
O&M Grade: **0**
Clock Start/From: **11**
Clock To:
1st Value: **4.000**
2nd Value:
Value Percent:
Continuous Index:
Within 8" of Joint:
Remarks:

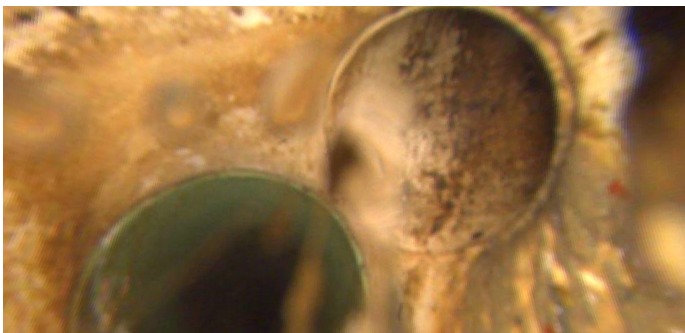
Code: **TF**
Description: **Tap Factory**

Distance (ft): **132.7**
Structural Grade: **0**
O&M Grade: **0**
Clock Start/From: **2**
Clock To:
1st Value: **4.000**
2nd Value:
Value Percent:
Continuous Index:
Within 8" of Joint:
Remarks:

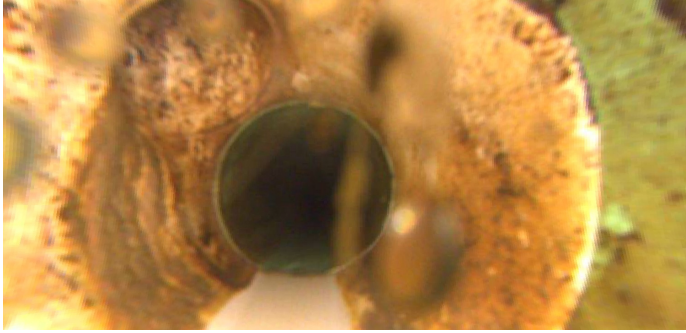
Code: **TF**
Description: **Tap Factory**

Distance (ft): **137.9**
Structural Grade: **0**
O&M Grade: **0**
Clock Start/From: **10**
Clock To:
1st Value: **4.000**
2nd Value:
Value Percent:
Continuous Index:
Within 8" of Joint:
Remarks:

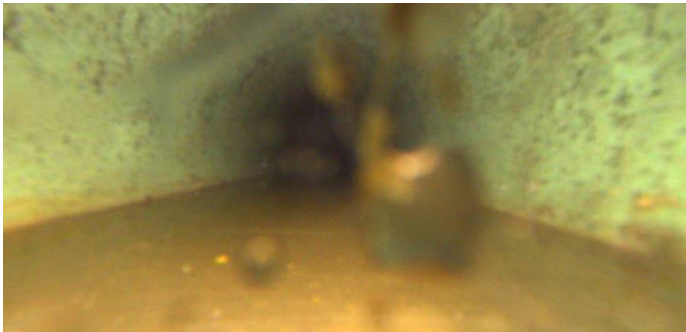
Code: **MWL**
Description: **Water Level**

Distance (ft): **258.6**
Structural Grade: **0**
O&M Grade: **0**
Clock Start/From:
Clock To:
1st Value:
2nd Value:
Value Percent: **40.000**
Continuous Index:
Within 8" of Joint: **NO**
Remarks:

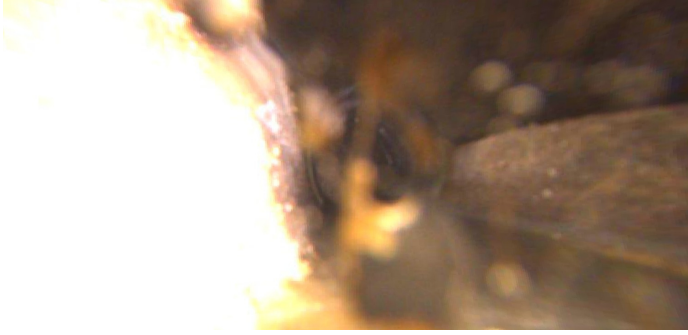
Code:	AMH
Description:	Manhole
Distance (ft):	263.2
Structural Grade:	0
O&M Grade:	0
Clock Start/From:	
Clock To:	
1st Value:	
2nd Value:	
Value Percent:	
Continuous Index:	
Within 8" of Joint:	NO
Remarks:	M-809-019
