Profile/Photo Observation Report

Date:	03/23/2018	Weather:		Coding:	PACP 6.0
Pipe Length (ft):	246.0	Owner:	NA	Pre Clean:	Not Known
P.O.#:		Surveyor:	Justin Gonzales	PSR:	P-809-031-032
Customer:		Clean Date:	01/01/1900	Shape:	C

Street:	EIDER AVE	Flow Control:	Not Controlled
City:	Hobart, IN	Year Renewed:	
Location:	Sidewalk	Tape/Media #:	
Purpose:	Maintenance Related	Dia/Height:	10"
Use:	Sanitary	Material:	PVC
Drain Area:	NA	Lining:	
Category:	NA		
Comment:

Location Details:		Direction of Survey:	Downstream
US MH:	M-809-032	DS MH:	M-809-031
		Total Length Surveyed (ft):	241.3

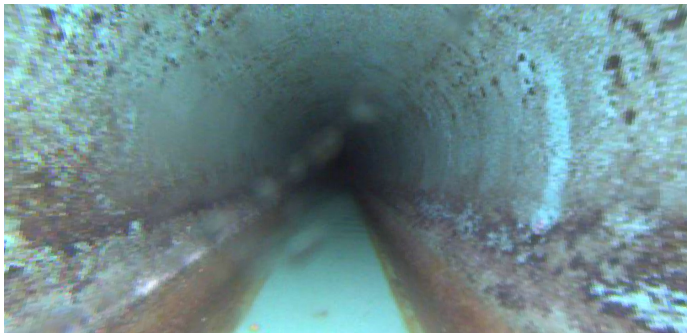
Code: **AMH**
Description: **Manhole**

Distance (ft): **.0**
Structural Grade: **0**
O&M Grade: **0**
Clock Start/From:
Clock To:
1st Value:
2nd Value:
Value Percent:
Continuous Index:
Within 8" of Joint: **NO**
Remarks: **M-809-032**

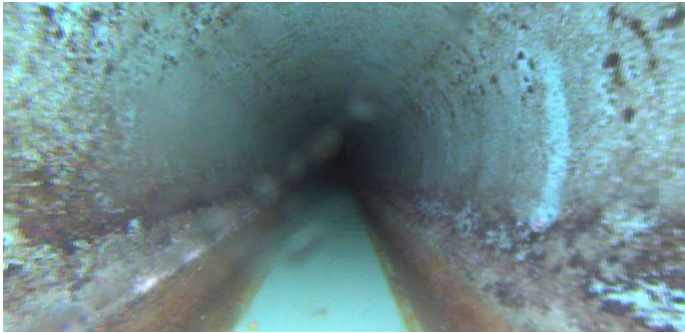
Code:	MWL
Description:	Water Level

Distance (ft):	.0
Structural Grade:	0
O&M Grade:	0
Clock Start/From:	
Clock To:	
1st Value:	
2nd Value:	
Value Percent:	5.000
Continuous Index:	
Within 8" of Joint:	NO
Remarks:

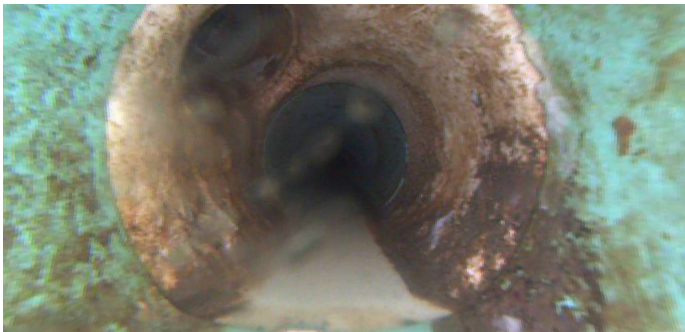
Code:	TF
Description:	Tap Factory

Distance (ft):	22.6
Structural Grade:	0
O&M Grade:	0
Clock Start/From:	10
Clock To:	
1st Value:	4.000
2nd Value:	
Value Percent:	
Continuous Index:	
Within 8" of Joint:	
Remarks:

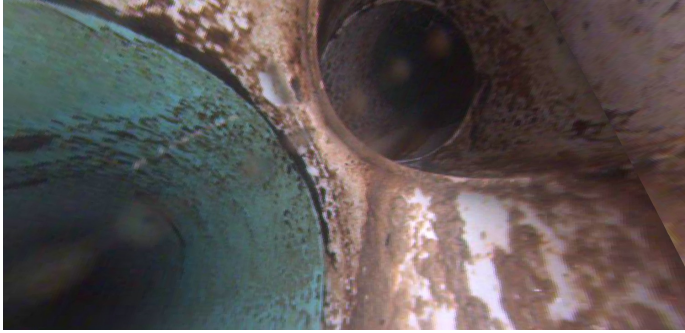
Code: **TF**
Description: **Tap Factory**

Distance (ft): **31.6**
Structural Grade: **0**
O&M Grade: **0**
Clock Start/From: **2**
Clock To:
1st Value: **4.000**
2nd Value:
Value Percent:
Continuous Index:
Within 8" of Joint:
Remarks:

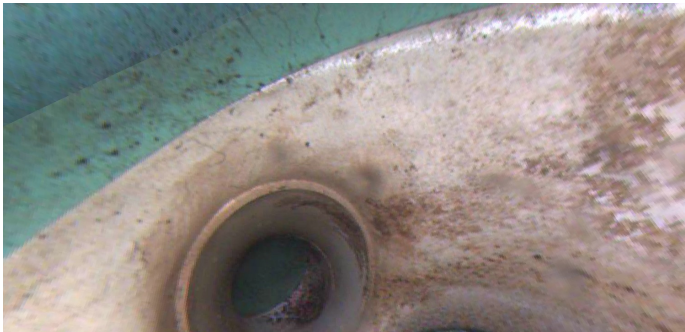
Code: **TF**
Description: **Tap Factory**

Distance (ft): **89.1**
Structural Grade: **0**
O&M Grade: **0**
Clock Start/From: **10**
Clock To:
1st Value: **4.000**
2nd Value:
Value Percent:
Continuous Index:
Within 8" of Joint:
Remarks:

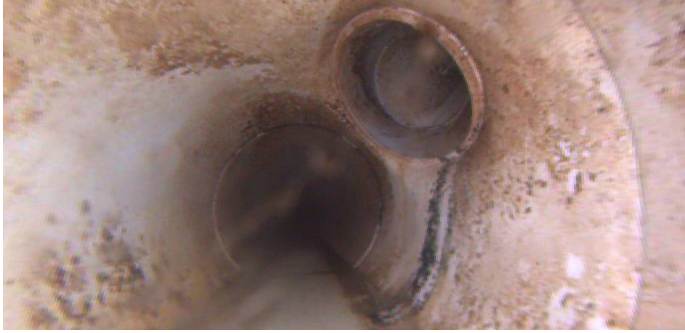
Code: **TF**
Description: **Tap Factory**

Distance (ft): **148.9**
Structural Grade: **0**
O&M Grade: **0**
Clock Start/From: **2**
Clock To:
1st Value: **4.000**
2nd Value:
Value Percent:
Continuous Index:
Within 8" of Joint:
Remarks:

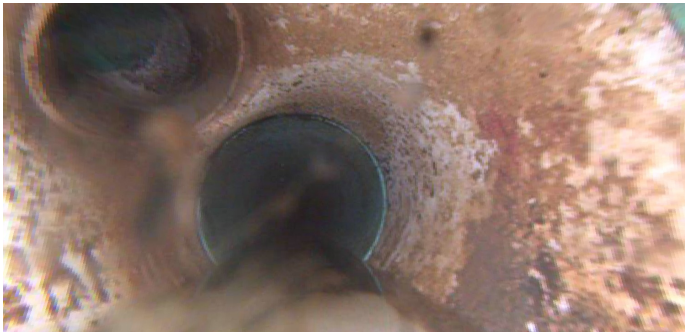
Code: **TF**
Description: **Tap Factory**

Distance (ft): **176.2**
Structural Grade: **0**
O&M Grade: **0**
Clock Start/From: **10**
Clock To:
1st Value: **4.000**
2nd Value:
Value Percent:
Continuous Index:
Within 8" of Joint:
Remarks:

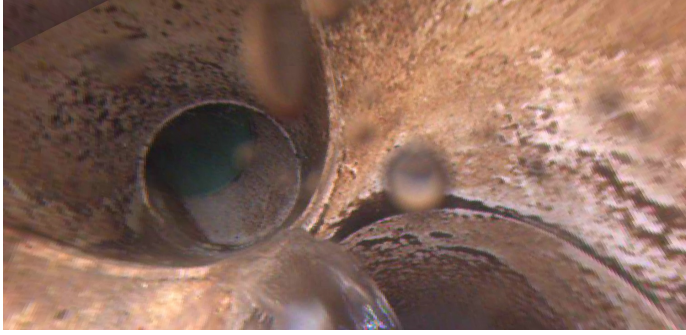
Code: **TFA**
Description: **Tap Factory Active**

Distance (ft): **228.9**
Structural Grade: **0**
O&M Grade: **0**
Clock Start/From: **10**
Clock To:
1st Value: **4.000**
2nd Value:
Value Percent:
Continuous Index:
Within 8" of Joint:
Remarks:

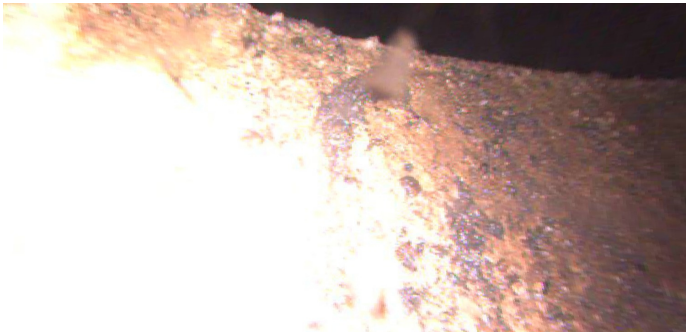
Code: **AMH**
Description: **Manhole**

Distance (ft): **241.3**
Structural Grade: **0**
O&M Grade: **0**
Clock Start/From:
Clock To:
1st Value:
2nd Value:
Value Percent:
Continuous Index:
Within 8" of Joint: **NO**
Remarks: **M-809-031**
