Profile/Photo Observation Report

Street:	TANAGER ST & KESTREL ST	Flow Control:	Not Controlled
City:	Hobart, IN	Year Renewed:	
Location:	Light Highway	Tape/Media #:	
Purpose:	Maintenance Related	Dia/Height:	12"
Use:	Sanitary	Material:	PVC
Drain Area:	NA	Lining:	
Category:	NA		
Comment:

Location Details:		Direction of Survey:	Downstream
US MH:	M-809-033	DS MH:	M-809-034
		Total Length Surveyed (ft):	248.0

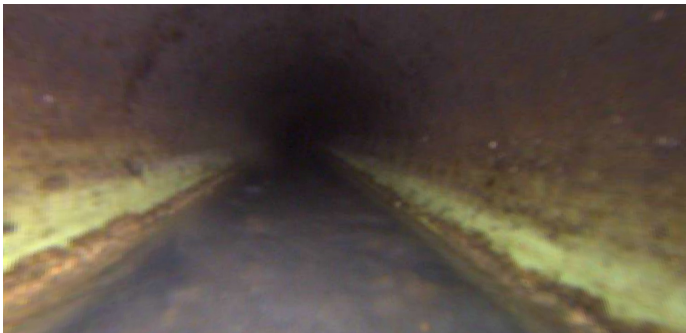
Code:	MWL
Description:	Water Level

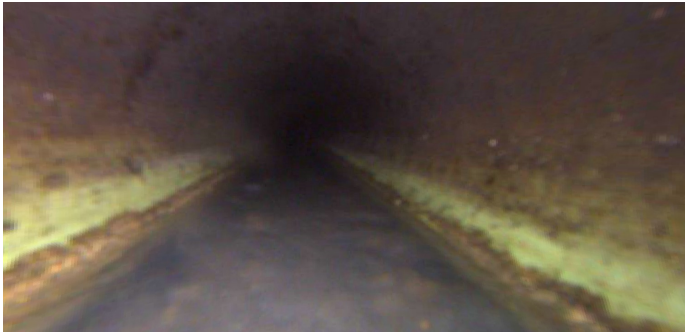
Distance (ft):	.0
Structural Grade:	0
O&M Grade:	0
Clock Start/From:	
Clock To:	
1st Value:	
2nd Value:	
Value Percent:	5.000
Continuous Index:	
Within 8" of Joint:	NO
Remarks:

Code:	TF
Description:	Tap Factory

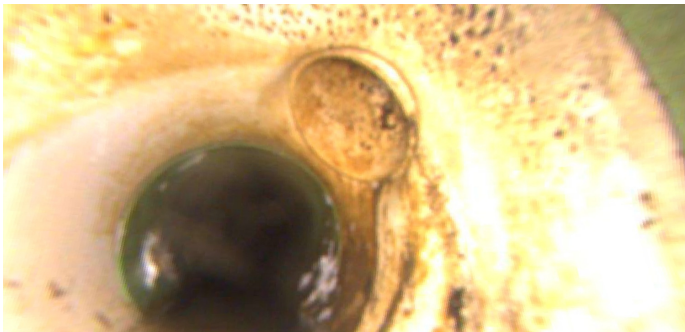
Distance (ft):	10.8
Structural Grade:	0
O&M Grade:	0
Clock Start/From:	1
Clock To:	
1st Value:	4.000
2nd Value:	
Value Percent:	
Continuous Index:	
Within 8" of Joint:	YES
Remarks:

Code: **TF**
Description: **Tap Factory**

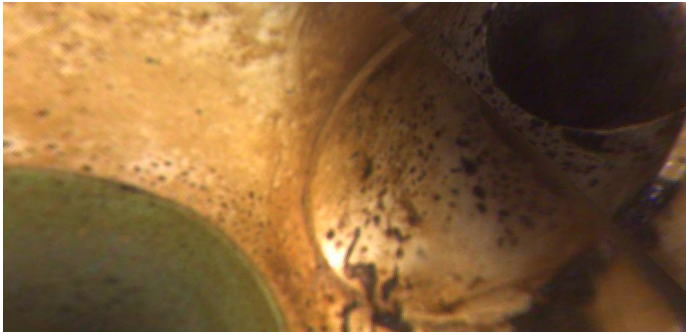
Distance (ft): **90.2**
Structural Grade: **0**
O&M Grade: **0**
Clock Start/From: **1**
Clock To:
1st Value: **4.000**
2nd Value:
Value Percent:
Continuous Index:
Within 8" of Joint: **YES**
Remarks:

Code: **TF**
Description: **Tap Factory**

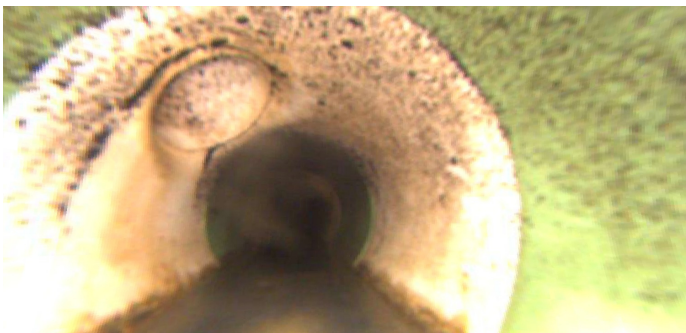
Distance (ft): **173.5**
Structural Grade: **0**
O&M Grade: **0**
Clock Start/From: **11**
Clock To:
1st Value: **4.000**
2nd Value:
Value Percent:
Continuous Index:
Within 8" of Joint: **YES**
Remarks:

Code: **TF**
Description: **Tap Factory**

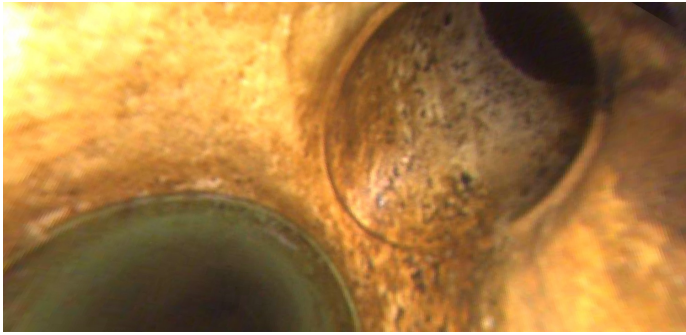
Distance (ft): **176.9**
Structural Grade: **0**
O&M Grade: **0**
Clock Start/From: **1**
Clock To:
1st Value: **4.000**
2nd Value:
Value Percent:
Continuous Index:
Within 8" of Joint: **YES**
Remarks:

Code: **TF**
Description: **Tap Factory**

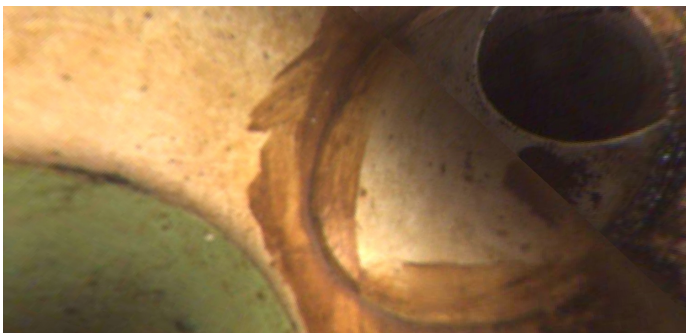
Distance (ft): **230.5**
Structural Grade: **0**
O&M Grade: **0**
Clock Start/From: **1**
Clock To:
1st Value: **4.000**
2nd Value:
Value Percent:
Continuous Index:
Within 8" of Joint: **YES**
Remarks:

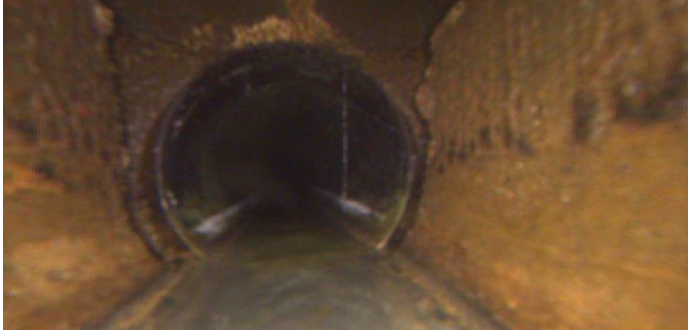
Code:	AMH
Description:	Manhole
Distance (ft):	248.0
Structural Grade:	0
O&M Grade:	0
Clock Start/From:	
Clock To:	
1st Value:	
2nd Value:	
Value Percent:	
Continuous Index:	
Within 8" of Joint:	NO
Remarks:	M-809-034
