Profile/Photo Observation Report

Street:	Oak	Flow Control:	Not Controlled
City:	Hobart, IN	Year Renewed:	
Location:	Light Highway	Tape/Media #:	
Purpose:	Maintenance Related	Dia/Height:	12"
Use:	Sanitary	Material:	PVC
Drain Area:	NA	Lining:	
Category:	NA		
Comment:

Location Details:		Direction of Survey:	Downstream
US MH:	M-809-033	DS MH:	M-809-034
		Total Length Surveyed (ft):	248.0

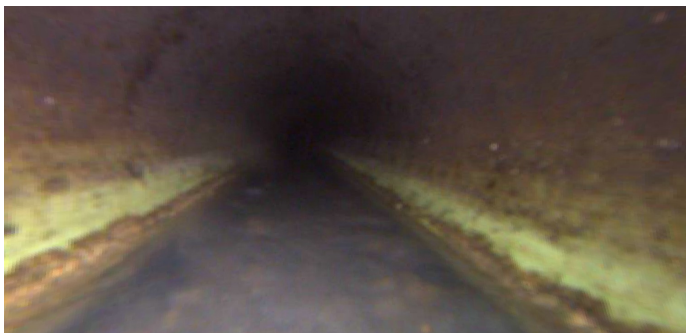
Code: **AMH**
Description: **Manhole**

Distance (ft): **.0**
Structural Grade: **0**
O&M Grade: **0**
Clock Start/From:
Clock To:
1st Value:
2nd Value:
Value Percent:
Continuous Index:
Within 8" of Joint: **NO**
Remarks: **M-809-033**

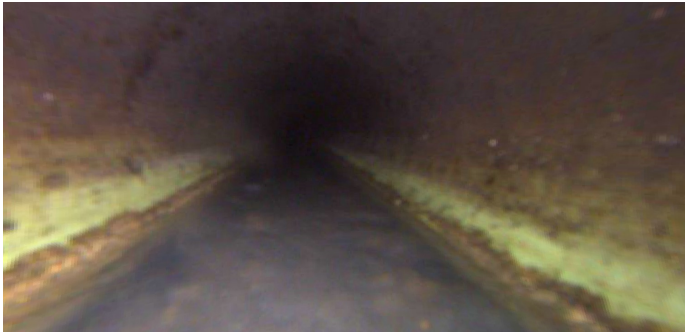
Code:	MWL
Description:	Water Level

Distance (ft):	.0
Structural Grade:	0
O&M Grade:	0
Clock Start/From:	
Clock To:	
1st Value:	
2nd Value:	
Value Percent:	5.000
Continuous Index:	
Within 8" of Joint:	NO
Remarks:

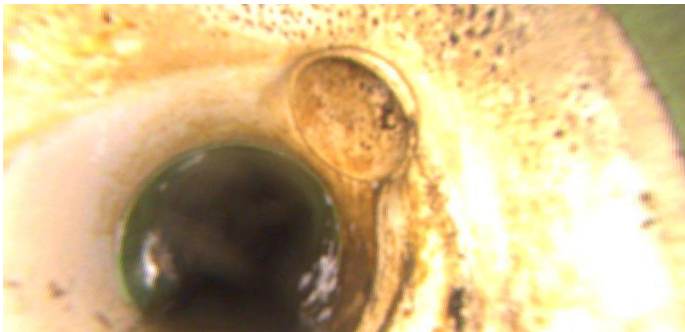
Code:	TF
Description:	Tap Factory

Distance (ft):	10.8
Structural Grade:	0
O&M Grade:	0
Clock Start/From:	1
Clock To:	
1st Value:	4.000
2nd Value:	
Value Percent:	
Continuous Index:	
Within 8" of Joint:	YES
Remarks:

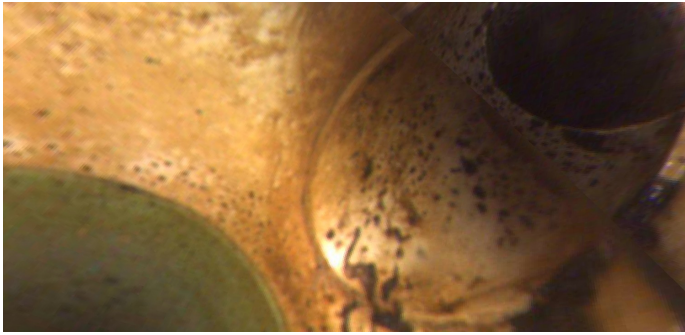
Code: **TF**
Description: **Tap Factory**

Distance (ft): **90.2**
Structural Grade: **0**
O&M Grade: **0**
Clock Start/From: **1**
Clock To:
1st Value: **4.000**
2nd Value:
Value Percent:
Continuous Index:
Within 8" of Joint: **YES**
Remarks:

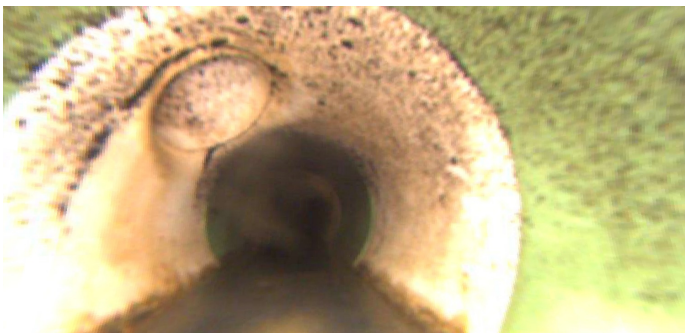
Code: **TF**
Description: **Tap Factory**

Distance (ft): **173.5**
Structural Grade: **0**
O&M Grade: **0**
Clock Start/From: **11**
Clock To:
1st Value: **4.000**
2nd Value:
Value Percent:
Continuous Index:
Within 8" of Joint: **YES**
Remarks:

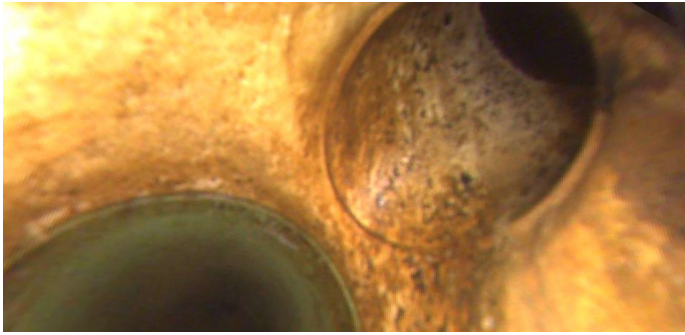
Code: **TF**
Description: **Tap Factory**

Distance (ft): **176.9**
Structural Grade: **0**
O&M Grade: **0**
Clock Start/From: **1**
Clock To:
1st Value: **4.000**
2nd Value:
Value Percent:
Continuous Index:
Within 8" of Joint: **YES**
Remarks:

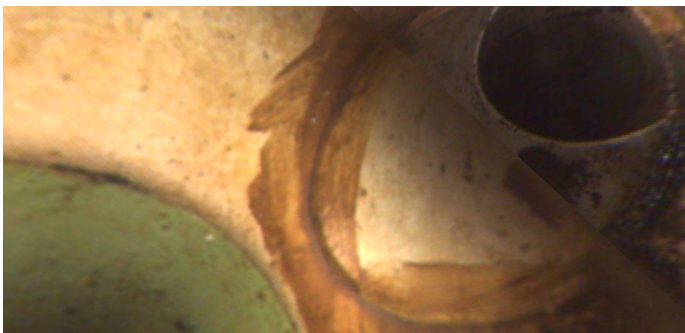
Code: **TF**
Description: **Tap Factory**

Distance (ft): **230.5**
Structural Grade: **0**
O&M Grade: **0**
Clock Start/From: **1**
Clock To:
1st Value: **4.000**
2nd Value:
Value Percent:
Continuous Index:
Within 8" of Joint: **YES**
Remarks:

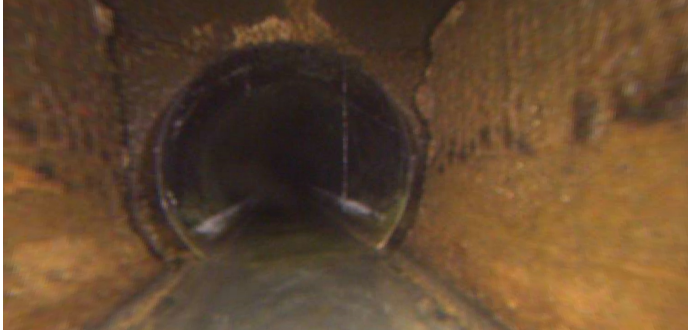
Code:	AMH
Description:	Manhole
Distance (ft):	248.0
Structural Grade:	0
O&M Grade:	0
Clock Start/From:	
Clock To:	
1st Value:	
2nd Value:	
Value Percent:	
Continuous Index:	
Within 8" of Joint:	NO
Remarks:	M-809-034
