Profile/Photo Observation Report

Street:	Oak	Flow Control:	Not Controlled
City:	Hobart, IN	Year Renewed:	
Location:	Sidewalk	Tape/Media #:	
Purpose:	Maintenance Related	Dia/Height:	12"
Use:	Sanitary	Material:	PVC
Drain Area:	NA	Lining:	
Category:	NA		
Comment:

Location Details:		Direction of Survey:	Downstream
US MH:	M-809-036	DS MH:	M-809-037
		Total Length Surveyed (ft):	308.4

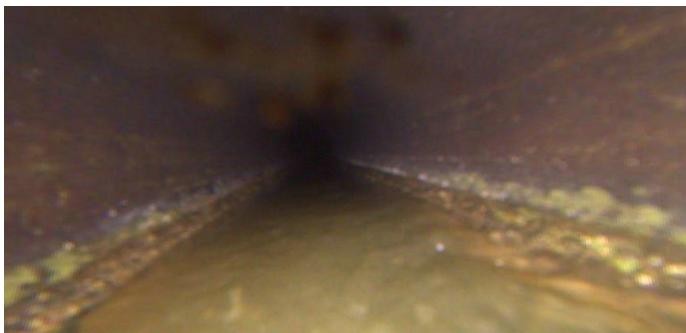
Code: **AMH**
Description: **Manhole**

Distance (ft): **.0**
Structural Grade: **0**
O&M Grade: **0**
Clock Start/From:
Clock To:
1st Value:
2nd Value:
Value Percent:
Continuous Index:
Within 8" of Joint: **NO**
Remarks: **M-809-036**

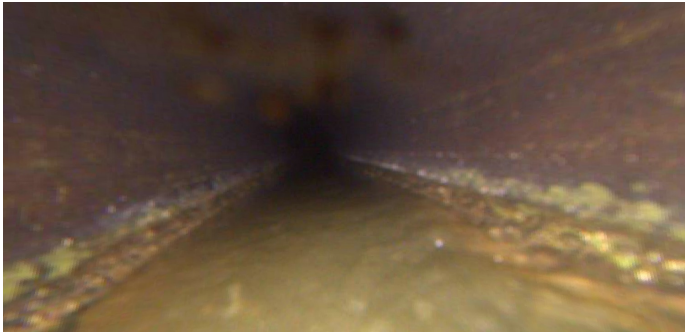
Code:	MWL
Description:	Water Level

Distance (ft):	.0
Structural Grade:	0
O&M Grade:	0
Clock Start/From:	
Clock To:	
1st Value:	
2nd Value:	
Value Percent:	5.000
Continuous Index:	
Within 8" of Joint:	NO
Remarks:

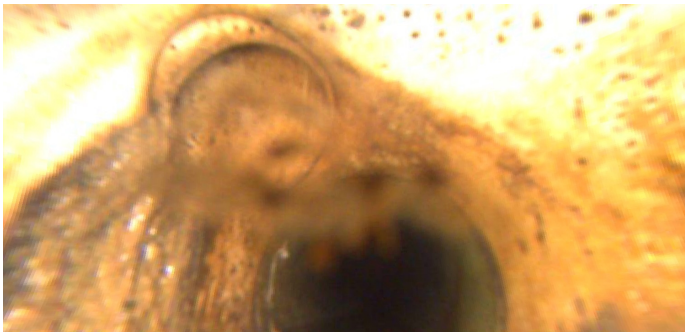
Code:	TF
Description:	Tap Factory

Distance (ft):	14.3
Structural Grade:	0
O&M Grade:	0
Clock Start/From:	11
Clock To:	
1st Value:	4.000
2nd Value:	
Value Percent:	
Continuous Index:	
Within 8" of Joint:	YES
Remarks:

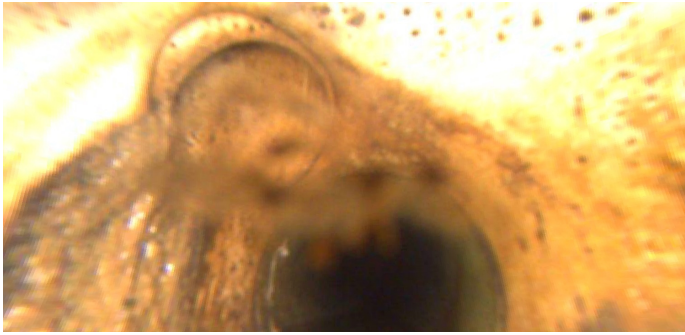
Code: **DAGS**
Description: **Deposits Attached Grease**

Distance (ft): **14.3**
Structural Grade: **0**
O&M Grade: **2**
Clock Start/From: **7**
Clock To: **5**
1st Value:
2nd Value:
Value Percent: **5.000**
Continuous Index:
Within 8" of Joint: **YES**
Remarks:

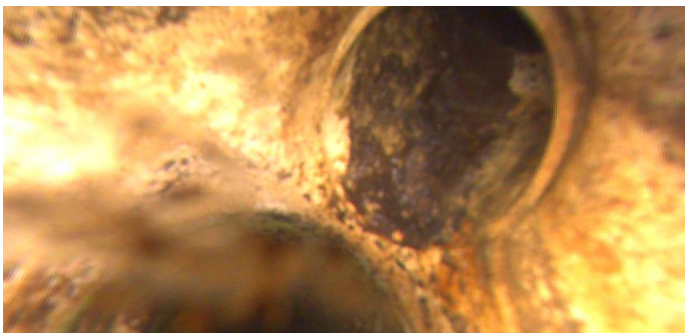
Code: **TF**
Description: **Tap Factory**

Distance (ft): **38.6**
Structural Grade: **0**
O&M Grade: **0**
Clock Start/From: **1**
Clock To:
1st Value: **4.000**
2nd Value:
Value Percent:
Continuous Index:
Within 8" of Joint: **YES**
Remarks:

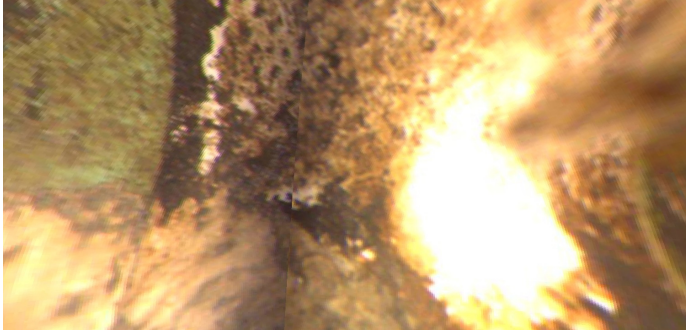
Code: **DAGS**
Description: **Deposits Attached Grease**

Distance (ft): **38.6**
Structural Grade: **0**
O&M Grade: **2**
Clock Start/From: **7**
Clock To: **5**
1st Value:
2nd Value:
Value Percent: **5.000**
Continuous Index: **S01**
Within 8" of Joint: **YES**
Remarks: **at taps**

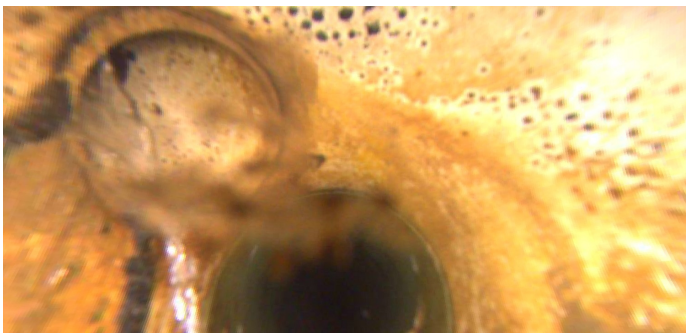
Code: **TFA**
Description: **Tap Factory Active**

Distance (ft): **99.5**
Structural Grade: **0**
O&M Grade: **0**
Clock Start/From: **11**
Clock To:
1st Value: **4.000**
2nd Value:
Value Percent:
Continuous Index:
Within 8" of Joint: **YES**
Remarks:

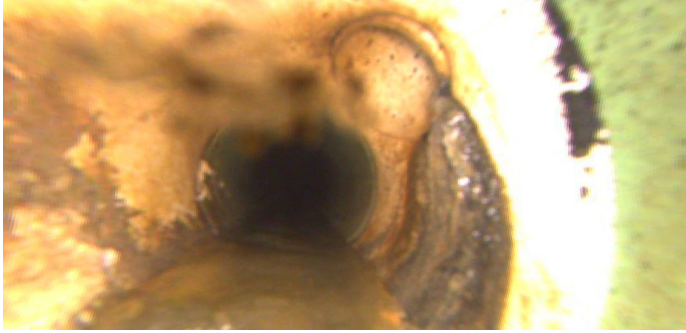
Code: **TF**
Description: **Tap Factory**

Distance (ft): **141.6**
Structural Grade: **0**
O&M Grade: **0**
Clock Start/From: **1**
Clock To:
1st Value: **4.000**
2nd Value:
Value Percent:
Continuous Index:
Within 8" of Joint: **YES**
Remarks:

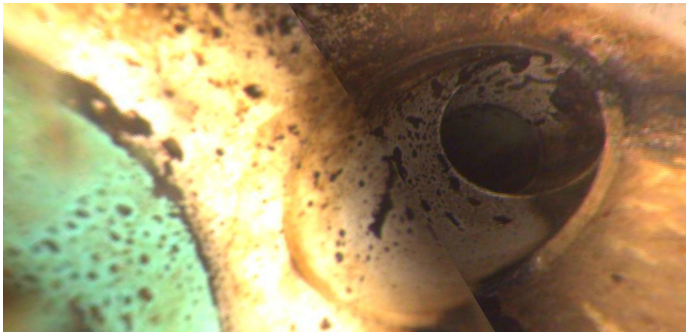
Code: **TF**
Description: **Tap Factory**

Distance (ft): **178.2**
Structural Grade: **0**
O&M Grade: **0**
Clock Start/From: **1**
Clock To:
1st Value: **4.000**
2nd Value:
Value Percent:
Continuous Index:
Within 8" of Joint: **YES**
Remarks:

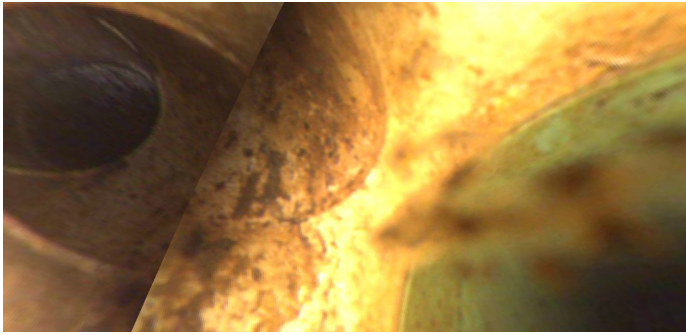
Code: **TF**
Description: **Tap Factory**

Distance (ft): **180.5**
Structural Grade: **0**
O&M Grade: **0**
Clock Start/From: **11**
Clock To:
1st Value: **4.000**
2nd Value:
Value Percent:
Continuous Index:
Within 8" of Joint: **YES**
Remarks:

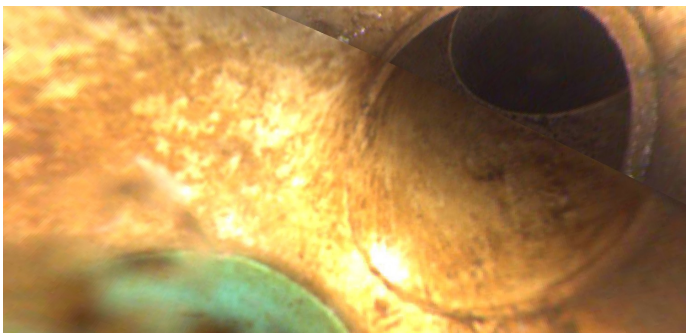
Code: **TF**
Description: **Tap Factory**

Distance (ft): **257.7**
Structural Grade: **0**
O&M Grade: **0**
Clock Start/From: **1**
Clock To:
1st Value: **4.000**
2nd Value:
Value Percent:
Continuous Index:
Within 8" of Joint: **YES**
Remarks:

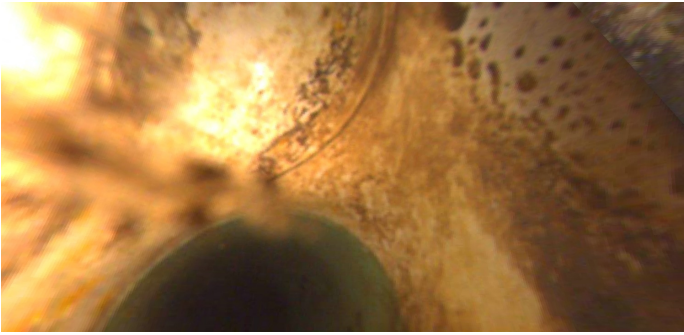
Code: **TF**
Description: **Tap Factory**

Distance (ft): **259.9**
Structural Grade: **0**
O&M Grade: **0**
Clock Start/From: **12**
Clock To:
1st Value: **4.000**
2nd Value:
Value Percent:
Continuous Index:
Within 8" of Joint: **YES**
Remarks:

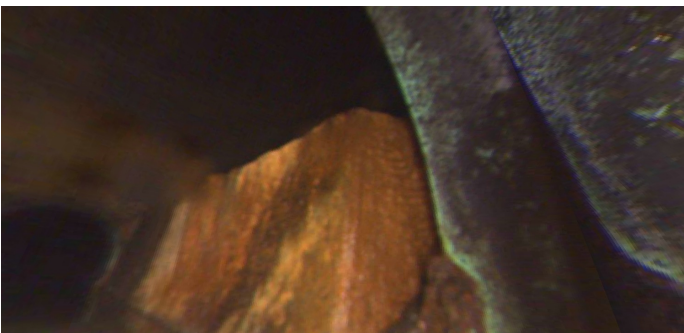
Code: **DAGS**
Description: **Deposits Attached Grease**

Distance (ft): **306.5**
Structural Grade: **0**
O&M Grade: **2**
Clock Start/From: **7**
Clock To: **5**
1st Value:
2nd Value:
Value Percent: **5.000**
Continuous Index: **F01**
Within 8" of Joint: **YES**
Remarks: **at taps**

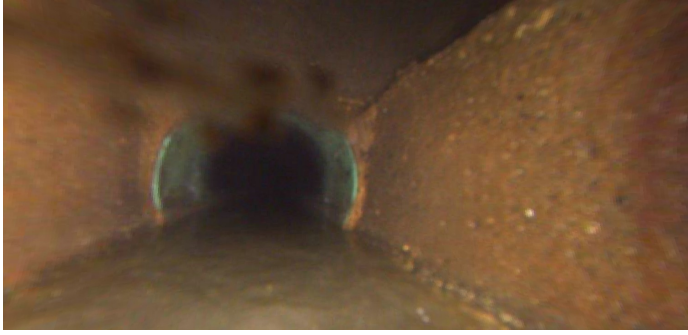
Code:	AMH
Description:	Manhole
Distance (ft):	308.4
Structural Grade:	0
O&M Grade:	0
Clock Start/From:	
Clock To:	
1st Value:	
2nd Value:	
Value Percent:	
Continuous Index:	
Within 8" of Joint:	NO
Remarks:	M-809-037
