Profile/Photo Observation Report

Street:	Oak	Flow Control:	Not Controlled
City:	Hobart, IN	Year Renewed:	
Location:	Sidewalk	Tape/Media #:	
Purpose:	Maintenance Related	Dia/Height:	12"
Use:	Sanitary	Material:	PVC
Drain Area:	NA	Lining:	
Category:	NA		
Comment:

Location Details:		Direction of Survey:	Upstream
US MH:	M-809-037	DS MH:	M-809-038
		Total Length Surveyed (ft):	282.6

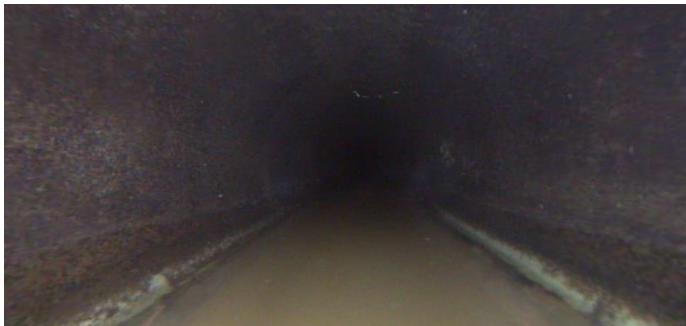
Code: **AMH**
Description: **Manhole**

Distance (ft): **.0**
Structural Grade: **0**
O&M Grade: **0**
Clock Start/From:
Clock To:
1st Value:
2nd Value:
Value Percent:
Continuous Index:
Within 8" of Joint: **NO**
Remarks: **M-809-038**

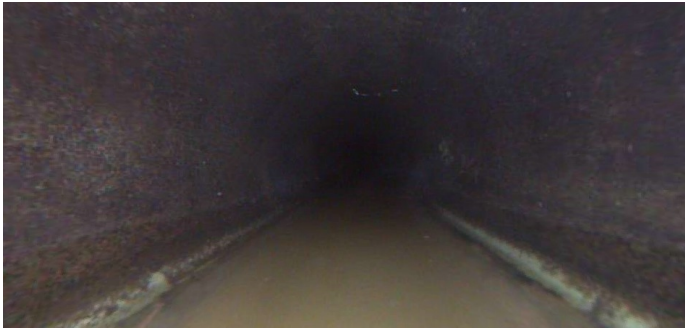
Code:	MWL
Description:	Water Level

Distance (ft):	.0
Structural Grade:	0
O&M Grade:	0
Clock Start/From:	
Clock To:	
1st Value:	
2nd Value:	
Value Percent:	20.000
Continuous Index:	
Within 8" of Joint:	NO
Remarks:

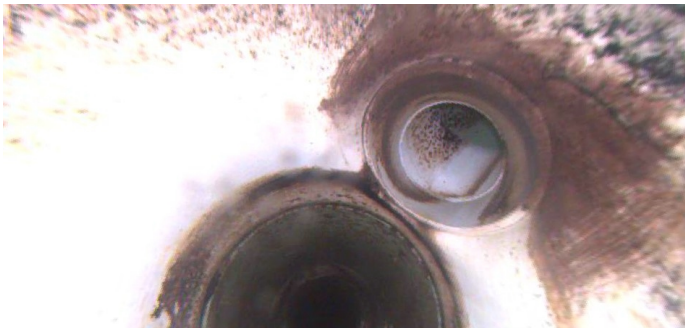
Code:	TF
Description:	Tap Factory

Distance (ft):	27.8
Structural Grade:	0
O&M Grade:	0
Clock Start/From:	1
Clock To:	
1st Value:	4.000
2nd Value:	
Value Percent:	
Continuous Index:	
Within 8" of Joint:	
Remarks:

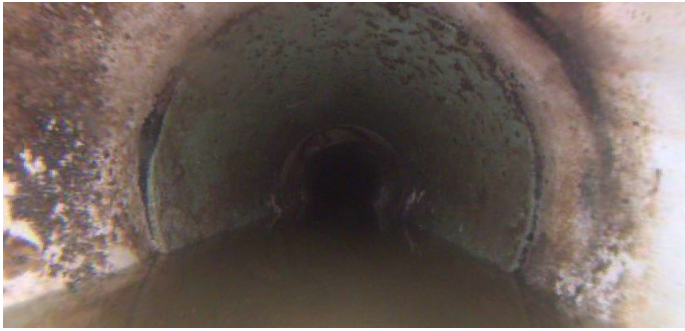
Code: **MWL**
Description: **Water Level**

Distance (ft): **28.4**
Structural Grade: **0**
O&M Grade: **0**
Clock Start/From:
Clock To:
1st Value:
2nd Value:
Value Percent: **30.000**
Continuous Index:
Within 8" of Joint: **NO**
Remarks:

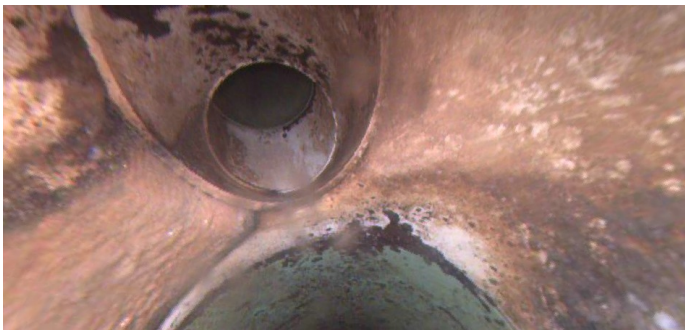
Code: **TF**
Description: **Tap Factory**

Distance (ft): **31.0**
Structural Grade: **0**
O&M Grade: **0**
Clock Start/From: **1**
Clock To:
1st Value: **4.000**
2nd Value:
Value Percent:
Continuous Index:
Within 8" of Joint:
Remarks:

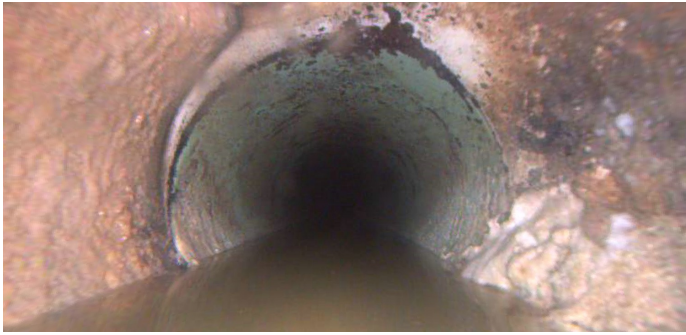
Code: **DAGS**
Description: **Deposits Attached Grease**

Distance (ft): **31.0**
Structural Grade: **0**
O&M Grade: **2**
Clock Start/From: **3**
Clock To: **4**
1st Value:
2nd Value:
Value Percent: **5.000**
Continuous Index:
Within 8" of Joint: **NO**
Remarks:

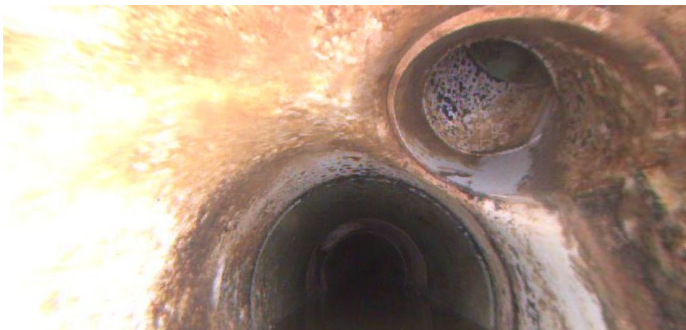
Code: **TF**
Description: **Tap Factory**

Distance (ft): **114.0**
Structural Grade: **0**
O&M Grade: **0**
Clock Start/From: **1**
Clock To:
1st Value: **4.000**
2nd Value:
Value Percent:
Continuous Index:
Within 8" of Joint:
Remarks:

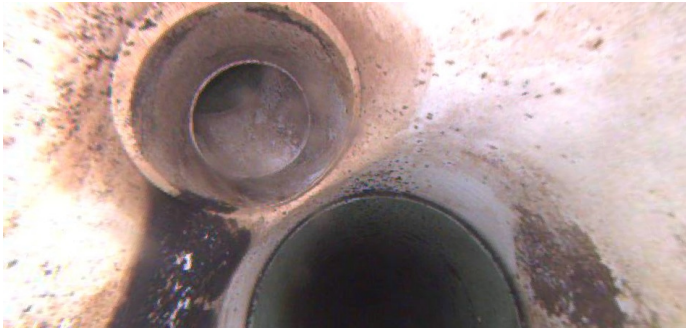
Code: **TF**
Description: **Tap Factory**

Distance (ft): **116.4**
Structural Grade: **0**
O&M Grade: **0**
Clock Start/From: **11**
Clock To:
1st Value: **4.000**
2nd Value:
Value Percent:
Continuous Index:
Within 8" of Joint:
Remarks:

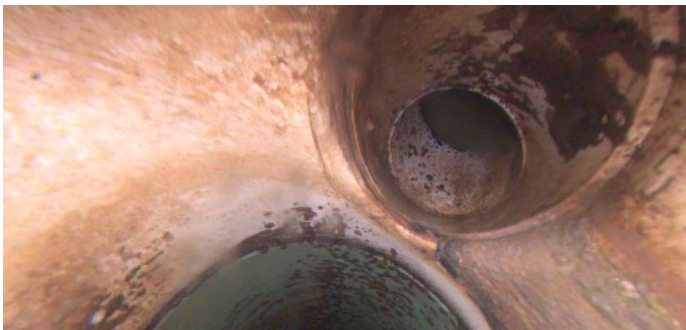
Code: **TF**
Description: **Tap Factory**

Distance (ft): **182.4**
Structural Grade: **0**
O&M Grade: **0**
Clock Start/From: **1**
Clock To:
1st Value: **4.000**
2nd Value:
Value Percent:
Continuous Index:
Within 8" of Joint:
Remarks:

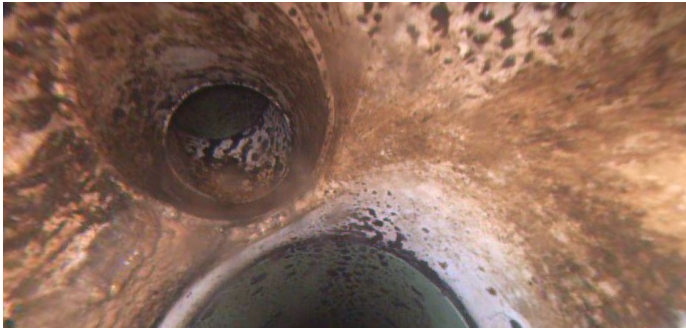
Code: **TF**
Description: **Tap Factory**

Distance (ft): **184.7**
Structural Grade: **0**
O&M Grade: **0**
Clock Start/From: **11**
Clock To:
1st Value: **4.000**
2nd Value:
Value Percent:
Continuous Index:
Within 8" of Joint:
Remarks:

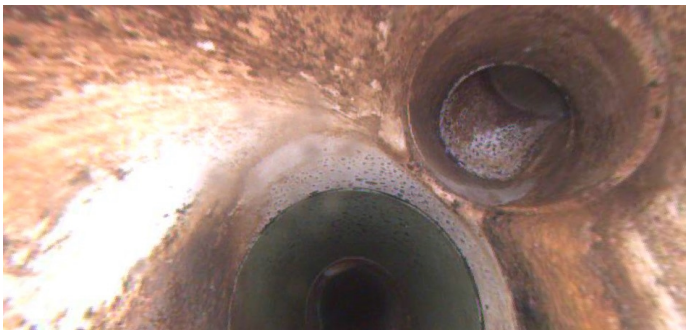
Code: **TF**
Description: **Tap Factory**

Distance (ft): **254.4**
Structural Grade: **0**
O&M Grade: **0**
Clock Start/From: **1**
Clock To:
1st Value: **4.000**
2nd Value:
Value Percent:
Continuous Index:
Within 8" of Joint:
Remarks:

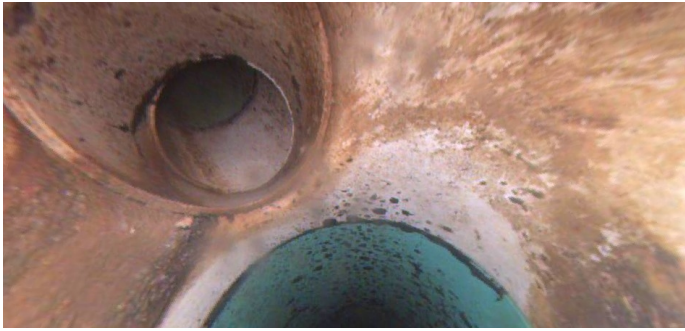
Code: **TF**
Description: **Tap Factory**

Distance (ft): **257.7**
Structural Grade: **0**
O&M Grade: **0**
Clock Start/From: **11**
Clock To:
1st Value: **4.000**
2nd Value:
Value Percent:
Continuous Index:
Within 8" of Joint:
Remarks:

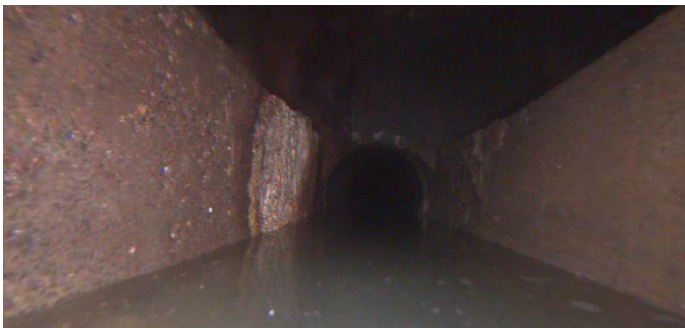
Code: **AMH**
Description: **Manhole**

Distance (ft): **282.6**
Structural Grade: **0**
O&M Grade: **0**
Clock Start/From:
Clock To:
1st Value:
2nd Value:
Value Percent:
Continuous Index:
Within 8" of Joint: **NO**
Remarks: **M-809-037**
