## Profile/Photo Observation Report

Street:	<b>KESTREL ST</b>	Flow Control:	<b>Not Controlled</b>
City:	<b>Hobart, IN</b>	Year Renewed:	
Location:	<b>Sidewalk</b>	Tape/Media #:	
Purpose:	<b>Maintenance Related</b>	Dia/Height:	<b>8"</b>
Use:	<b>Sanitary</b>	Material:	<b>PVC</b>
Drain Area:	<b>NA</b>	Lining:	
Category:	<b>NA</b>		
Comment:

Location Details:		Direction of Survey:	<b>Downstream</b>
US MH:	<b>M-809-039</b>	DS MH:	<b>M-709-036</b>
		Total Length Surveyed (ft):	<b>100.7</b>

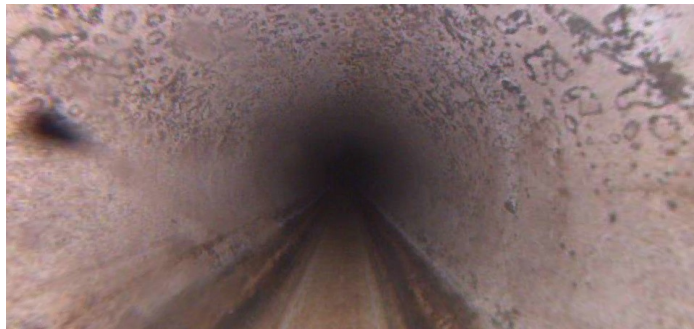
Code: **AMH**  
Description: **Manhole**

Distance (ft): **.0**  
Structural Grade: **0**  
O&M Grade: **0**  
Clock Start/From:  
Clock To:  
1st Value:  
2nd Value:  
Value Percent:  
Continuous Index:  
Within 8" of Joint: **NO**  
Remarks: **M-809-039**

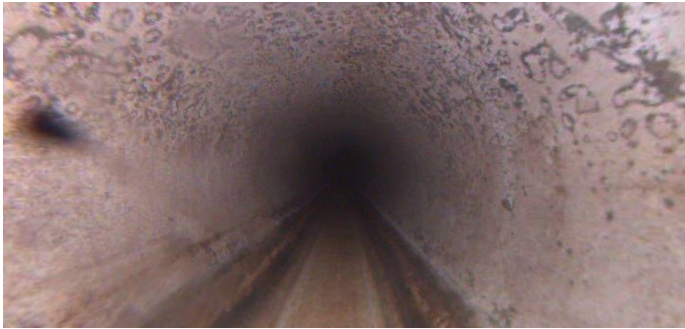
Code:	<b>MWL</b>
Description:	<b>Water Level</b>

Distance (ft):	<b>.0</b>
Structural Grade:	<b>0</b>
O&M Grade:	<b>0</b>
Clock Start/From:	
Clock To:	
1st Value:	
2nd Value:	
Value Percent:	<b>5.000</b>
Continuous Index:	
Within 8" of Joint:	<b>NO</b>
Remarks:

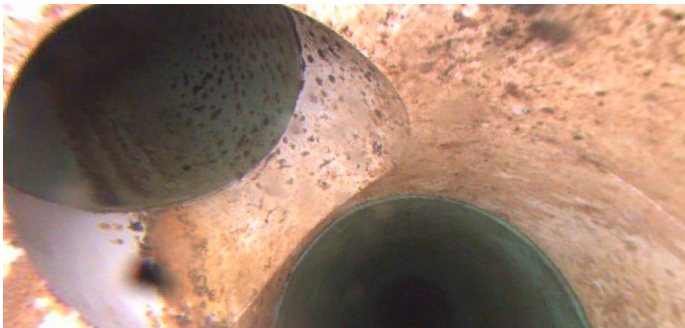
Code:	<b>TF</b>
Description:	<b>Tap Factory</b>

Distance (ft):	<b>50.9</b>
Structural Grade:	<b>0</b>
O&M Grade:	<b>0</b>
Clock Start/From:	<b>10</b>
Clock To:	
1st Value:	<b>4.000</b>
2nd Value:	
Value Percent:	
Continuous Index:	
Within 8" of Joint:	
Remarks:

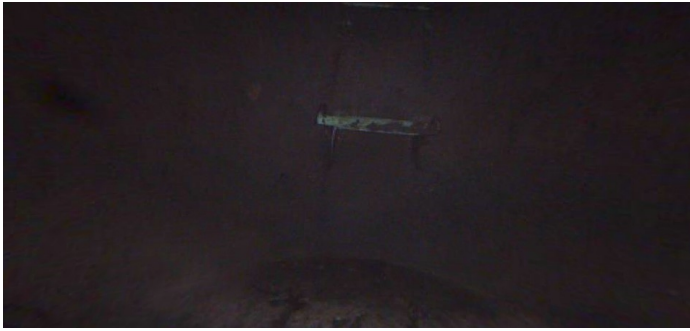
Code:	<b>AMH</b>
Description:	<b>Manhole</b>
Distance (ft):	<b>100.7</b>
Structural Grade:	<b>0</b>
O&M Grade:	<b>0</b>
Clock Start/From:	
Clock To:	
1st Value:	
2nd Value:	
Value Percent:	
Continuous Index:	
Within 8" of Joint:	<b>NO</b>
Remarks:	<b>M-709-036</b>
