Profile/Photo Observation Report

Street:	Oak	Flow Control:	Not Controlled
City:	Hobart, IN	Year Renewed:	
Location:	Sidewalk	Tape/Media #:	
Purpose:	Maintenance Related	Dia/Height:	8"
Use:	Sanitary	Material:	PVC
Drain Area:	NA	Lining:	
Category:	NA		
Comment:	mh, flow direction incorrect.

Location Details:		Direction of Survey:	Upstream
US MH:	M-809-039	DS MH:	M-809-040
		Total Length Surveyed (ft):	86.1

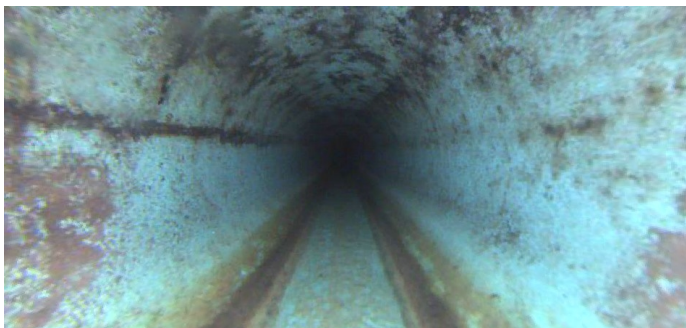
Code: **AMH**
Description: **Manhole**

Distance (ft): **.0**
Structural Grade: **0**
O&M Grade: **0**
Clock Start/From:
Clock To:
1st Value:
2nd Value:
Value Percent:
Continuous Index:
Within 8" of Joint: **NO**
Remarks: **M-809-040**

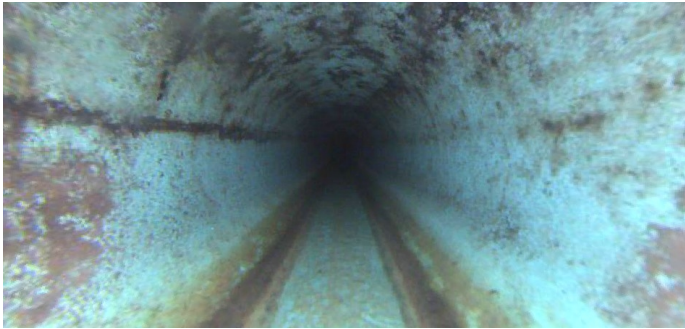
Code:	MWL
Description:	Water Level

Distance (ft):	.0
Structural Grade:	0
O&M Grade:	0
Clock Start/From:	
Clock To:	
1st Value:	
2nd Value:	
Value Percent:	10.000
Continuous Index:	
Within 8" of Joint:	NO
Remarks:

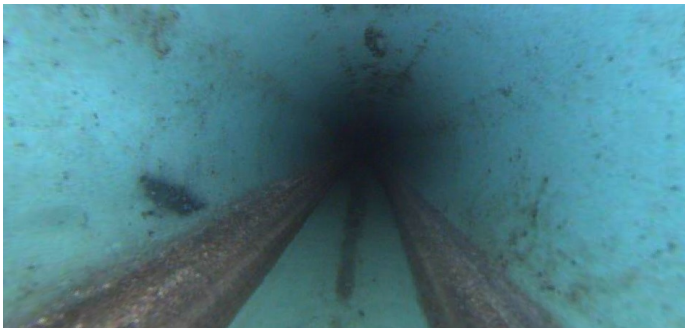
Code:	DAGS
Description:	Deposits Attached Grease

Distance (ft):	29.4
Structural Grade:	0
O&M Grade:	2
Clock Start/From:	4
Clock To:	8
1st Value:	
2nd Value:	
Value Percent:	10.000
Continuous Index:	S01
Within 8" of Joint:	NO
Remarks:

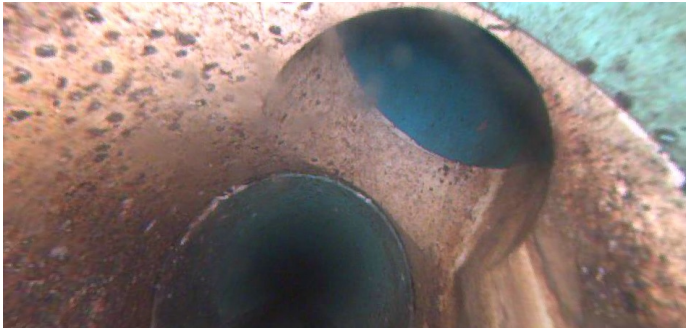
Code: **TF**
Description: **Tap Factory**

Distance (ft): **33.9**
Structural Grade: **0**
O&M Grade: **0**
Clock Start/From: **2**
Clock To:
1st Value: **4.000**
2nd Value:
Value Percent:
Continuous Index:
Within 8" of Joint:
Remarks:

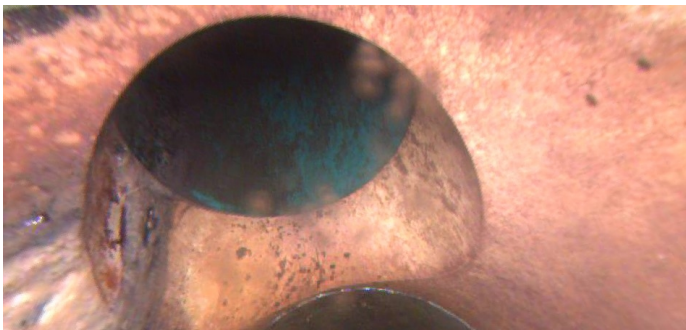
Code: **TF**
Description: **Tap Factory**

Distance (ft): **57.8**
Structural Grade: **0**
O&M Grade: **0**
Clock Start/From: **11**
Clock To:
1st Value: **4.000**
2nd Value:
Value Percent:
Continuous Index:
Within 8" of Joint:
Remarks:

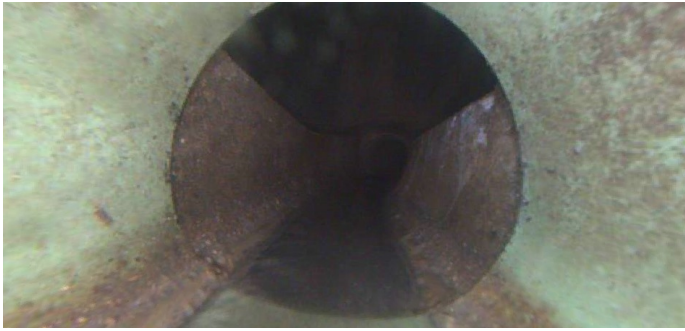
Code: **DAGS**
Description: **Deposits Attached Grease**

Distance (ft): **83.7**
Structural Grade: **0**
O&M Grade: **2**
Clock Start/From: **4**
Clock To: **8**
1st Value:
2nd Value:
Value Percent: **10.000**
Continuous Index: **F01**
Within 8" of Joint: **NO**
Remarks: **Clock positions vary**

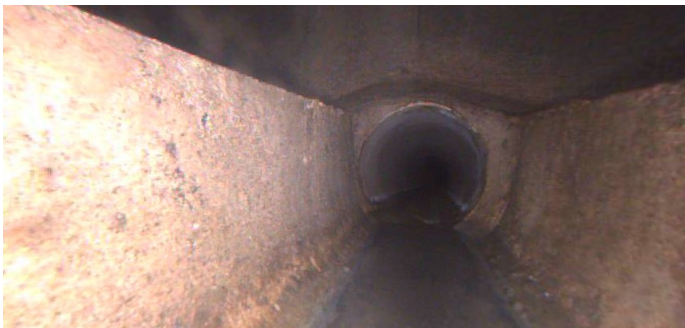
Code: **AMH**
Description: **Manhole**

Distance (ft): **86.1**
Structural Grade: **0**
O&M Grade: **0**
Clock Start/From:
Clock To:
1st Value:
2nd Value:
Value Percent:
Continuous Index:
Within 8" of Joint: **NO**
Remarks: **M-809-039**
