Profile/Photo Observation Report

Street:	Oak	Flow Control:	Not Controlled
City:	Hobart, IN	Year Renewed:	
Location:	Sidewalk	Tape/Media #:	
Purpose:	Maintenance Related	Dia/Height:	8"
Use:	Sanitary	Material:	PVC
Drain Area:	NA	Lining:	
Category:	NA		
Comment:	Reverse setup. mh, flow direction is wrong.

Location Details:		Direction of Survey:	Upstream
US MH:	M-809-040	DS MH:	M-809-041
		Total Length Surveyed (ft):	84.9

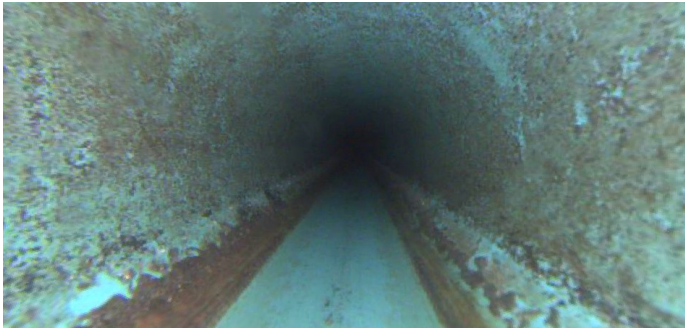
Code:	MWL
Description:	Water Level

Distance (ft):	.0
Structural Grade:	0
O&M Grade:	0
Clock Start/From:	
Clock To:	
1st Value:	
2nd Value:	
Value Percent:	10.000
Continuous Index:	
Within 8" of Joint:	NO
Remarks:

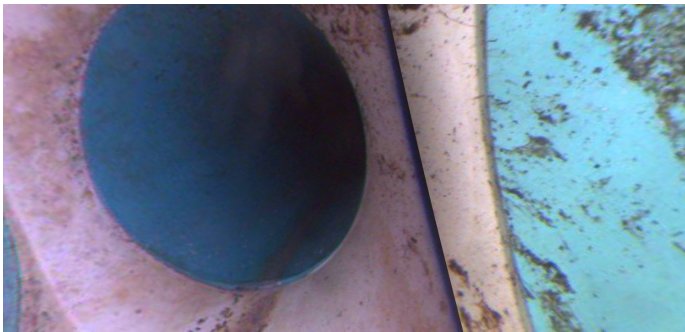
Code:	TF
Description:	Tap Factory

Distance (ft):	13.0
Structural Grade:	0
O&M Grade:	0
Clock Start/From:	10
Clock To:	
1st Value:	4.000
2nd Value:	
Value Percent:	
Continuous Index:	
Within 8" of Joint:	
Remarks:

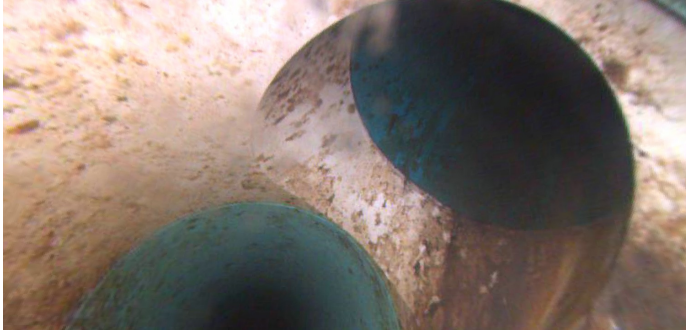
Code: **TF**
Description: **Tap Factory**

Distance (ft): **13.9**
Structural Grade: **0**
O&M Grade: **0**
Clock Start/From: **1**
Clock To:
1st Value: **4.000**
2nd Value:
Value Percent:
Continuous Index:
Within 8" of Joint:
Remarks:

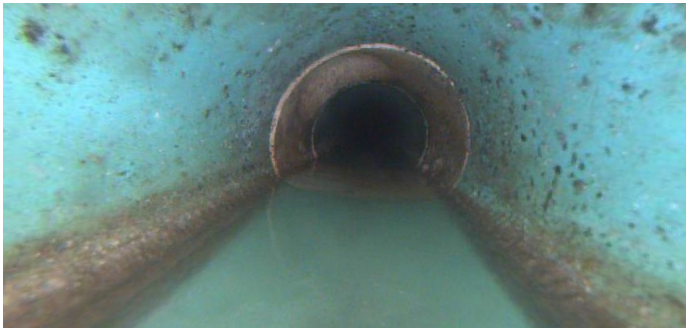
Code: **MWL**
Description: **Water Level**

Distance (ft): **68.6**
Structural Grade: **0**
O&M Grade: **0**
Clock Start/From:
Clock To:
1st Value:
2nd Value:
Value Percent: **20.000**
Continuous Index:
Within 8" of Joint: **NO**
Remarks:

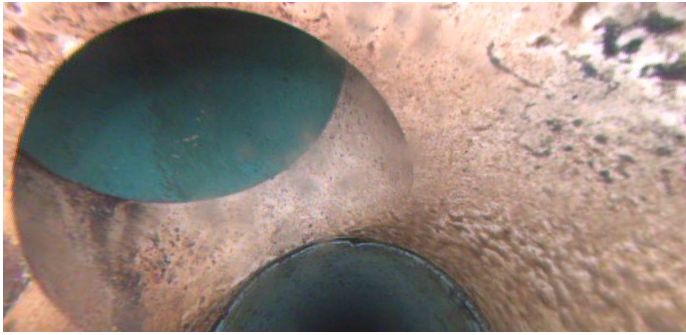
Code: **TF**
Description: **Tap Factory**

Distance (ft): **69.5**
Structural Grade: **0**
O&M Grade: **0**
Clock Start/From: **11**
Clock To:
1st Value: **4.000**
2nd Value:
Value Percent:
Continuous Index:
Within 8" of Joint:
Remarks:

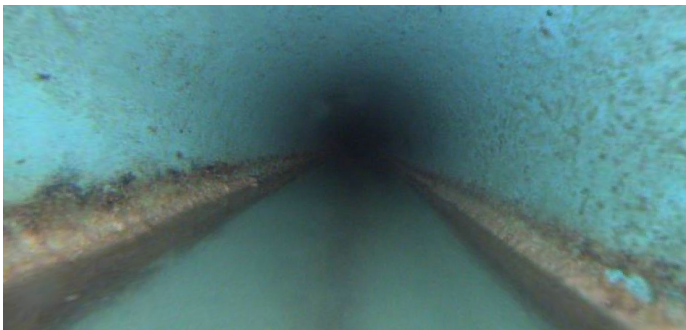
Code: **MWL**
Description: **Water Level**

Distance (ft): **71.3**
Structural Grade: **0**
O&M Grade: **0**
Clock Start/From:
Clock To:
1st Value:
2nd Value:
Value Percent: **35.000**
Continuous Index:
Within 8" of Joint: **NO**
Remarks:

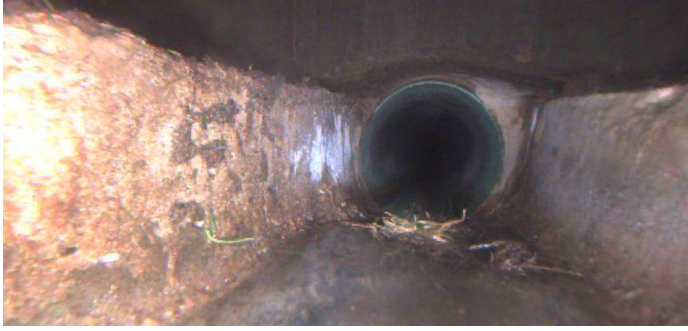
Code:	AMH
Description:	Manhole
Distance (ft):	84.9
Structural Grade:	0
O&M Grade:	0
Clock Start/From:	
Clock To:	
1st Value:	
2nd Value:	
Value Percent:	
Continuous Index:	
Within 8" of Joint:	NO
Remarks:	M-809-040
