Profile/Photo Observation Report

Date:	03/20/2018	Weather:		Coding:	PACP 6.0
Pipe Length (ft):	87.8	Owner:	NA	Pre Clean:	Not Known
P.O.#:		Surveyor:	John Kuglmaier	PSR:	P-809-042-041
Customer:		Clean Date:	01/01/1900	Shape:	C

Street:	KESTREL ST	Flow Control:	Not Controlled
City:	Hobart, IN	Year Renewed:	
Location:	Sidewalk	Tape/Media #:	
Purpose:	Maintenance Related	Dia/Height:	8"
Use:	Sanitary	Material:	PVC
Drain Area:	NA	Lining:	
Category:	NA		
Comment:

Location Details:		Direction of Survey:	Upstream
US MH:	M-809-041	DS MH:	M-809-042
		Total Length Surveyed (ft):	86.9

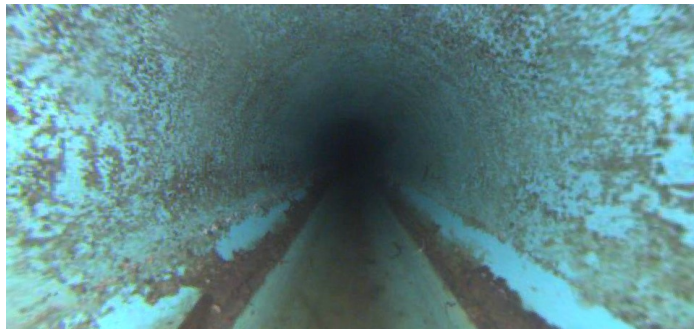
Code: **AMH**
Description: **Manhole**

Distance (ft): **.0**
Structural Grade: **0**
O&M Grade: **0**
Clock Start/From:
Clock To:
1st Value:
2nd Value:
Value Percent:
Continuous Index:
Within 8" of Joint: **NO**
Remarks: **M-809-042**

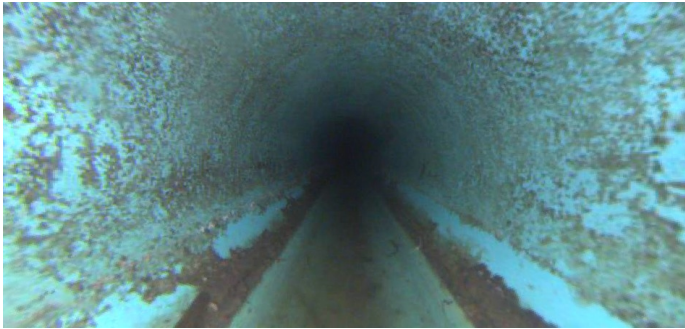
Code:	MWL
Description:	Water Level

Distance (ft):	.0
Structural Grade:	0
O&M Grade:	0
Clock Start/From:	
Clock To:	
1st Value:	
2nd Value:	
Value Percent:	15.000
Continuous Index:	
Within 8" of Joint:	NO
Remarks:

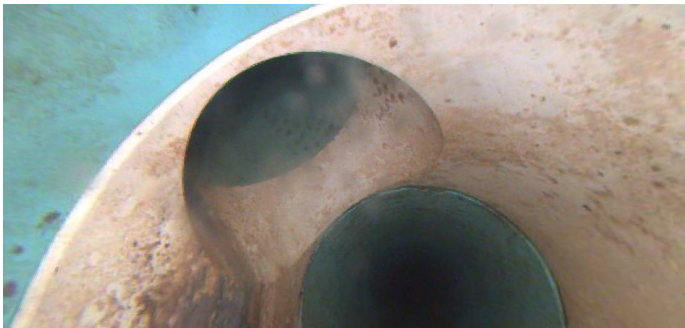
Code:	TF
Description:	Tap Factory

Distance (ft):	33.7
Structural Grade:	0
O&M Grade:	0
Clock Start/From:	10
Clock To:	
1st Value:	4.000
2nd Value:	
Value Percent:	
Continuous Index:	
Within 8" of Joint:	
Remarks:

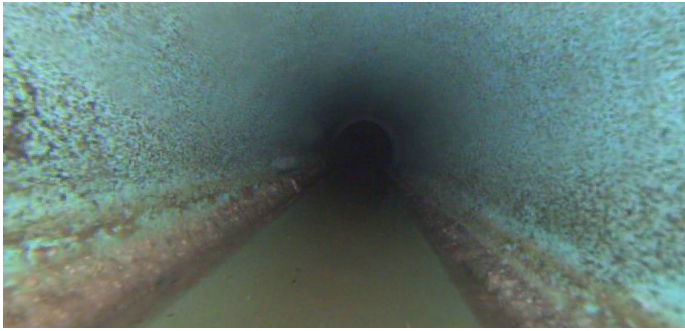
Code: **MWL**
Description: **Water Level**

Distance (ft): **81.9**
Structural Grade: **0**
O&M Grade: **0**
Clock Start/From:
Clock To:
1st Value:
2nd Value:
Value Percent: **20.000**
Continuous Index:
Within 8" of Joint: **NO**
Remarks:

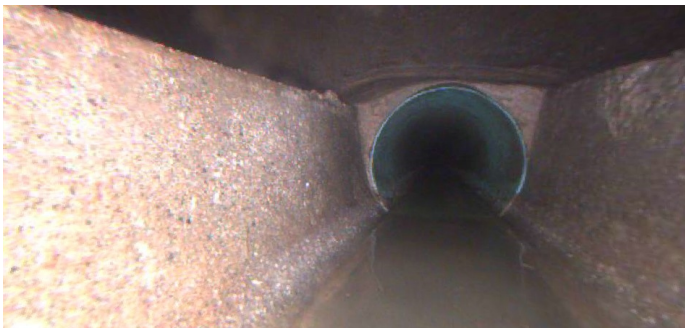
Code: **AMH**
Description: **Manhole**

Distance (ft): **86.9**
Structural Grade: **0**
O&M Grade: **0**
Clock Start/From:
Clock To:
1st Value:
2nd Value:
Value Percent:
Continuous Index:
Within 8" of Joint: **NO**
Remarks: **M-809-041**
