Profile/Photo Observation Report

Date:	03/20/2018	Weather:		Coding:	PACP 6.0
Pipe Length (ft):	87.8	Owner:	NA	Pre Clean:	Not Known
P.O.#:		Surveyor:	John Kuglmaier	PSR:	P-809-042-041
Customer:		Clean Date:	01/01/1900	Shape:	C

Location Details:		Direction of Survey:	Upstream
US MH:	M-809-041	DS MH:	M-809-042
		Total Length Surveyed (ft):	86.9

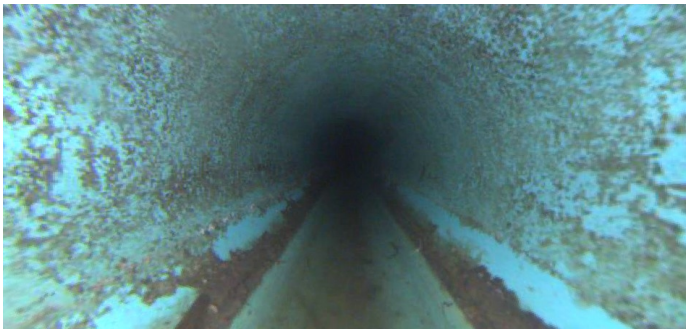
Diagram illustrating a vertical pipe structure with a camera direction arrow pointing downwards. The pipe is labeled with manhole IDs M-809-042 at the top and M-809-041 at the bottom. A table to the right lists observations from the camera view.

Position	Code	Observation	Video (sec)	Grade
.0	AMH	Manhole	10	NA
.0	MWL	Water Level	21	NA
33.7	TF	Tap Factory	100	NA
81.9	MWL	Water Level	208	NA
86.9	AMH	Manhole	230	NA

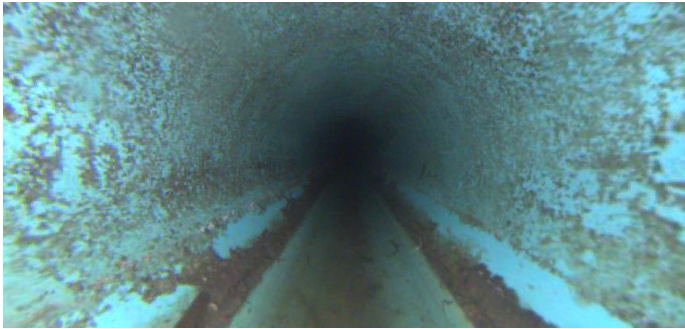
Code: **MWL**
Description: **Water Level**

Distance (ft): **.0**
Structural Grade: **0**
O&M Grade: **0**
Clock Start/From:
Clock To:
1st Value:
2nd Value:
Value Percent: **15.000**
Continuous Index:
Within 8" of Joint: **NO**
Remarks:

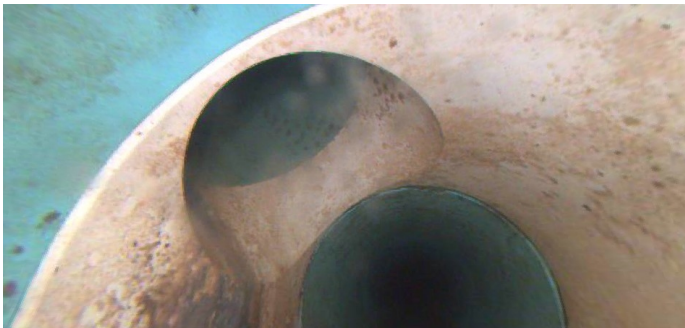
Code: **TF**
Description: **Tap Factory**

Distance (ft): **33.7**
Structural Grade: **0**
O&M Grade: **0**
Clock Start/From: **10**
Clock To:
1st Value: **4.000**
2nd Value:
Value Percent:
Continuous Index:
Within 8" of Joint:
Remarks:

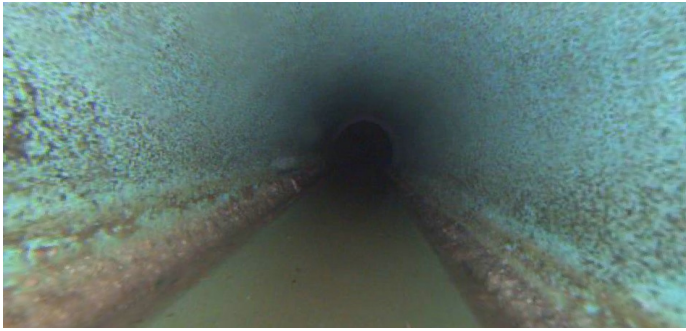
Code: **MWL**
Description: **Water Level**

Distance (ft): **81.9**
Structural Grade: **0**
O&M Grade: **0**
Clock Start/From:
Clock To:
1st Value:
2nd Value:
Value Percent: **20.000**
Continuous Index:
Within 8" of Joint: **NO**
Remarks:

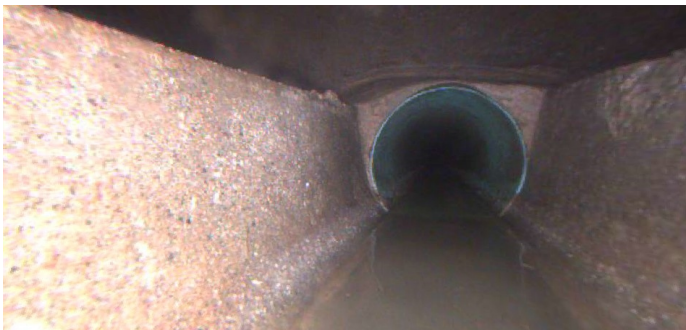
Code: **AMH**
Description: **Manhole**

Distance (ft): **86.9**
Structural Grade: **0**
O&M Grade: **0**
Clock Start/From:
Clock To:
1st Value:
2nd Value:
Value Percent:
Continuous Index:
Within 8" of Joint: **NO**
Remarks: **M-809-041**
