Profile/Photo Observation Report

Date:	03/20/2018	Weather:		Coding:	PACP 6.0
Pipe Length (ft):	88.1	Owner:	NA	Pre Clean:	Not Known
P.O.#:		Surveyor:	John Kuglmaier	PSR:	P-809-043-042
Customer:		Clean Date:	01/01/1900	Shape:	C

Street:	KESTREL ST	Flow Control:	Not Controlled
City:	Hobart, IN	Year Renewed:	
Location:	Sidewalk	Tape/Media #:	
Purpose:	Maintenance Related	Dia/Height:	8"
Use:	Sanitary	Material:	PVC
Drain Area:	NA	Lining:	
Category:	NA		
Comment:

Location Details:		Direction of Survey:	Downstream
US MH:	M-809-042	DS MH:	M-809-043
		Total Length Surveyed (ft):	86.0

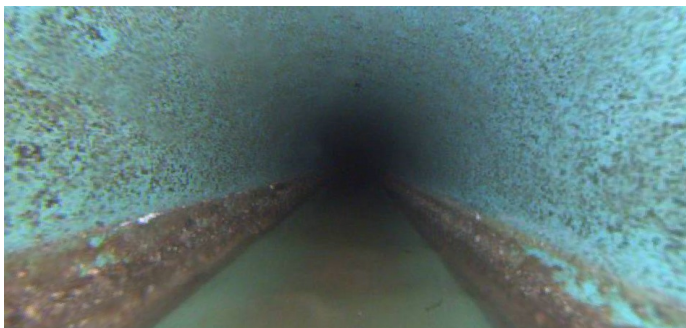
Code: **AMH**
Description: **Manhole**

Distance (ft): **.0**
Structural Grade: **0**
O&M Grade: **0**
Clock Start/From:
Clock To:
1st Value:
2nd Value:
Value Percent:
Continuous Index:
Within 8" of Joint: **NO**
Remarks: **M-809-042**

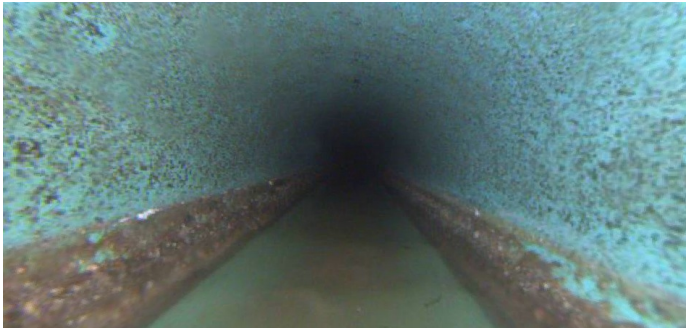
Code:	MWL
Description:	Water Level

Distance (ft):	.0
Structural Grade:	0
O&M Grade:	0
Clock Start/From:	
Clock To:	
1st Value:	
2nd Value:	
Value Percent:	20.000
Continuous Index:	
Within 8" of Joint:	NO
Remarks:

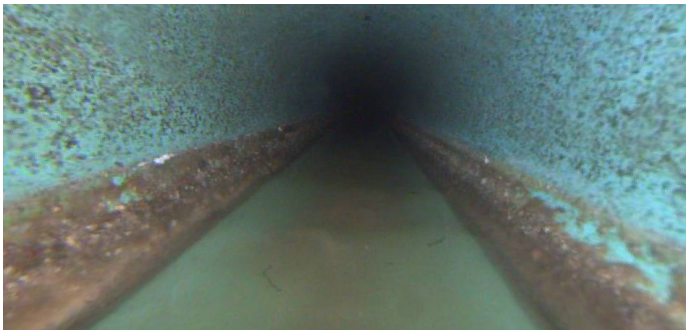
Code:	DAGS
Description:	Deposits Attached Grease

Distance (ft):	.0
Structural Grade:	0
O&M Grade:	2
Clock Start/From:	4
Clock To:	8
1st Value:	
2nd Value:	
Value Percent:	10.000
Continuous Index:	S01
Within 8" of Joint:	NO
Remarks:

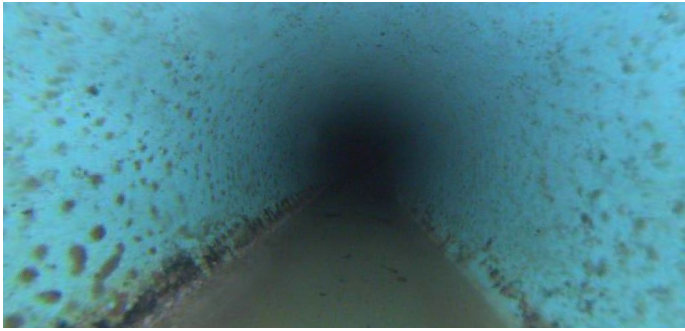
Code: **DAGS**
Description: **Deposits Attached Grease**

Distance (ft): **15.0**
Structural Grade: **0**
O&M Grade: **2**
Clock Start/From: **4**
Clock To: **8**
1st Value:
2nd Value:
Value Percent: **10.000**
Continuous Index: **F01**
Within 8" of Joint: **NO**
Remarks: **Clock positions vary**

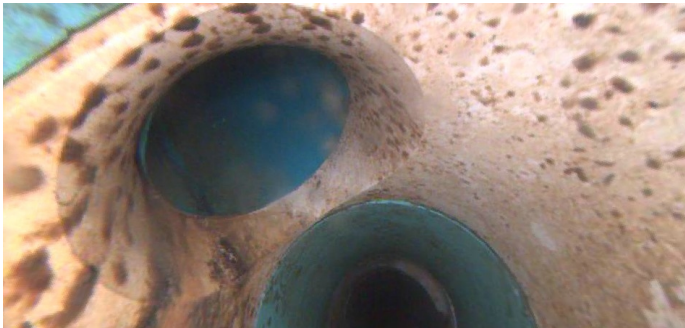
Code: **TF**
Description: **Tap Factory**

Distance (ft): **38.0**
Structural Grade: **0**
O&M Grade: **0**
Clock Start/From: **10**
Clock To:
1st Value: **4.000**
2nd Value:
Value Percent:
Continuous Index:
Within 8" of Joint:
Remarks:

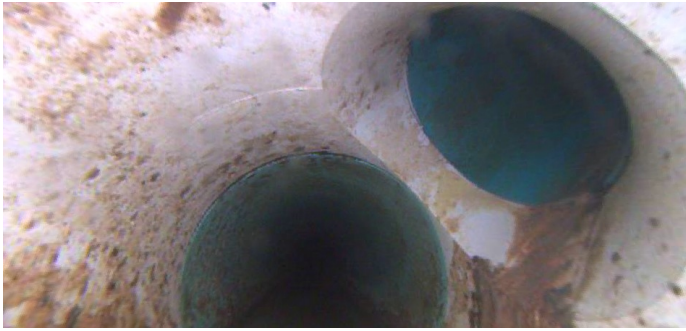
Code: **TF**
Description: **Tap Factory**

Distance (ft): **39.6**
Structural Grade: **0**
O&M Grade: **0**
Clock Start/From: **2**
Clock To:
1st Value: **4.000**
2nd Value:
Value Percent:
Continuous Index:
Within 8" of Joint:
Remarks:

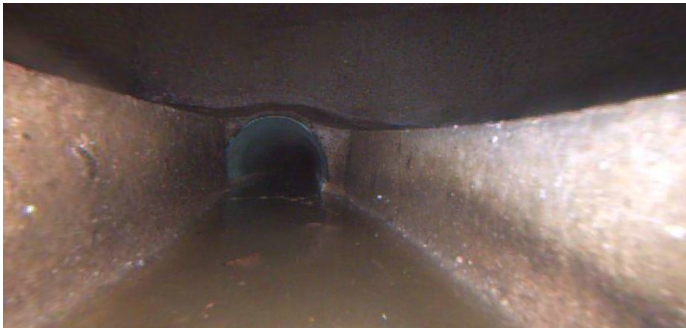
Code: **AMH**
Description: **Manhole**

Distance (ft): **86.0**
Structural Grade: **0**
O&M Grade: **0**
Clock Start/From:
Clock To:
1st Value:
2nd Value:
Value Percent:
Continuous Index:
Within 8" of Joint: **NO**
Remarks: **M-809-043**
