Profile/Photo Observation Report

Street:	Oak	Flow Control:	Not Controlled
City:	Hobart, IN	Year Renewed:	
Location:	Sidewalk	Tape/Media #:	
Purpose:	Maintenance Related	Dia/Height:	8"
Use:	Sanitary	Material:	PVC
Drain Area:	NA	Lining:	
Category:	NA		
Comment:

Location Details:		Direction of Survey:	Downstream
US MH:	M-809-042	DS MH:	M-809-043
		Total Length Surveyed (ft):	86.0

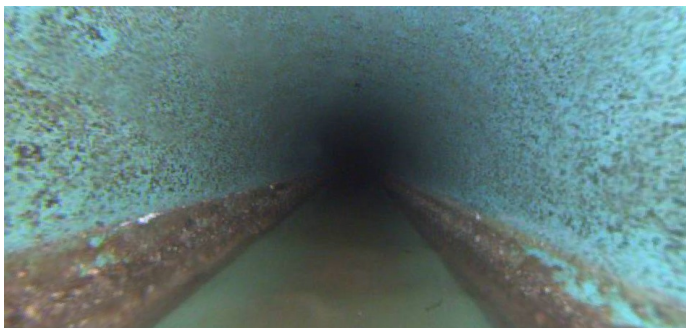
Code: **AMH**
Description: **Manhole**

Distance (ft): **.0**
Structural Grade: **0**
O&M Grade: **0**
Clock Start/From:
Clock To:
1st Value:
2nd Value:
Value Percent:
Continuous Index:
Within 8" of Joint: **NO**
Remarks: **M-809-042**

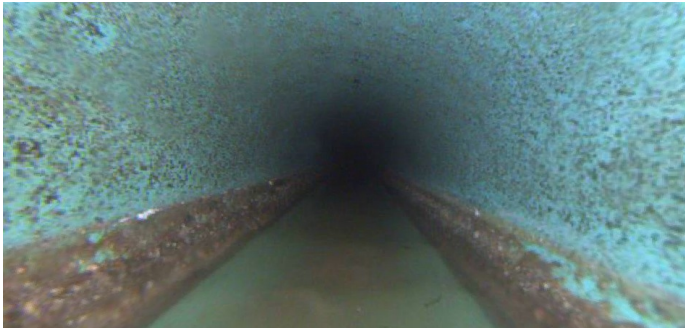
Code:	MWL
Description:	Water Level

Distance (ft):	.0
Structural Grade:	0
O&M Grade:	0
Clock Start/From:	
Clock To:	
1st Value:	
2nd Value:	
Value Percent:	20.000
Continuous Index:	
Within 8" of Joint:	NO
Remarks:

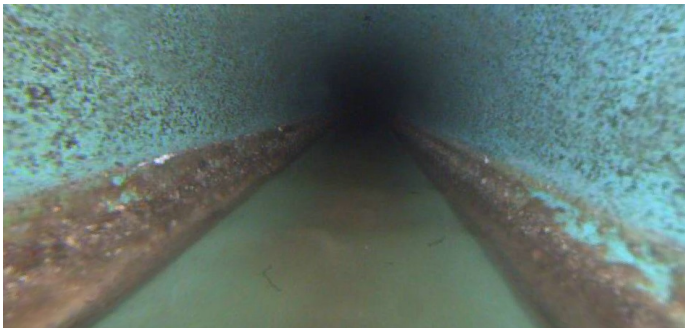
Code:	DAGS
Description:	Deposits Attached Grease

Distance (ft):	.0
Structural Grade:	0
O&M Grade:	2
Clock Start/From:	4
Clock To:	8
1st Value:	
2nd Value:	
Value Percent:	10.000
Continuous Index:	S01
Within 8" of Joint:	NO
Remarks:

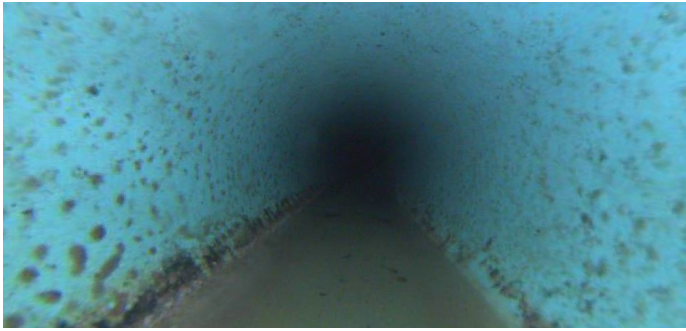
Code: **DAGS**
Description: **Deposits Attached Grease**

Distance (ft): **15.0**
Structural Grade: **0**
O&M Grade: **2**
Clock Start/From: **4**
Clock To: **8**
1st Value:
2nd Value:
Value Percent: **10.000**
Continuous Index: **F01**
Within 8" of Joint: **NO**
Remarks: **Clock positions vary**

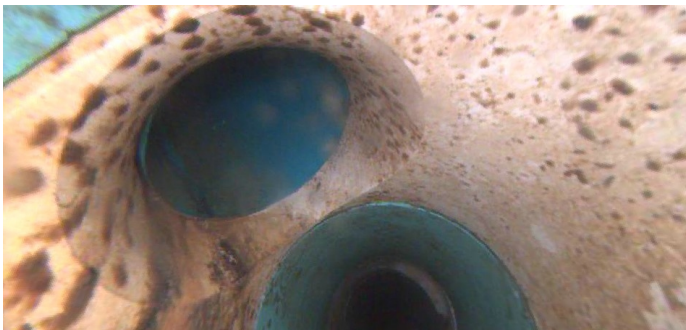
Code: **TF**
Description: **Tap Factory**

Distance (ft): **38.0**
Structural Grade: **0**
O&M Grade: **0**
Clock Start/From: **10**
Clock To:
1st Value: **4.000**
2nd Value:
Value Percent:
Continuous Index:
Within 8" of Joint:
Remarks:

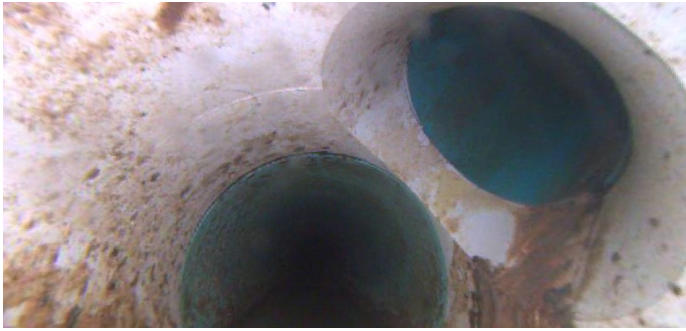
Code: **TF**
Description: **Tap Factory**

Distance (ft): **39.6**
Structural Grade: **0**
O&M Grade: **0**
Clock Start/From: **2**
Clock To:
1st Value: **4.000**
2nd Value:
Value Percent:
Continuous Index:
Within 8" of Joint:
Remarks:

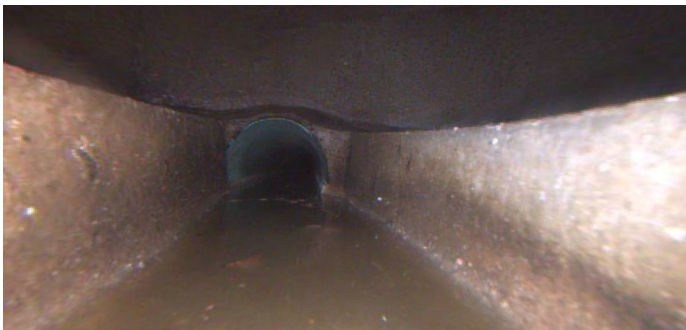
Code: **AMH**
Description: **Manhole**

Distance (ft): **86.0**
Structural Grade: **0**
O&M Grade: **0**
Clock Start/From:
Clock To:
1st Value:
2nd Value:
Value Percent:
Continuous Index:
Within 8" of Joint: **NO**
Remarks: **M-809-043**
