## Profile/Photo Observation Report

Street:	<b>KESTREL ST</b>	Flow Control:	<b>Not Controlled</b>
City:	<b>Hobart, IN</b>	Year Renewed:	
Location:	<b>Sidewalk</b>	Tape/Media #:	
Purpose:	<b>Maintenance Related</b>	Dia/Height:	<b>8"</b>
Use:	<b>Sanitary</b>	Material:	<b>PVC</b>
Drain Area:	<b>NA</b>	Lining:	
Category:	<b>NA</b>		
Comment:	<b>flow direction incorrect.</b>

Location Details:		Direction of Survey:	<b>Upstream</b>
US MH:	<b>M-809-043</b>	DS MH:	<b>M-809-044</b>
		Total Length Surveyed (ft):	<b>233.0</b>

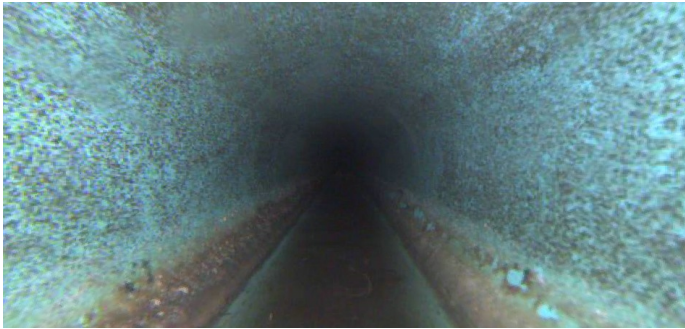
Code:	<b>MWL</b>
Description:	<b>Water Level</b>

Distance (ft):	<b>.0</b>
Structural Grade:	<b>0</b>
O&M Grade:	<b>0</b>
Clock Start/From:	
Clock To:	
1st Value:	
2nd Value:	
Value Percent:	<b>10.000</b>
Continuous Index:	
Within 8" of Joint:	<b>NO</b>
Remarks:

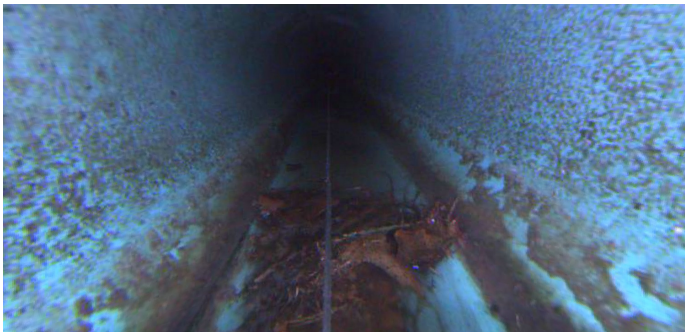
Code:	<b>DSZ</b>
Description:	<b>Deposits Settled Other</b>

Distance (ft):	<b>10.4</b>
Structural Grade:	<b>0</b>
O&M Grade:	<b>2</b>
Clock Start/From:	<b>6</b>
Clock To:	
1st Value:	
2nd Value:	
Value Percent:	<b>5.000</b>
Continuous Index:	
Within 8" of Joint:	<b>NO</b>
Remarks:	<b>leaves</b>

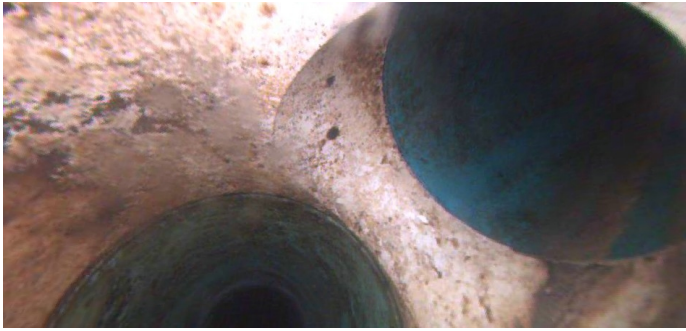
Code: **TF**  
Description: **Tap Factory**

Distance (ft): **23.2**  
Structural Grade: **0**  
O&M Grade: **0**  
Clock Start/From: **2**  
Clock To:  
1st Value: **4.000**  
2nd Value:  
Value Percent:  
Continuous Index:  
Within 8" of Joint:  
Remarks:

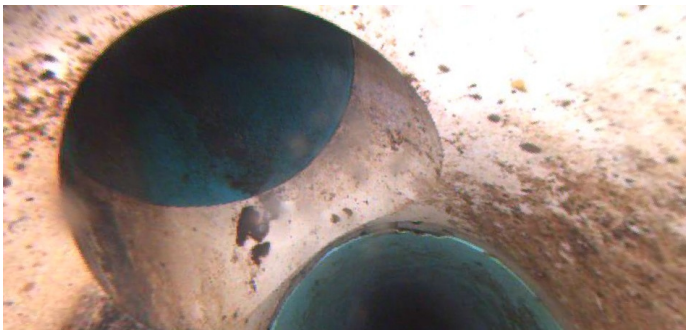
Code: **TF**  
Description: **Tap Factory**

Distance (ft): **49.5**  
Structural Grade: **0**  
O&M Grade: **0**  
Clock Start/From: **10**  
Clock To:  
1st Value: **4.000**  
2nd Value:  
Value Percent:  
Continuous Index:  
Within 8" of Joint:  
Remarks:

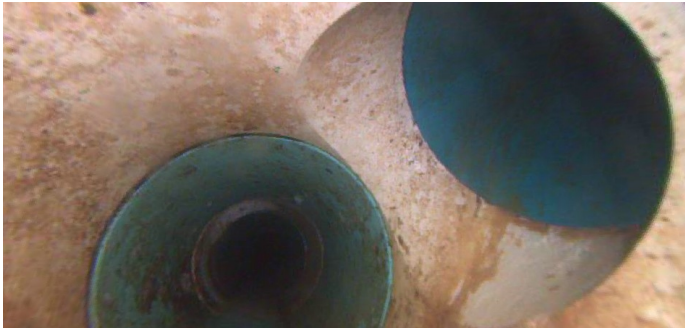
Code: **TF**  
Description: **Tap Factory**

Distance (ft): **116.8**  
Structural Grade: **0**  
O&M Grade: **0**  
Clock Start/From: **2**  
Clock To:  
1st Value: **4.000**  
2nd Value:  
Value Percent:  
Continuous Index:  
Within 8" of Joint:  
Remarks:

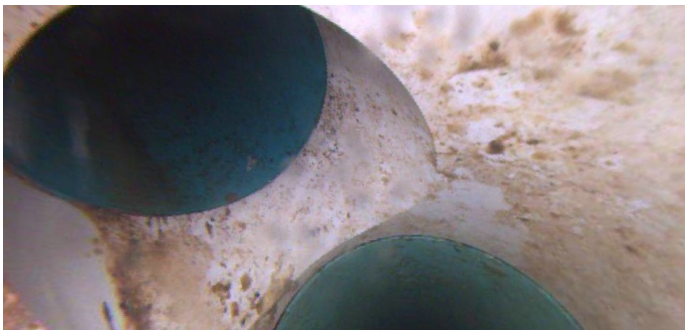
Code: **TF**  
Description: **Tap Factory**

Distance (ft): **118.4**  
Structural Grade: **0**  
O&M Grade: **0**  
Clock Start/From: **10**  
Clock To:  
1st Value: **4.000**  
2nd Value:  
Value Percent:  
Continuous Index:  
Within 8" of Joint:  
Remarks:

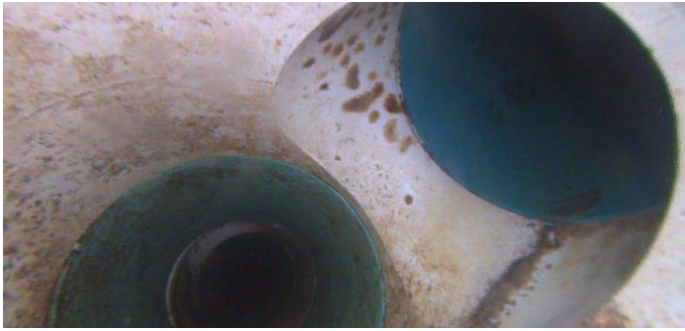
Code: **TF**  
Description: **Tap Factory**

Distance (ft): **190.5**  
Structural Grade: **0**  
O&M Grade: **0**  
Clock Start/From: **2**  
Clock To:  
1st Value: **4.000**  
2nd Value:  
Value Percent:  
Continuous Index:  
Within 8" of Joint:  
Remarks:

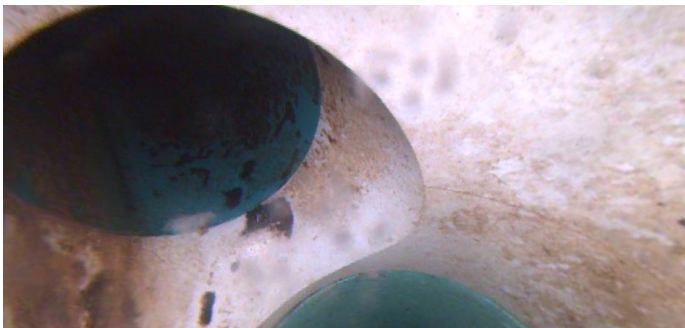
Code: **TF**  
Description: **Tap Factory**

Distance (ft): **192.1**  
Structural Grade: **0**  
O&M Grade: **0**  
Clock Start/From: **10**  
Clock To:  
1st Value: **4.000**  
2nd Value:  
Value Percent:  
Continuous Index:  
Within 8" of Joint:  
Remarks:

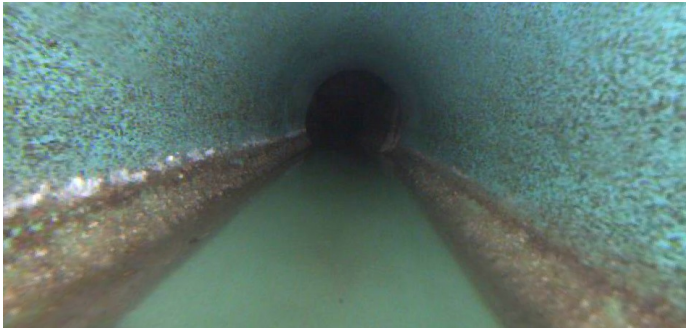
Code: **MWL**  
Description: **Water Level**

Distance (ft): **229.3**  
Structural Grade: **0**  
O&M Grade: **0**  
Clock Start/From:  
Clock To:  
1st Value:  
2nd Value:  
Value Percent: **20.000**  
Continuous Index:  
Within 8" of Joint: **NO**  
Remarks:

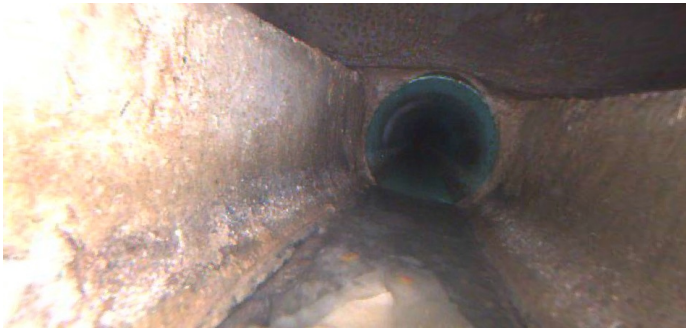
Code: **AMH**  
Description: **Manhole**

Distance (ft): **233.0**  
Structural Grade: **0**  
O&M Grade: **0**  
Clock Start/From:  
Clock To:  
1st Value:  
2nd Value:  
Value Percent:  
Continuous Index:  
Within 8" of Joint: **NO**  
Remarks: **M-809-043**
