Profile/Photo Observation Report

Street:	KESTREL ST	Flow Control:	Not Controlled
City:	Hobart, IN	Year Renewed:	
Location:	Sidewalk	Tape/Media #:	
Purpose:	Maintenance Related	Dia/Height:	8"
Use:	Sanitary	Material:	PVC
Drain Area:	NA	Lining:	
Category:	NA		
Comment:

Location Details:		Direction of Survey:	Upstream
US MH:	M-809-044	DS MH:	M-809-045
		Total Length Surveyed (ft):	343.7

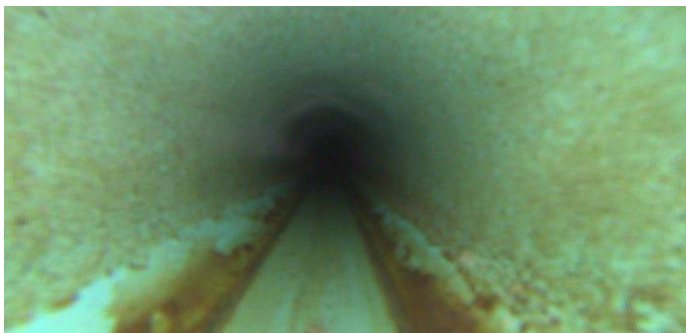
Code: **AMH**
Description: **Manhole**

Distance (ft): **.0**
Structural Grade: **0**
O&M Grade: **0**
Clock Start/From:
Clock To:
1st Value:
2nd Value:
Value Percent:
Continuous Index:
Within 8" of Joint: **NO**
Remarks: **M-809-045**

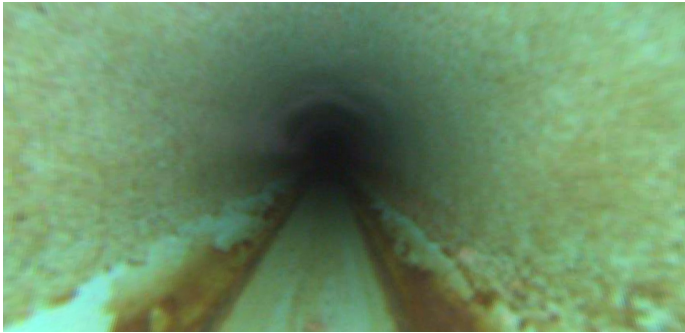
Code:	MWL
Description:	Water Level

Distance (ft):	.0
Structural Grade:	0
O&M Grade:	0
Clock Start/From:	
Clock To:	
1st Value:	
2nd Value:	
Value Percent:	5.000
Continuous Index:	
Within 8" of Joint:	NO
Remarks:

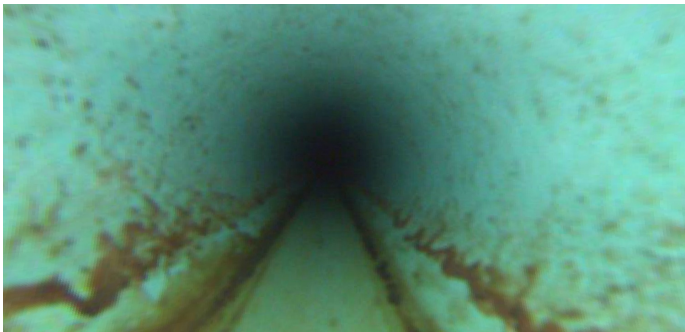
Code:	DAZ
Description:	Deposits Attached Other

Distance (ft):	5.3
Structural Grade:	0
O&M Grade:	2
Clock Start/From:	7
Clock To:	5
1st Value:	
2nd Value:	
Value Percent:	5.000
Continuous Index:	S01
Within 8" of Joint:	YES
Remarks:	WANDER

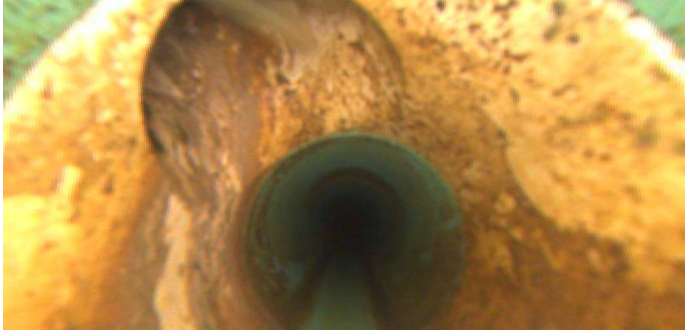
Code: **TF**
Description: **Tap Factory**

Distance (ft): **17.0**
Structural Grade: **0**
O&M Grade: **0**
Clock Start/From: **11**
Clock To:
1st Value: **4.000**
2nd Value:
Value Percent:
Continuous Index:
Within 8" of Joint:
Remarks:

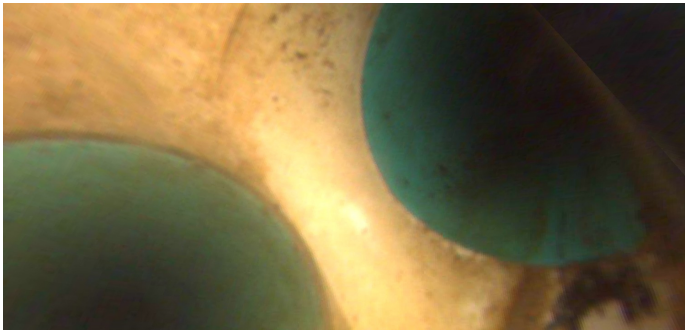
Code: **TF**
Description: **Tap Factory**

Distance (ft): **43.4**
Structural Grade: **0**
O&M Grade: **0**
Clock Start/From: **2**
Clock To:
1st Value: **4.000**
2nd Value:
Value Percent:
Continuous Index:
Within 8" of Joint:
Remarks:

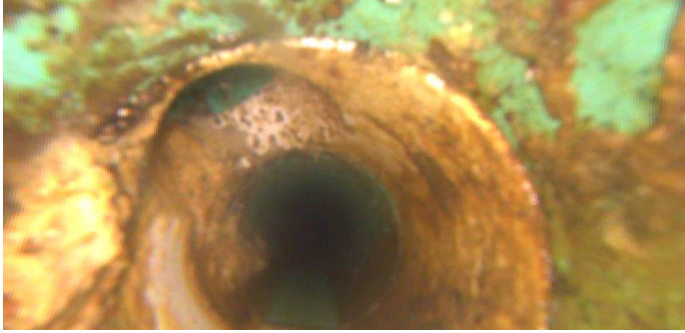
Code: **TF**
Description: **Tap Factory**

Distance (ft): **81.6**
Structural Grade: **0**
O&M Grade: **0**
Clock Start/From: **11**
Clock To:
1st Value: **4.000**
2nd Value:
Value Percent:
Continuous Index:
Within 8" of Joint:
Remarks:

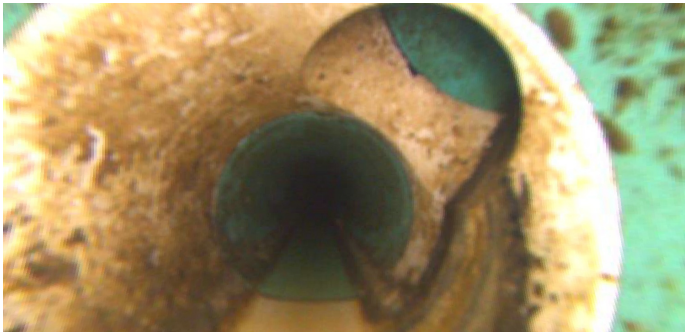
Code: **TF**
Description: **Tap Factory**

Distance (ft): **120.7**
Structural Grade: **0**
O&M Grade: **0**
Clock Start/From: **2**
Clock To:
1st Value: **4.000**
2nd Value:
Value Percent:
Continuous Index:
Within 8" of Joint:
Remarks:

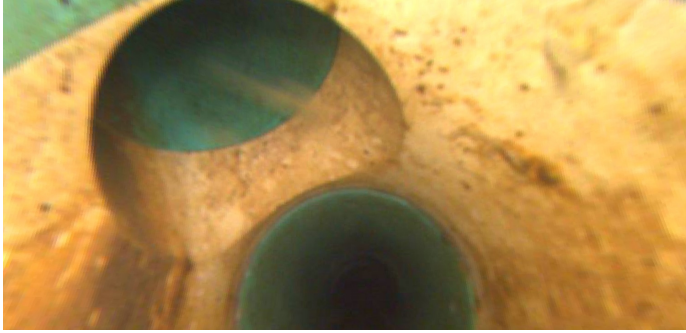
Code: **TF**
Description: **Tap Factory**

Distance (ft): **161.5**
Structural Grade: **0**
O&M Grade: **0**
Clock Start/From: **11**
Clock To:
1st Value: **4.000**
2nd Value:
Value Percent:
Continuous Index:
Within 8" of Joint:
Remarks:

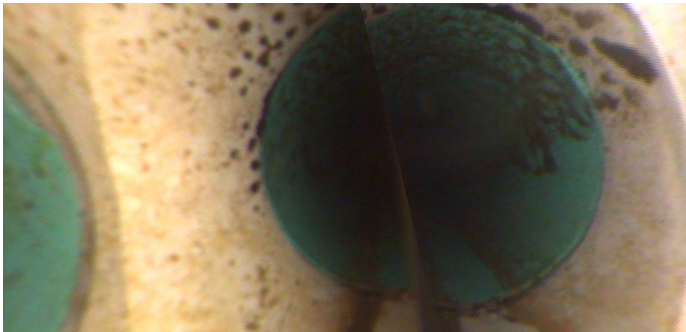
Code: **TF**
Description: **Tap Factory**

Distance (ft): **200.6**
Structural Grade: **0**
O&M Grade: **0**
Clock Start/From: **2**
Clock To:
1st Value: **4.000**
2nd Value:
Value Percent:
Continuous Index:
Within 8" of Joint:
Remarks:

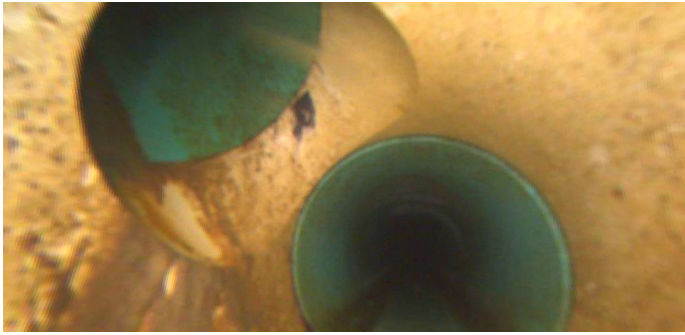
Code: **TF**
Description: **Tap Factory**

Distance (ft): **238.9**
Structural Grade: **0**
O&M Grade: **0**
Clock Start/From: **10**
Clock To:
1st Value: **4.000**
2nd Value:
Value Percent:
Continuous Index:
Within 8" of Joint:
Remarks:

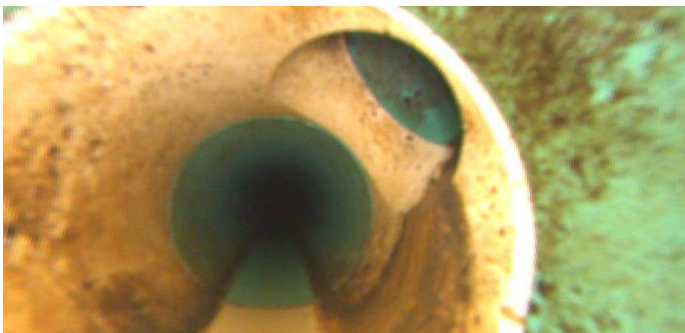
Code: **TF**
Description: **Tap Factory**

Distance (ft): **277.1**
Structural Grade: **0**
O&M Grade: **0**
Clock Start/From: **2**
Clock To:
1st Value: **4.000**
2nd Value:
Value Percent:
Continuous Index:
Within 8" of Joint:
Remarks:

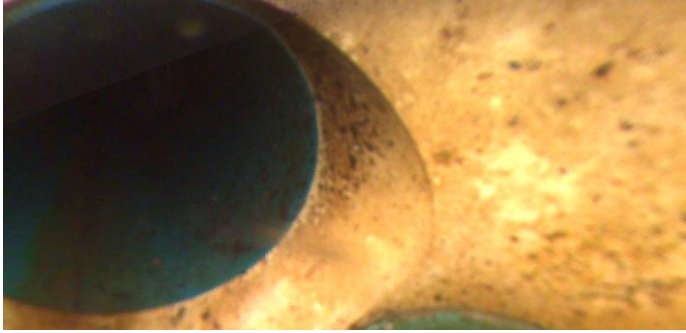
Code: **TF**
Description: **Tap Factory**

Distance (ft): **316.1**
Structural Grade: **0**
O&M Grade: **0**
Clock Start/From: **10**
Clock To:
1st Value: **4.000**
2nd Value:
Value Percent:
Continuous Index:
Within 8" of Joint:
Remarks:

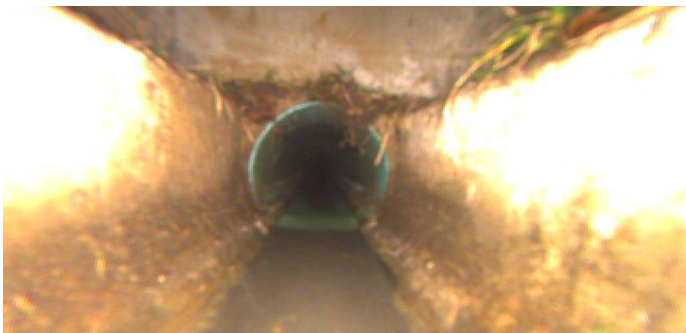
Code: **AMH**
Description: **Manhole**

Distance (ft): **343.7**
Structural Grade: **0**
O&M Grade: **0**
Clock Start/From:
Clock To:
1st Value:
2nd Value:
Value Percent:
Continuous Index:
Within 8" of Joint: **NO**
Remarks: **M-809-044**

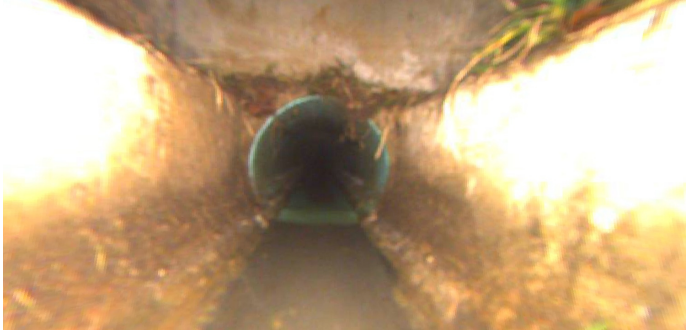
Code:	DAZ
Description:	Deposits Attached Other
Distance (ft):	343.7
Structural Grade:	0
O&M Grade:	2
Clock Start/From:	7
Clock To:	5
1st Value:	
2nd Value:	
Value Percent:	5.000
Continuous Index:	F01
Within 8" of Joint:	YES
Remarks:	WANDER
