Profile/Photo Observation Report

Date:	03/23/2018	Weather:		Coding:	PACP 6.0
Pipe Length (ft):	348.2	Owner:	NA	Pre Clean:	Not Known
P.O.#:		Surveyor:	Mark Ruby	PSR:	P-809-045-044
Customer:		Clean Date:	01/01/1900	Shape:	C

Street:	Oak	Flow Control:	Not Controlled
City:	Hobart, IN	Year Renewed:	
Location:	Sidewalk	Tape/Media #:	
Purpose:	Maintenance Related	Dia/Height:	8"
Use:	Sanitary	Material:	PVC
Drain Area:	NA	Lining:	
Category:	NA		
Comment:

Location Details:		Direction of Survey:	Upstream
US MH:	M-809-044	DS MH:	M-809-045
		Total Length Surveyed (ft):	343.7

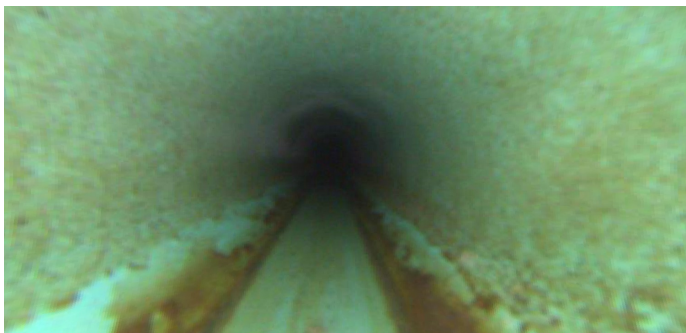
Code: **AMH**
Description: **Manhole**

Distance (ft): **.0**
Structural Grade: **0**
O&M Grade: **0**
Clock Start/From:
Clock To:
1st Value:
2nd Value:
Value Percent:
Continuous Index:
Within 8" of Joint: **NO**
Remarks: **M-809-045**

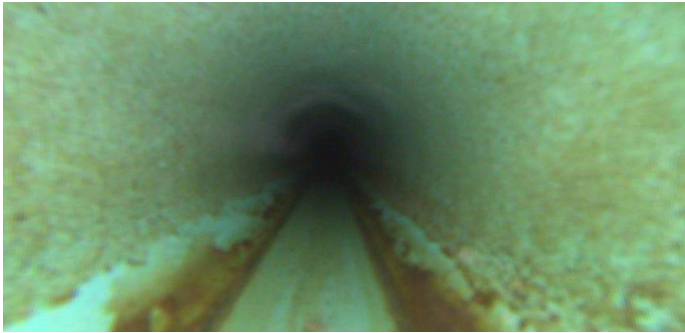
Code:	MWL
Description:	Water Level

Distance (ft):	.0
Structural Grade:	0
O&M Grade:	0
Clock Start/From:	
Clock To:	
1st Value:	
2nd Value:	
Value Percent:	5.000
Continuous Index:	
Within 8" of Joint:	NO
Remarks:

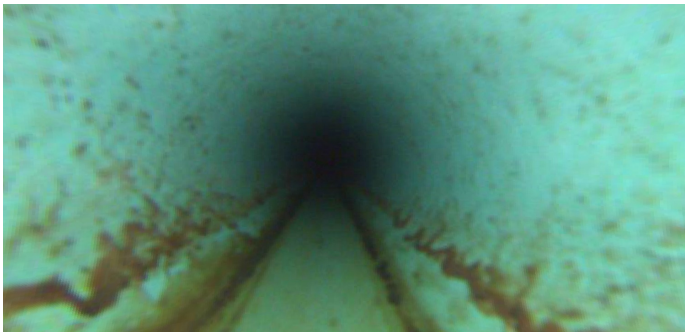
Code:	DAZ
Description:	Deposits Attached Other

Distance (ft):	5.3
Structural Grade:	0
O&M Grade:	2
Clock Start/From:	7
Clock To:	5
1st Value:	
2nd Value:	
Value Percent:	5.000
Continuous Index:	S01
Within 8" of Joint:	YES
Remarks:	WANDER

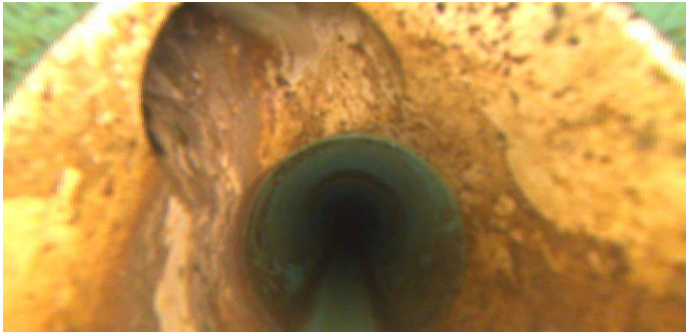
Code: **TF**
Description: **Tap Factory**

Distance (ft): **17.0**
Structural Grade: **0**
O&M Grade: **0**
Clock Start/From: **11**
Clock To:
1st Value: **4.000**
2nd Value:
Value Percent:
Continuous Index:
Within 8" of Joint:
Remarks:

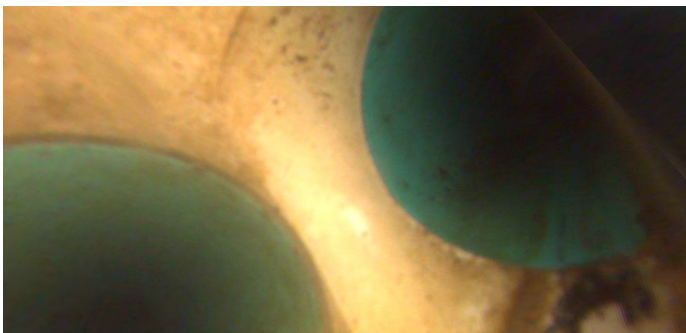
Code: **TF**
Description: **Tap Factory**

Distance (ft): **43.4**
Structural Grade: **0**
O&M Grade: **0**
Clock Start/From: **2**
Clock To:
1st Value: **4.000**
2nd Value:
Value Percent:
Continuous Index:
Within 8" of Joint:
Remarks:

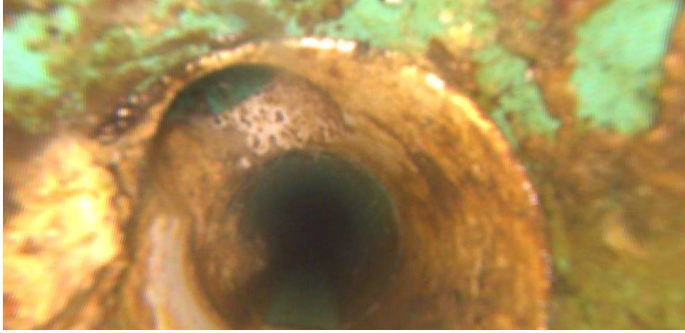
Code: **TF**
Description: **Tap Factory**

Distance (ft): **81.6**
Structural Grade: **0**
O&M Grade: **0**
Clock Start/From: **11**
Clock To:
1st Value: **4.000**
2nd Value:
Value Percent:
Continuous Index:
Within 8" of Joint:
Remarks:

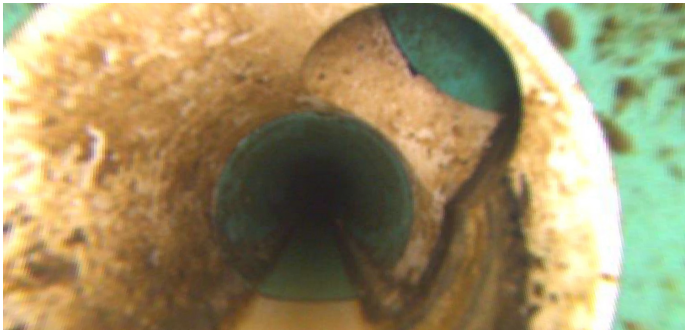
Code: **TF**
Description: **Tap Factory**

Distance (ft): **120.7**
Structural Grade: **0**
O&M Grade: **0**
Clock Start/From: **2**
Clock To:
1st Value: **4.000**
2nd Value:
Value Percent:
Continuous Index:
Within 8" of Joint:
Remarks:

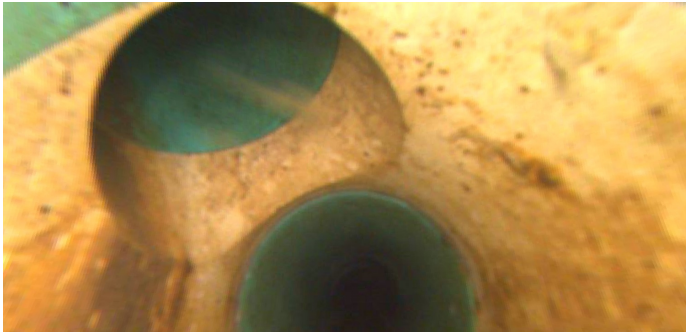
Code: **TF**
Description: **Tap Factory**

Distance (ft): **161.5**
Structural Grade: **0**
O&M Grade: **0**
Clock Start/From: **11**
Clock To:
1st Value: **4.000**
2nd Value:
Value Percent:
Continuous Index:
Within 8" of Joint:
Remarks:

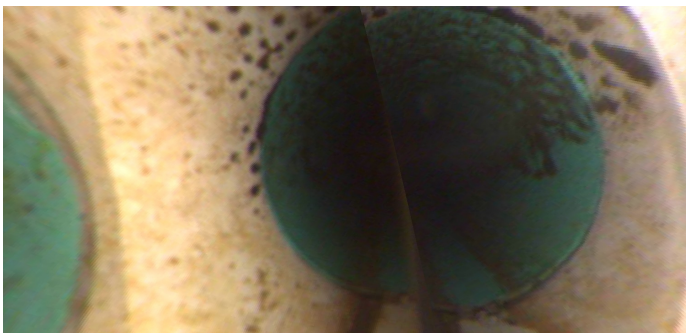
Code: **TF**
Description: **Tap Factory**

Distance (ft): **200.6**
Structural Grade: **0**
O&M Grade: **0**
Clock Start/From: **2**
Clock To:
1st Value: **4.000**
2nd Value:
Value Percent:
Continuous Index:
Within 8" of Joint:
Remarks:

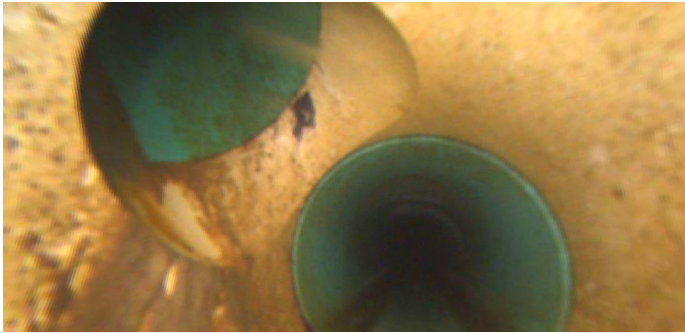
Code: **TF**
Description: **Tap Factory**

Distance (ft): **238.9**
Structural Grade: **0**
O&M Grade: **0**
Clock Start/From: **10**
Clock To:
1st Value: **4.000**
2nd Value:
Value Percent:
Continuous Index:
Within 8" of Joint:
Remarks:

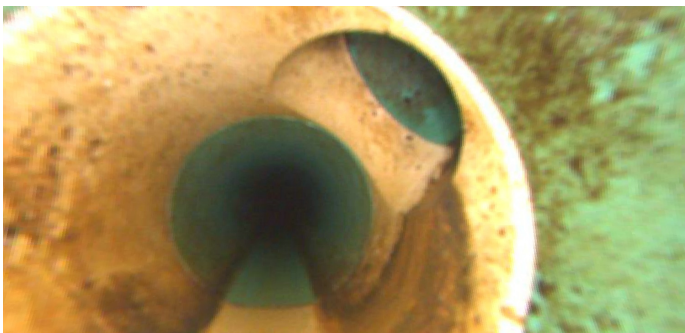
Code: **TF**
Description: **Tap Factory**

Distance (ft): **277.1**
Structural Grade: **0**
O&M Grade: **0**
Clock Start/From: **2**
Clock To:
1st Value: **4.000**
2nd Value:
Value Percent:
Continuous Index:
Within 8" of Joint:
Remarks:

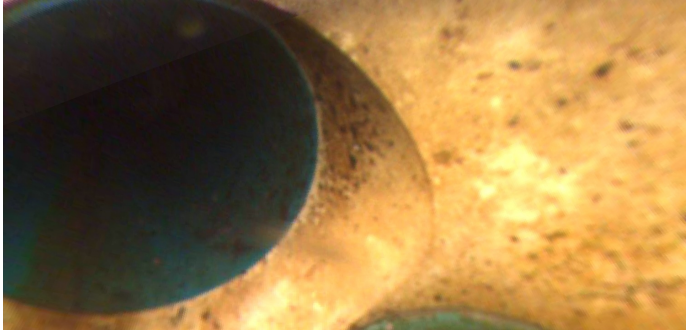
Code: **TF**
Description: **Tap Factory**

Distance (ft): **316.1**
Structural Grade: **0**
O&M Grade: **0**
Clock Start/From: **10**
Clock To:
1st Value: **4.000**
2nd Value:
Value Percent:
Continuous Index:
Within 8" of Joint:
Remarks:

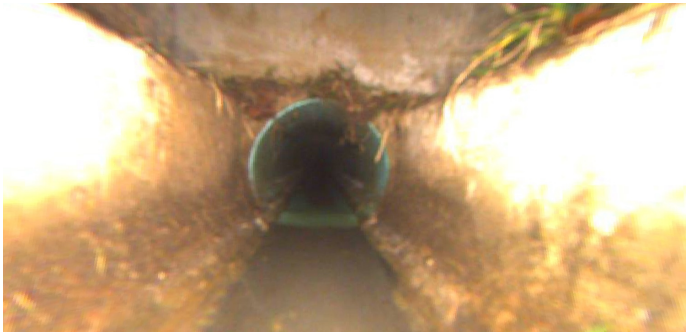
Code: **AMH**
Description: **Manhole**

Distance (ft): **343.7**
Structural Grade: **0**
O&M Grade: **0**
Clock Start/From:
Clock To:
1st Value:
2nd Value:
Value Percent:
Continuous Index:
Within 8" of Joint: **NO**
Remarks: **M-809-044**

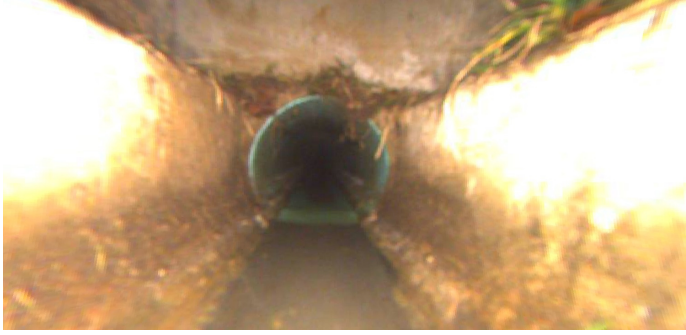
Code:	DAZ
Description:	Deposits Attached Other
Distance (ft):	343.7
Structural Grade:	0
O&M Grade:	2
Clock Start/From:	7
Clock To:	5
1st Value:	
2nd Value:	
Value Percent:	5.000
Continuous Index:	F01
Within 8" of Joint:	YES
Remarks:	WANDER
