Profile/Photo Observation Report

Street:	KESTREL ST	Flow Control:	Not Controlled
City:	Hobart, IN	Year Renewed:	
Location:	Sidewalk	Tape/Media #:	
Purpose:	Maintenance Related	Dia/Height:	8"
Use:	Sanitary	Material:	PVC
Drain Area:	NA	Lining:	
Category:	NA		
Comment:

Location Details:		Direction of Survey:	Downstream
US MH:	M-809-045	DS MH:	M-809-046
		Total Length Surveyed (ft):	334.2

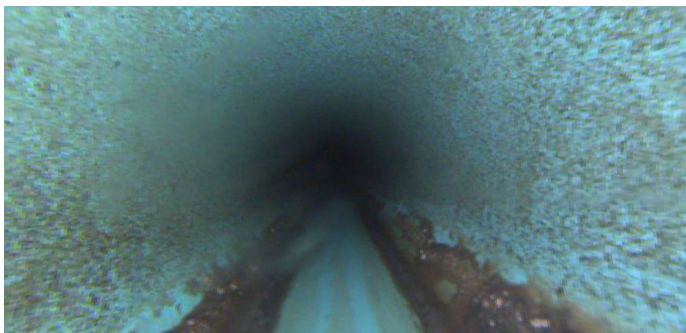
Code: **AMH**
Description: **Manhole**

Distance (ft): **.0**
Structural Grade: **0**
O&M Grade: **0**
Clock Start/From:
Clock To:
1st Value:
2nd Value:
Value Percent:
Continuous Index:
Within 8" of Joint: **NO**
Remarks: **M-809-045**

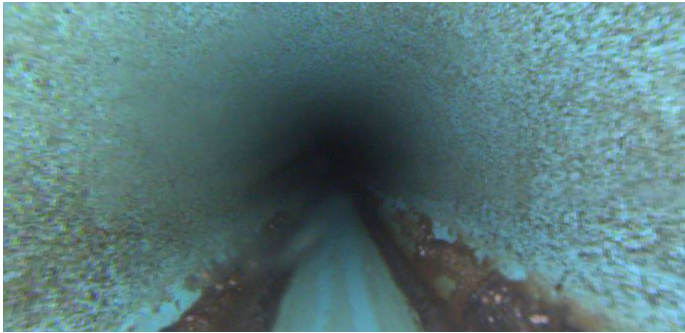
Code:	MWL
Description:	Water Level

Distance (ft):	.0
Structural Grade:	0
O&M Grade:	0
Clock Start/From:	
Clock To:	
1st Value:	
2nd Value:	
Value Percent:	5.000
Continuous Index:	
Within 8" of Joint:	NO
Remarks:

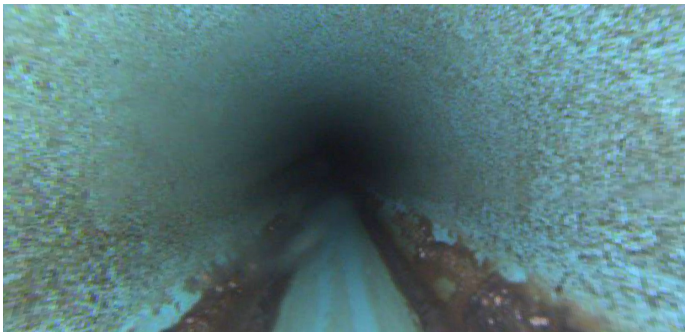
Code:	DAZ
Description:	Deposits Attached Other

Distance (ft):	.0
Structural Grade:	0
O&M Grade:	2
Clock Start/From:	7
Clock To:	5
1st Value:	
2nd Value:	
Value Percent:	5.000
Continuous Index:	S01
Within 8" of Joint:	YES
Remarks:	WANDER

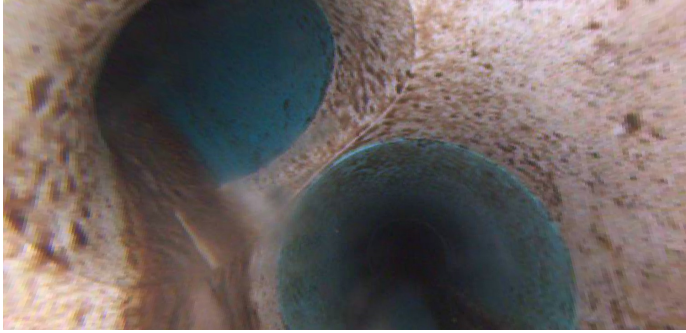
Code: **TF**
Description: **Tap Factory**

Distance (ft): **32.7**
Structural Grade: **0**
O&M Grade: **0**
Clock Start/From: **10**
Clock To:
1st Value: **4.000**
2nd Value:
Value Percent:
Continuous Index:
Within 8" of Joint:
Remarks:

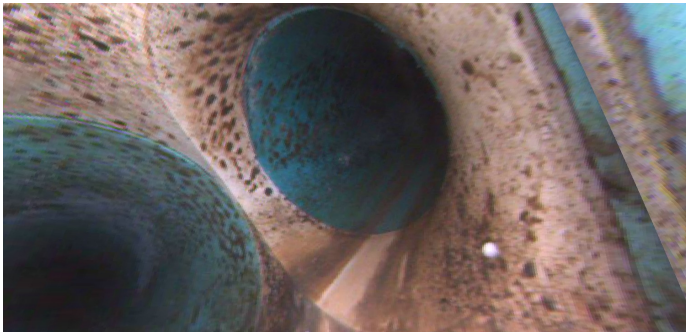
Code: **TF**
Description: **Tap Factory**

Distance (ft): **73.5**
Structural Grade: **0**
O&M Grade: **0**
Clock Start/From: **2**
Clock To:
1st Value: **4.000**
2nd Value:
Value Percent:
Continuous Index:
Within 8" of Joint:
Remarks:

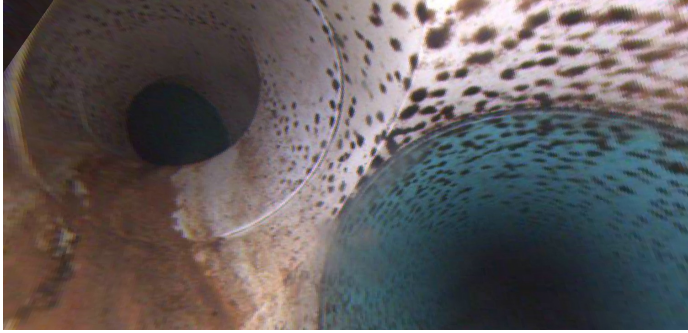
Code: **TF**
Description: **Tap Factory**

Distance (ft): **112.5**
Structural Grade: **0**
O&M Grade: **0**
Clock Start/From: **11**
Clock To:
1st Value: **4.000**
2nd Value:
Value Percent:
Continuous Index:
Within 8" of Joint:
Remarks:

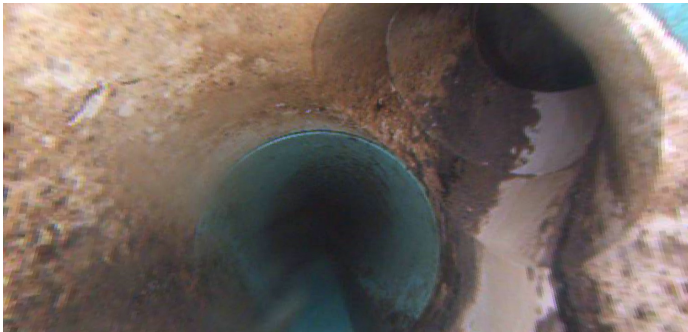
Code: **TF**
Description: **Tap Factory**

Distance (ft): **138.2**
Structural Grade: **0**
O&M Grade: **0**
Clock Start/From: **2**
Clock To:
1st Value: **4.000**
2nd Value:
Value Percent:
Continuous Index:
Within 8" of Joint:
Remarks:

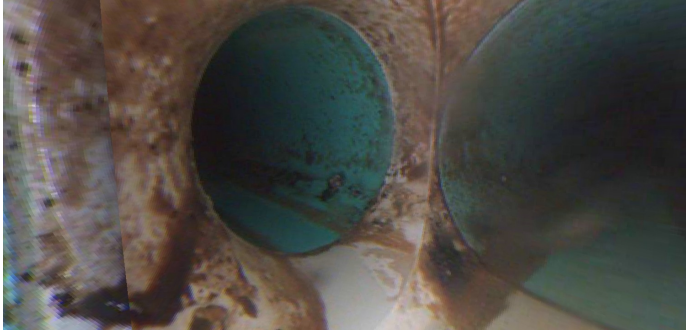
Code: **TF**
Description: **Tap Factory**

Distance (ft): **189.9**
Structural Grade: **0**
O&M Grade: **0**
Clock Start/From: **9**
Clock To:
1st Value: **4.000**
2nd Value:
Value Percent:
Continuous Index:
Within 8" of Joint:
Remarks:

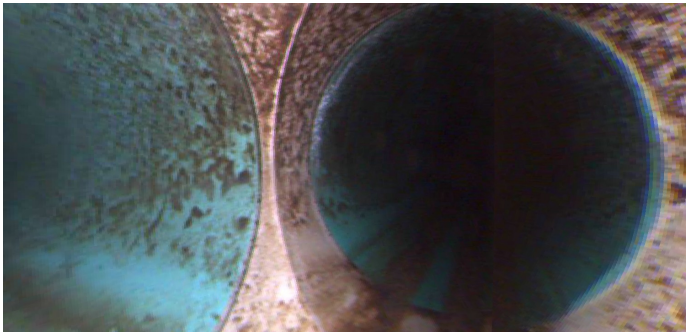
Code: **TF**
Description: **Tap Factory**

Distance (ft): **229.0**
Structural Grade: **0**
O&M Grade: **0**
Clock Start/From: **3**
Clock To:
1st Value: **4.000**
2nd Value:
Value Percent:
Continuous Index:
Within 8" of Joint:
Remarks:

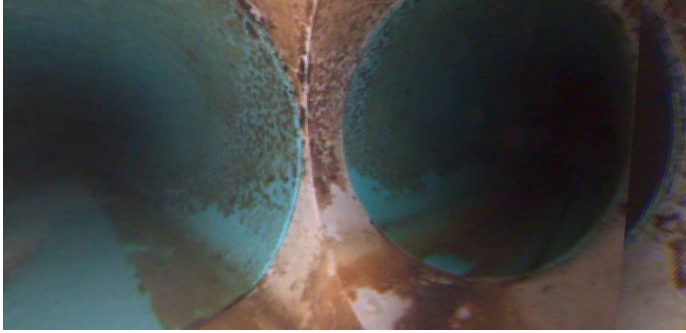
Code: **TF**
Description: **Tap Factory**

Distance (ft): **292.7**
Structural Grade: **0**
O&M Grade: **0**
Clock Start/From: **3**
Clock To:
1st Value: **4.000**
2nd Value:
Value Percent:
Continuous Index:
Within 8" of Joint:
Remarks:

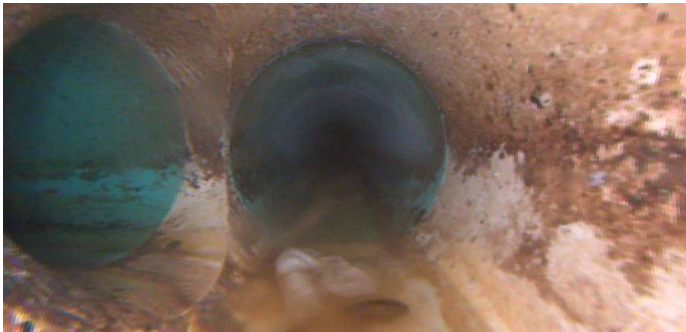
Code: **TF**
Description: **Tap Factory**

Distance (ft): **305.5**
Structural Grade: **0**
O&M Grade: **0**
Clock Start/From: **9**
Clock To:
1st Value: **4.000**
2nd Value:
Value Percent:
Continuous Index:
Within 8" of Joint:
Remarks:

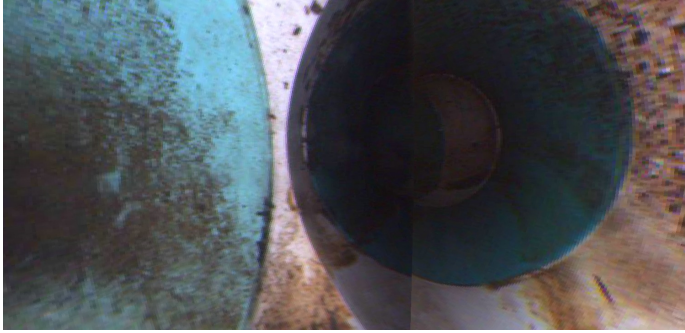
Code: **TF**
Description: **Tap Factory**

Distance (ft): **330.5**
Structural Grade: **0**
O&M Grade: **0**
Clock Start/From: **3**
Clock To:
1st Value: **4.000**
2nd Value:
Value Percent:
Continuous Index:
Within 8" of Joint:
Remarks:

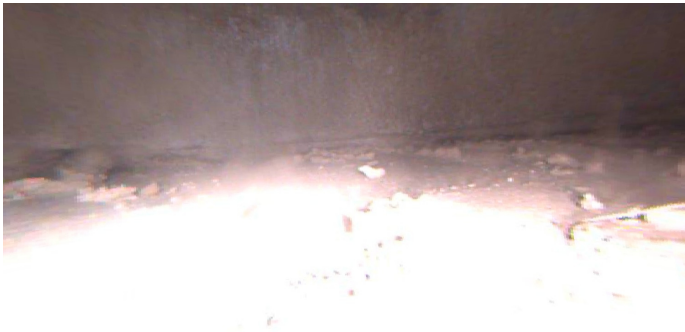
Code: **AMH**
Description: **Manhole**

Distance (ft): **334.2**
Structural Grade: **0**
O&M Grade: **0**
Clock Start/From:
Clock To:
1st Value:
2nd Value:
Value Percent:
Continuous Index:
Within 8" of Joint: **NO**
Remarks: **M-809-046**

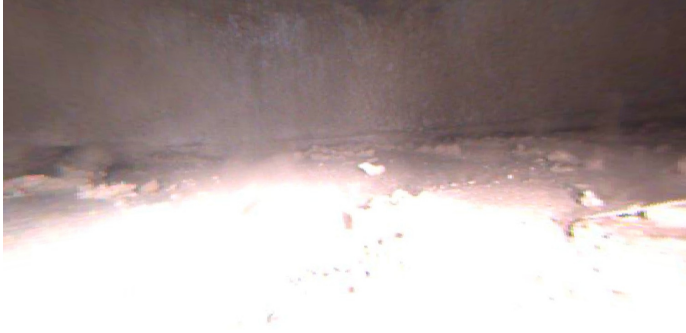
Code:	DAZ
Description:	Deposits Attached Other
Distance (ft):	334.2
Structural Grade:	0
O&M Grade:	2
Clock Start/From:	7
Clock To:	5
1st Value:	
2nd Value:	
Value Percent:	5.000
Continuous Index:	F01
Within 8" of Joint:	YES
Remarks:	WANDER
