# Profile/Photo Observation Report

Date:	<b>03/23/2018</b>	Weather:		Coding:	<b>PACP 6.0</b>
Pipe Length (ft):	<b>340.5</b>	Owner:	<b>NA</b>	Pre Clean:	<b>Not Known</b>
P.O.#:		Surveyor:	<b>Justin Gonzales</b>	PSR:	<b>P-809-046-045</b>
Customer:		Clean Date:	<b>01/01/1900</b>	Shape:	<b>C</b>

Street:	<b>Oak</b>	Flow Control:	<b>Not Controlled</b>
City:	<b>Hobart, IN</b>	Year Renewed:	
Location:	<b>Sidewalk</b>	Tape/Media #:	
Purpose:	<b>Maintenance Related</b>	Dia/Height:	<b>8"</b>
Use:	<b>Sanitary</b>	Material:	<b>PVC</b>
Drain Area:	<b>NA</b>	Lining:	
Category:	<b>NA</b>		
Comment:			
Location Details:		Direction of Survey:	<b>Downstream</b>
US MH:	<b>M-809-045</b>	DS MH:	<b>M-809-046</b>
		Total Length Surveyed (ft):	<b>334.2</b>

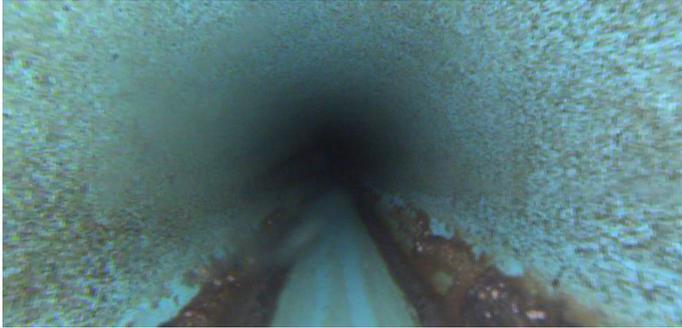
Code: **MWL**  
Description: **Water Level**

Distance (ft): **.0**  
Structural Grade: **0**  
O&M Grade: **0**  
Clock Start/From:  
Clock To:  
1st Value:  
2nd Value:  
Value Percent: **5.000**  
Continuous Index:  
Within 8" of Joint: **NO**  
Remarks:

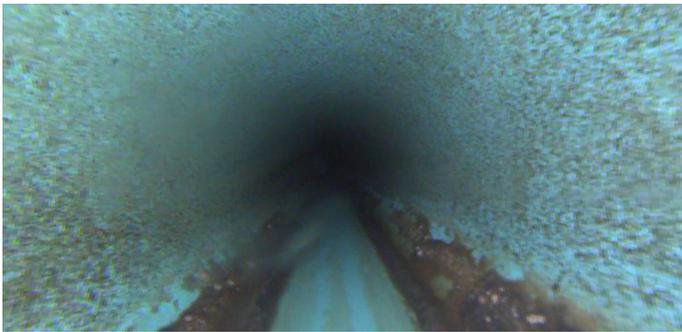
Code: **DAZ**  
Description: **Deposits Attached Other**

Distance (ft): **.0**  
Structural Grade: **0**  
O&M Grade: **2**  
Clock Start/From: **7**  
Clock To: **5**  
1st Value:  
2nd Value:  
Value Percent: **5.000**  
Continuous Index: **S01**  
Within 8" of Joint: **YES**  
Remarks: **WANDER**

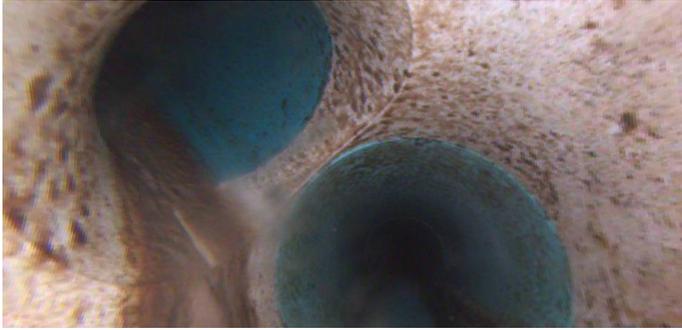
Code: **TF**  
Description: **Tap Factory**

Distance (ft): **32.7**  
Structural Grade: **0**  
O&M Grade: **0**  
Clock Start/From: **10**  
Clock To:  
1st Value: **4.000**  
2nd Value:  
Value Percent:  
Continuous Index:  
Within 8" of Joint:  
Remarks:

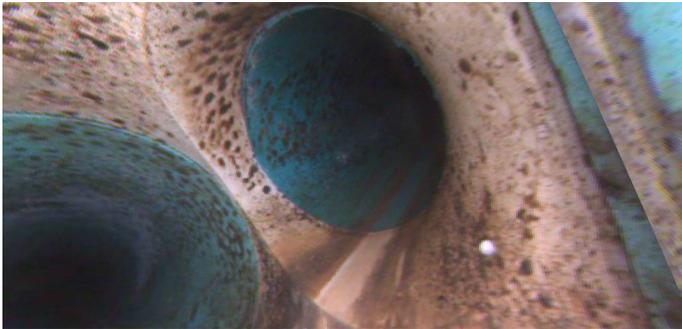
Code: **TF**  
Description: **Tap Factory**

Distance (ft): **73.5**  
Structural Grade: **0**  
O&M Grade: **0**  
Clock Start/From: **2**  
Clock To:  
1st Value: **4.000**  
2nd Value:  
Value Percent:  
Continuous Index:  
Within 8" of Joint:  
Remarks:

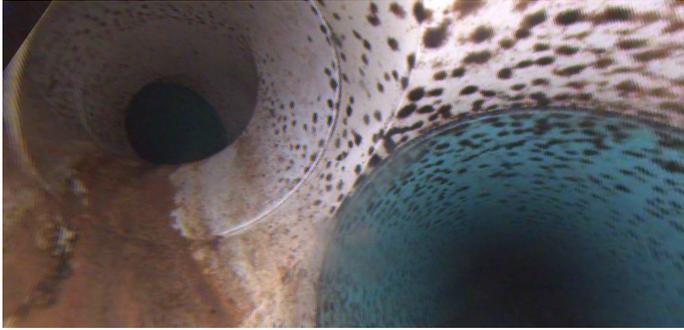
Code: **TF**  
Description: **Tap Factory**

Distance (ft): **112.5**  
Structural Grade: **0**  
O&M Grade: **0**  
Clock Start/From: **11**  
Clock To:  
1st Value: **4.000**  
2nd Value:  
Value Percent:  
Continuous Index:  
Within 8" of Joint:  
Remarks:

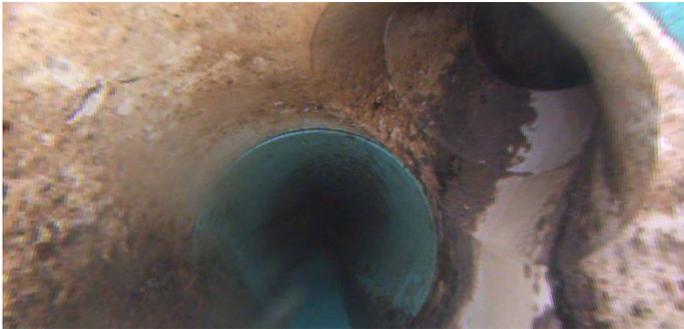
Code: **TF**  
Description: **Tap Factory**

Distance (ft): **138.2**  
Structural Grade: **0**  
O&M Grade: **0**  
Clock Start/From: **2**  
Clock To:  
1st Value: **4.000**  
2nd Value:  
Value Percent:  
Continuous Index:  
Within 8" of Joint:  
Remarks:

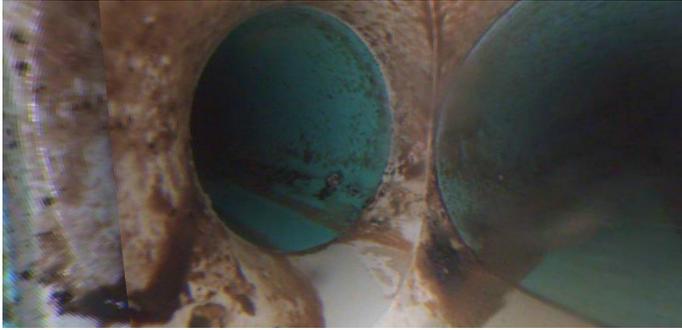
Code: **TF**  
Description: **Tap Factory**

Distance (ft): **189.9**  
Structural Grade: **0**  
O&M Grade: **0**  
Clock Start/From: **9**  
Clock To:  
1st Value: **4.000**  
2nd Value:  
Value Percent:  
Continuous Index:  
Within 8" of Joint:  
Remarks:

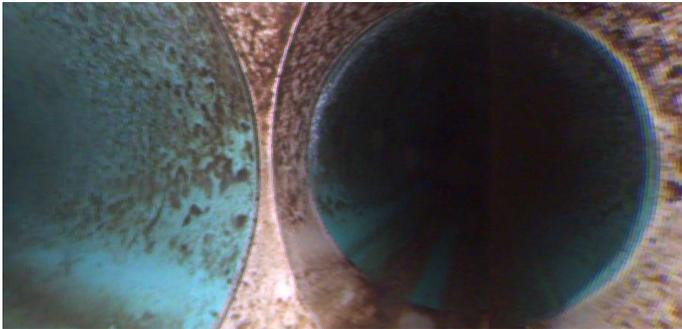
Code: **TF**  
Description: **Tap Factory**

Distance (ft): **229.0**  
Structural Grade: **0**  
O&M Grade: **0**  
Clock Start/From: **3**  
Clock To:  
1st Value: **4.000**  
2nd Value:  
Value Percent:  
Continuous Index:  
Within 8" of Joint:  
Remarks:

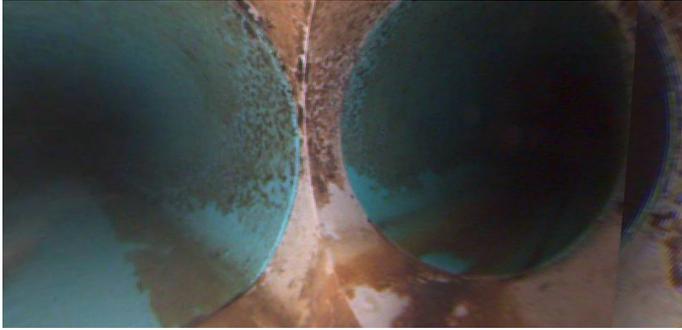
Code: **TF**  
Description: **Tap Factory**

Distance (ft): **292.7**  
Structural Grade: **0**  
O&M Grade: **0**  
Clock Start/From: **3**  
Clock To:  
1st Value: **4.000**  
2nd Value:  
Value Percent:  
Continuous Index:  
Within 8" of Joint:  
Remarks:

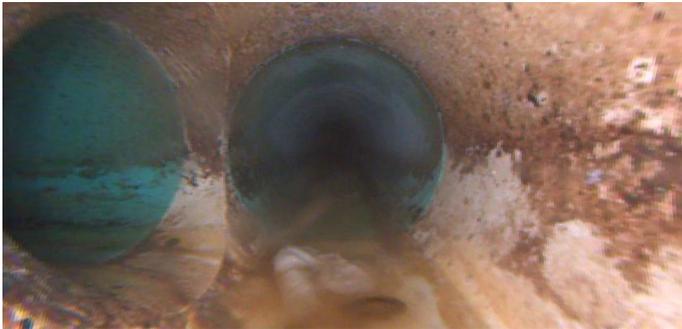
Code: **TF**  
Description: **Tap Factory**

Distance (ft): **305.5**  
Structural Grade: **0**  
O&M Grade: **0**  
Clock Start/From: **9**  
Clock To:  
1st Value: **4.000**  
2nd Value:  
Value Percent:  
Continuous Index:  
Within 8" of Joint:  
Remarks:

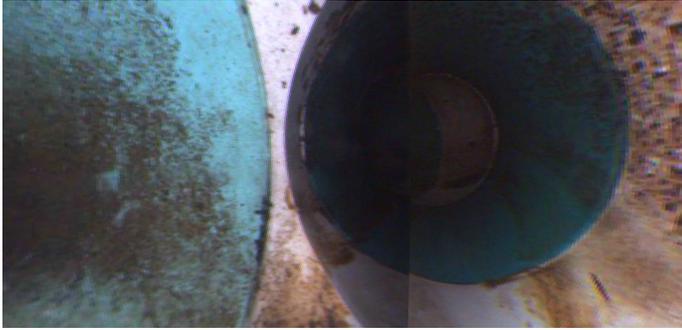
Code: **TF**  
Description: **Tap Factory**

Distance (ft): **330.5**  
Structural Grade: **0**  
O&M Grade: **0**  
Clock Start/From: **3**  
Clock To:  
1st Value: **4.000**  
2nd Value:  
Value Percent:  
Continuous Index:  
Within 8" of Joint:  
Remarks:

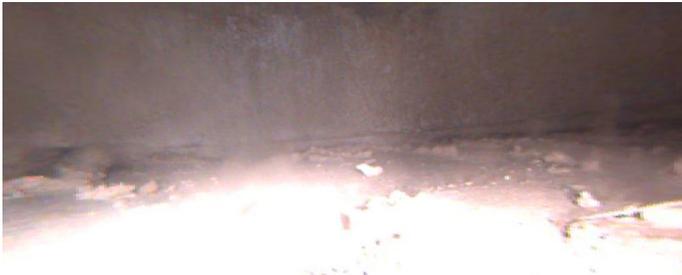
Code: **AMH**  
Description: **Manhole**

Distance (ft): **334.2**  
Structural Grade: **0**  
O&M Grade: **0**  
Clock Start/From:  
Clock To:  
1st Value:  
2nd Value:  
Value Percent:  
Continuous Index:  
Within 8" of Joint: **NO**  
Remarks: **M-809-046**

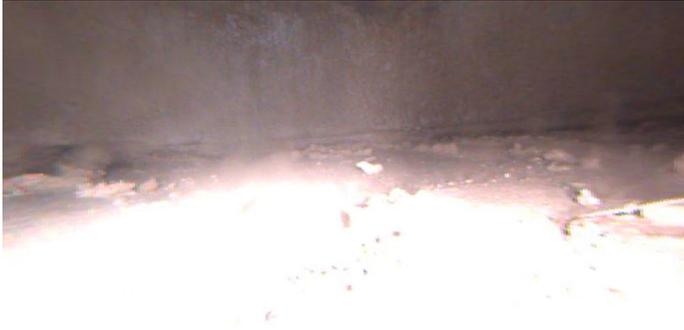
Code:	<b>DAZ</b>
Description:	<b>Deposits Attached Other</b>
Distance (ft):	<b>334.2</b>
Structural Grade:	<b>0</b>
O&M Grade:	<b>2</b>
Clock Start/From:	<b>7</b>
Clock To:	<b>5</b>
1st Value:	
2nd Value:	
Value Percent:	<b>5.000</b>
Continuous Index:	<b>F01</b>
Within 8" of Joint:	<b>YES</b>
Remarks:	<b>WANDER</b>
