Profile/Photo Observation Report

Street:	TANAGER ST	Flow Control:	Not Controlled
City:	Hobart, IN	Year Renewed:	
Location:	Sidewalk	Tape/Media #:	
Purpose:	Maintenance Related	Dia/Height:	8"
Use:	Sanitary	Material:	PVC
Drain Area:	NA	Lining:	
Category:	NA		
Comment:	Unknown reason for stop.

Location Details:		Direction of Survey:	Downstream
US MH:	M-809-049	DS MH:	M-809-050
		Total Length Surveyed (ft):	106.1

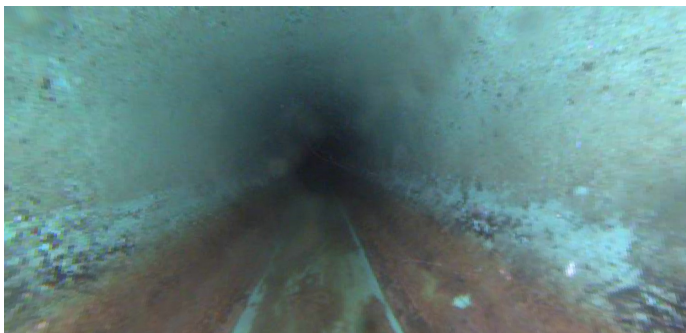
Code: **AMH**
Description: **Manhole**

Distance (ft): **.0**
Structural Grade: **0**
O&M Grade: **0**
Clock Start/From:
Clock To:
1st Value:
2nd Value:
Value Percent:
Continuous Index:
Within 8" of Joint: **NO**
Remarks: **M-809-049**

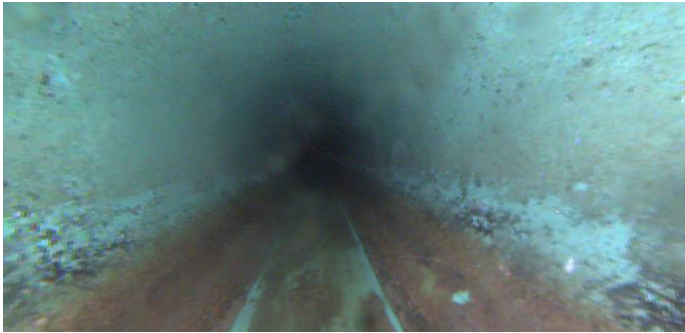
Code:	MWL
Description:	Water Level

Distance (ft):	.0
Structural Grade:	0
O&M Grade:	0
Clock Start/From:	
Clock To:	
1st Value:	
2nd Value:	
Value Percent:	5.000
Continuous Index:	
Within 8" of Joint:	NO
Remarks:

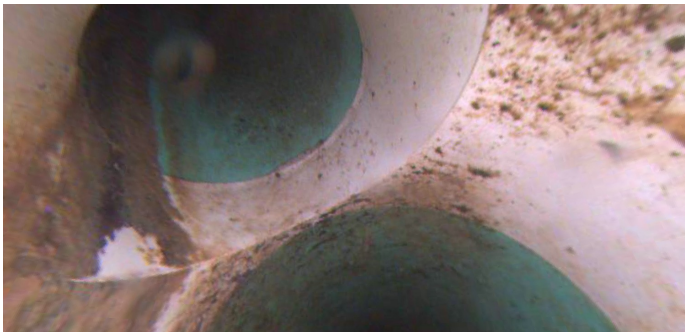
Code:	TF
Description:	Tap Factory

Distance (ft):	25.4
Structural Grade:	0
O&M Grade:	0
Clock Start/From:	1
Clock To:	
1st Value:	4.000
2nd Value:	
Value Percent:	
Continuous Index:	
Within 8" of Joint:	
Remarks:

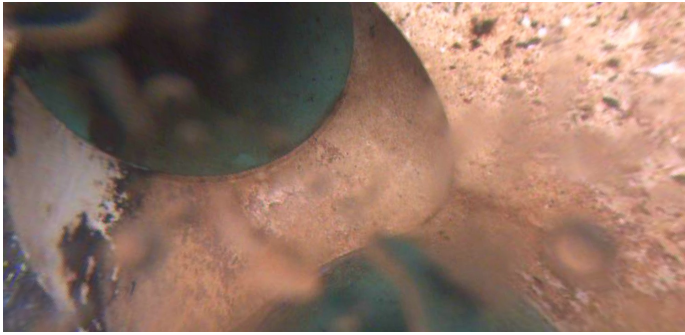
Code: **TF**
Description: **Tap Factory**

Distance (ft): **26.4**
Structural Grade: **0**
O&M Grade: **0**
Clock Start/From: **11**
Clock To:
1st Value: **4.000**
2nd Value:
Value Percent:
Continuous Index:
Within 8" of Joint:
Remarks:

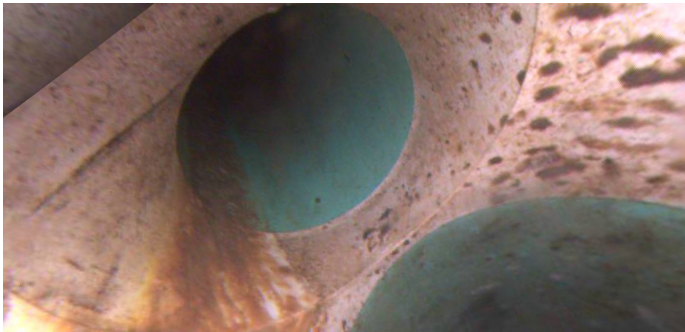
Code: **TF**
Description: **Tap Factory**

Distance (ft): **102.2**
Structural Grade: **0**
O&M Grade: **0**
Clock Start/From: **1**
Clock To:
1st Value: **4.000**
2nd Value:
Value Percent:
Continuous Index:
Within 8" of Joint:
Remarks:

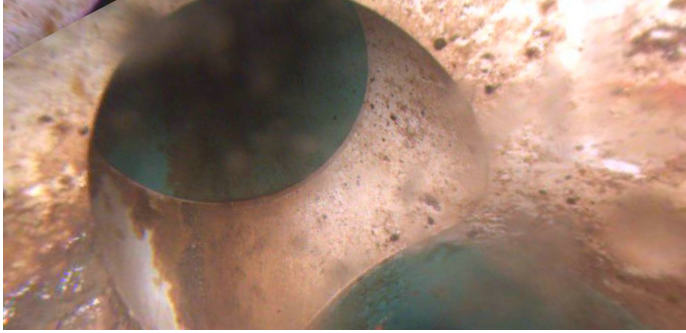
Code: **TF**
Description: **Tap Factory**

Distance (ft): **103.2**
Structural Grade: **0**
O&M Grade: **0**
Clock Start/From: **11**
Clock To:
1st Value: **4.000**
2nd Value:
Value Percent:
Continuous Index:
Within 8" of Joint:
Remarks:

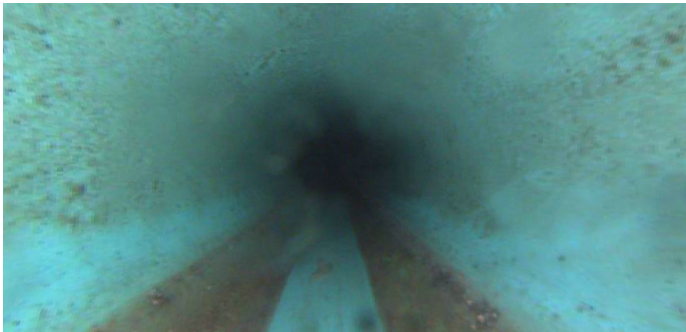
Code: **MSA**
Description: **Abandoned Survey**

Distance (ft): **106.1**
Structural Grade: **0**
O&M Grade: **0**
Clock Start/From:
Clock To:
1st Value:
2nd Value:
Value Percent:
Continuous Index:
Within 8" of Joint: **NO**
Remarks: **debris**
