Profile/Photo Observation Report

Street:	Tanager	Flow Control:	Not Controlled
City:	Hobart, IN	Year Renewed:	
Location:	Sidewalk	Tape/Media #:	
Purpose:	Maintenance Related	Dia/Height:	8"
Use:	Sanitary	Material:	PVC
Drain Area:	NA	Lining:	
Category:	NA		
Comment:	Unknown reason for stop.

Location Details:		Direction of Survey:	Downstream
US MH:	M-809-049	DS MH:	M-809-050
		Total Length Surveyed (ft):	106.1

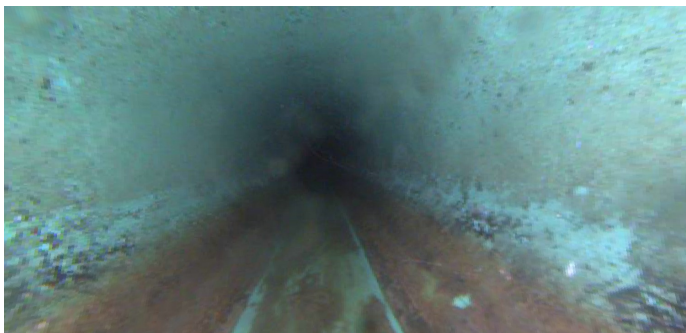
Code: **AMH**
Description: **Manhole**

Distance (ft): **.0**
Structural Grade: **0**
O&M Grade: **0**
Clock Start/From:
Clock To:
1st Value:
2nd Value:
Value Percent:
Continuous Index:
Within 8" of Joint: **NO**
Remarks: **M-809-049**

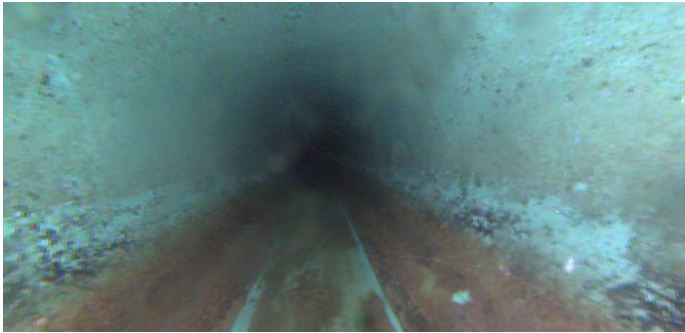
Code:	MWL
Description:	Water Level

Distance (ft):	.0
Structural Grade:	0
O&M Grade:	0
Clock Start/From:	
Clock To:	
1st Value:	
2nd Value:	
Value Percent:	5.000
Continuous Index:	
Within 8" of Joint:	NO
Remarks:

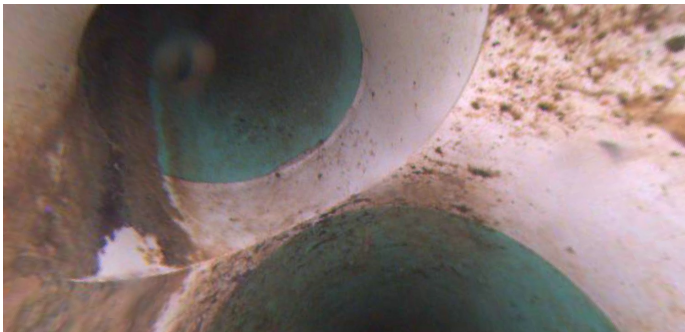
Code:	TF
Description:	Tap Factory

Distance (ft):	25.4
Structural Grade:	0
O&M Grade:	0
Clock Start/From:	1
Clock To:	
1st Value:	4.000
2nd Value:	
Value Percent:	
Continuous Index:	
Within 8" of Joint:	
Remarks:

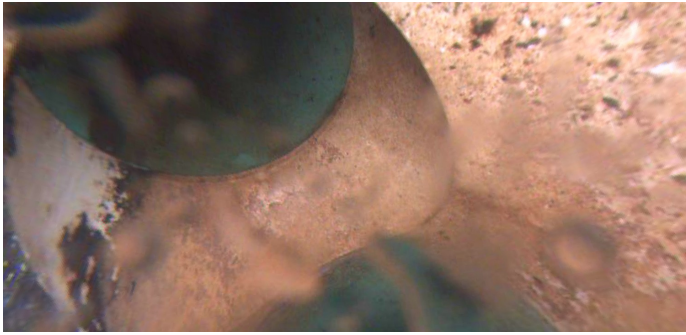
Code: **TF**
Description: **Tap Factory**

Distance (ft): **26.4**
Structural Grade: **0**
O&M Grade: **0**
Clock Start/From: **11**
Clock To:
1st Value: **4.000**
2nd Value:
Value Percent:
Continuous Index:
Within 8" of Joint:
Remarks:

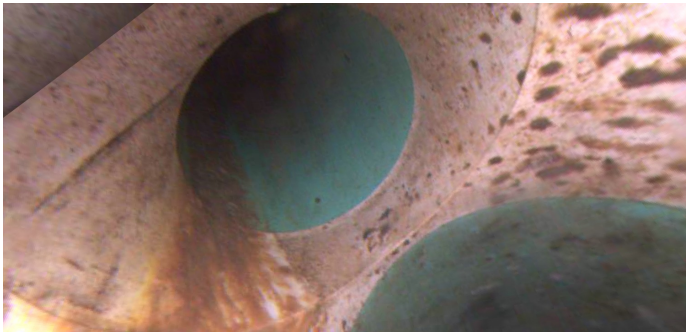
Code: **TF**
Description: **Tap Factory**

Distance (ft): **102.2**
Structural Grade: **0**
O&M Grade: **0**
Clock Start/From: **1**
Clock To:
1st Value: **4.000**
2nd Value:
Value Percent:
Continuous Index:
Within 8" of Joint:
Remarks:

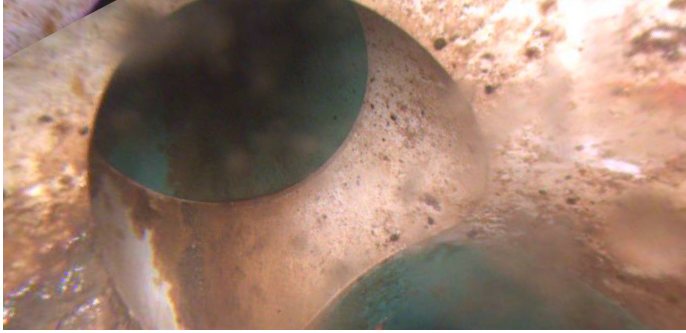
Code: **TF**
Description: **Tap Factory**

Distance (ft): **103.2**
Structural Grade: **0**
O&M Grade: **0**
Clock Start/From: **11**
Clock To:
1st Value: **4.000**
2nd Value:
Value Percent:
Continuous Index:
Within 8" of Joint:
Remarks:

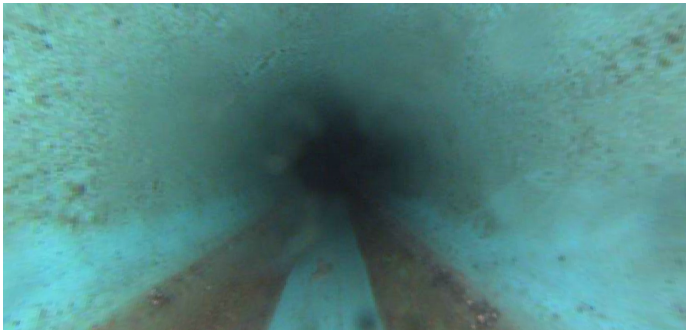
Code: **MSA**
Description: **Abandoned Survey**

Distance (ft): **106.1**
Structural Grade: **0**
O&M Grade: **0**
Clock Start/From:
Clock To:
1st Value:
2nd Value:
Value Percent:
Continuous Index:
Within 8" of Joint: **NO**
Remarks: **debris**
