Profile/Photo Observation Report

Street:	TANAGER ST	Flow Control:	Not Controlled
City:	Hobart, IN	Year Renewed:	
Location:	Light Highway	Tape/Media #:	
Purpose:	Maintenance Related	Dia/Height:	8"
Use:	Sanitary	Material:	PVC
Drain Area:	NA	Lining:	Cured in Place
Category:	NA		
Comment:

Location Details:		Direction of Survey:	Upstream
US MH:	M-809-050	DS MH:	M-709-035
		Total Length Surveyed (ft):	370.6

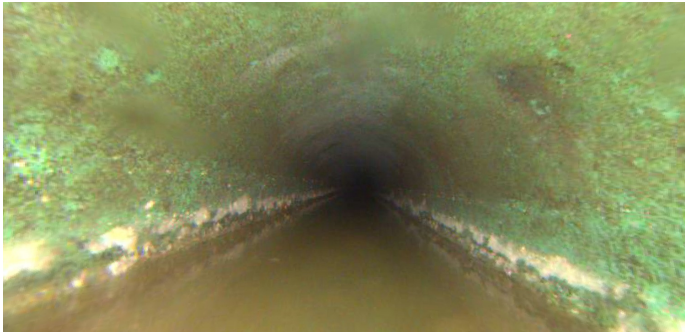
Code:	MWL
Description:	Water Level

Distance (ft):	.0
Structural Grade:	0
O&M Grade:	0
Clock Start/From:	
Clock To:	
1st Value:	
2nd Value:	
Value Percent:	20.000
Continuous Index:	
Within 8" of Joint:	NO
Remarks:	M-809-050

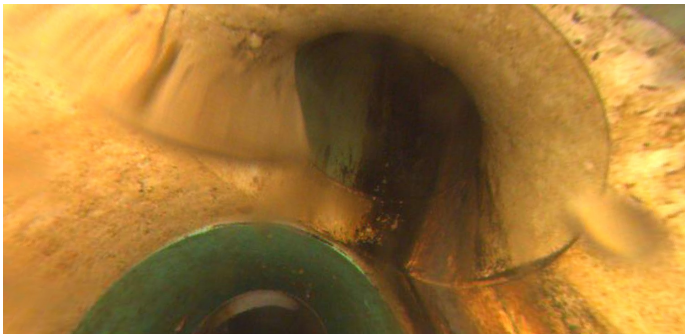
Code:	TF
Description:	Tap Factory

Distance (ft):	73.4
Structural Grade:	0
O&M Grade:	0
Clock Start/From:	1
Clock To:	
1st Value:	4.000
2nd Value:	
Value Percent:	
Continuous Index:	
Within 8" of Joint:	
Remarks:

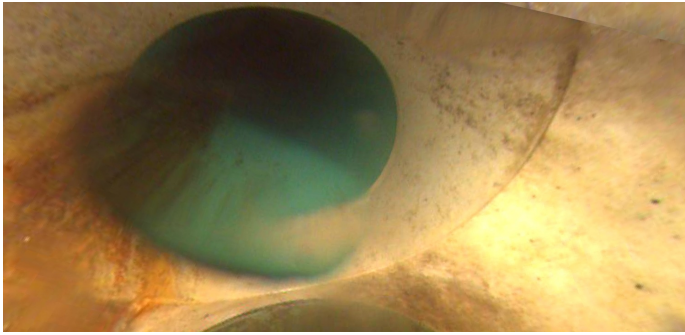
Code: **TFA**
Description: **Tap Factory Active**

Distance (ft): **75.4**
Structural Grade: **0**
O&M Grade: **0**
Clock Start/From: **11**
Clock To:
1st Value: **4.000**
2nd Value:
Value Percent:
Continuous Index:
Within 8" of Joint:
Remarks:

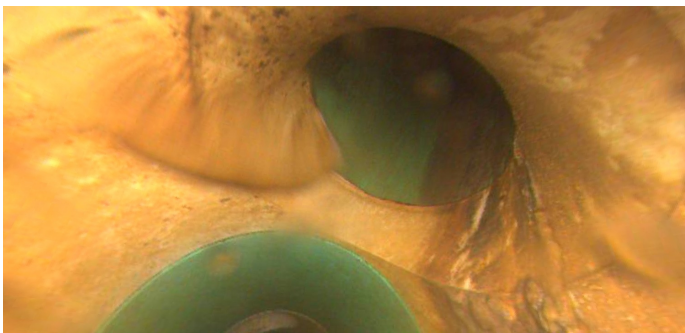
Code: **TF**
Description: **Tap Factory**

Distance (ft): **148.5**
Structural Grade: **0**
O&M Grade: **0**
Clock Start/From: **1**
Clock To:
1st Value: **4.000**
2nd Value:
Value Percent:
Continuous Index:
Within 8" of Joint:
Remarks:

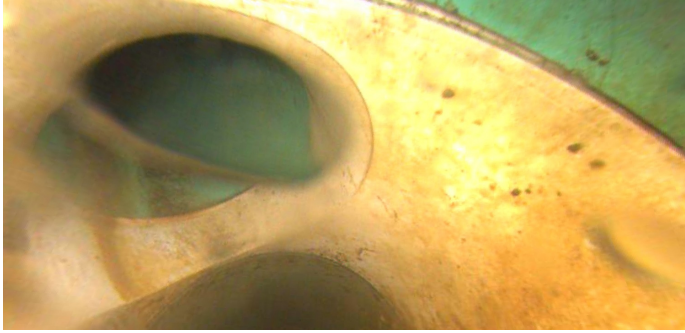
Code: **TF**
Description: **Tap Factory**

Distance (ft): **150.1**
Structural Grade: **0**
O&M Grade: **0**
Clock Start/From: **11**
Clock To:
1st Value: **4.000**
2nd Value:
Value Percent:
Continuous Index:
Within 8" of Joint:
Remarks:

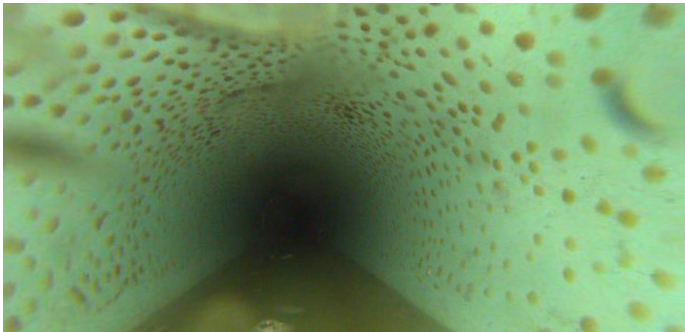
Code: **MWL**
Description: **Water Level**

Distance (ft): **161.2**
Structural Grade: **0**
O&M Grade: **0**
Clock Start/From:
Clock To:
1st Value:
2nd Value:
Value Percent: **10.000**
Continuous Index:
Within 8" of Joint: **NO**
Remarks:

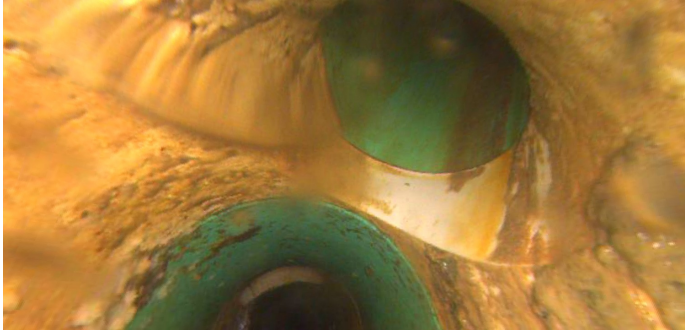
Code: **TF**
Description: **Tap Factory**

Distance (ft): **245.1**
Structural Grade: **0**
O&M Grade: **0**
Clock Start/From: **1**
Clock To:
1st Value: **4.000**
2nd Value:
Value Percent:
Continuous Index:
Within 8" of Joint:
Remarks:

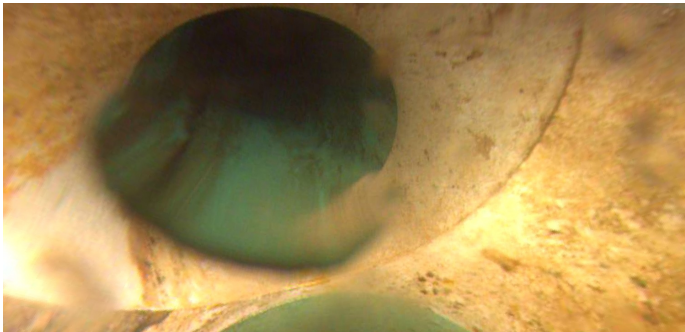
Code: **TF**
Description: **Tap Factory**

Distance (ft): **246.9**
Structural Grade: **0**
O&M Grade: **0**
Clock Start/From: **11**
Clock To:
1st Value: **4.000**
2nd Value:
Value Percent:
Continuous Index:
Within 8" of Joint:
Remarks:

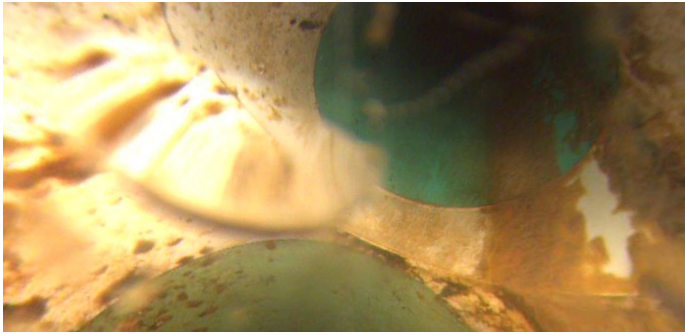
Code: **TF**
Description: **Tap Factory**

Distance (ft): **317.1**
Structural Grade: **0**
O&M Grade: **0**
Clock Start/From: **1**
Clock To:
1st Value: **4.000**
2nd Value:
Value Percent:
Continuous Index:
Within 8" of Joint:
Remarks:

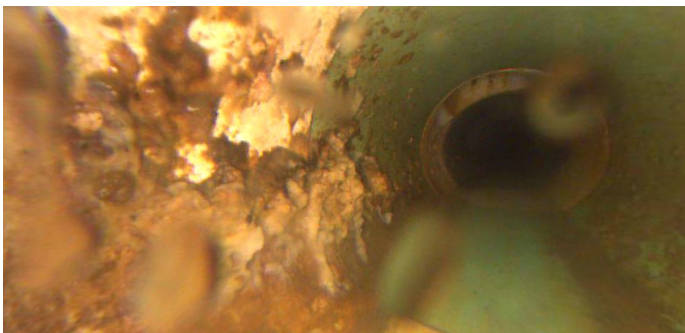
Code: **DAGS**
Description: **Deposits Attached Grease**

Distance (ft): **317.1**
Structural Grade: **0**
O&M Grade: **2**
Clock Start/From: **7**
Clock To: **9**
1st Value:
2nd Value:
Value Percent: **5.000**
Continuous Index:
Within 8" of Joint: **NO**
Remarks:

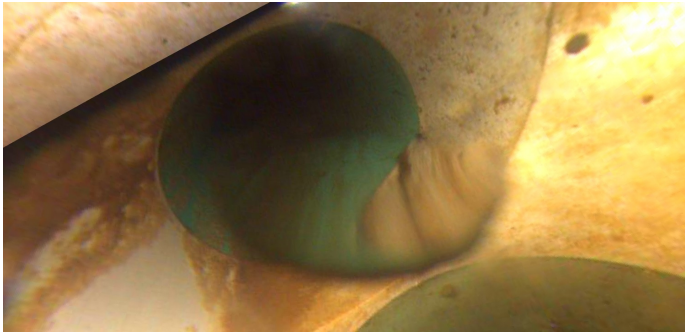
Code: **TF**
Description: **Tap Factory**

Distance (ft): **318.8**
Structural Grade: **0**
O&M Grade: **0**
Clock Start/From: **11**
Clock To:
1st Value: **4.000**
2nd Value:
Value Percent:
Continuous Index:
Within 8" of Joint:
Remarks:

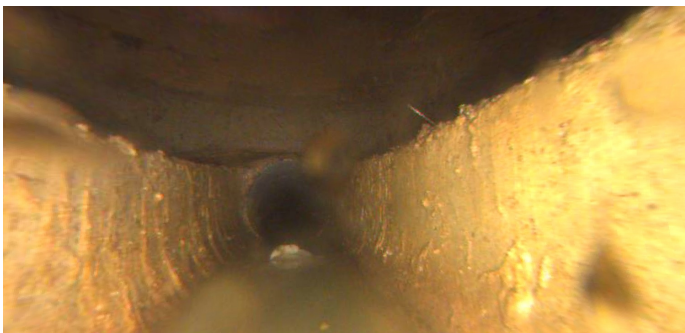
Code: **AMH**
Description: **Manhole**

Distance (ft): **370.6**
Structural Grade: **0**
O&M Grade: **0**
Clock Start/From:
Clock To:
1st Value:
2nd Value:
Value Percent:
Continuous Index:
Within 8" of Joint: **NO**
Remarks: **M-809-050**
