Profile/Photo Observation Report

Street:	Oak	Flow Control:	Not Controlled
City:	Hobart, IN	Year Renewed:	
Location:	Sidewalk	Tape/Media #:	
Purpose:	Maintenance Related	Dia/Height:	8"
Use:	Sanitary	Material:	PVC
Drain Area:	NA	Lining:	
Category:	NA		
Comment:

Location Details:		Direction of Survey:	Downstream
US MH:	M-809-052	DS MH:	M-809-053
		Total Length Surveyed (ft):	355.1

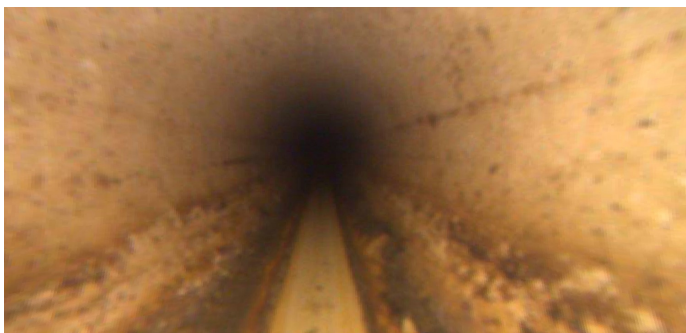
Code: **AMH**
Description: **Manhole**

Distance (ft): **.0**
Structural Grade: **0**
O&M Grade: **0**
Clock Start/From:
Clock To:
1st Value:
2nd Value:
Value Percent:
Continuous Index:
Within 8" of Joint: **NO**
Remarks: **M-809-052**

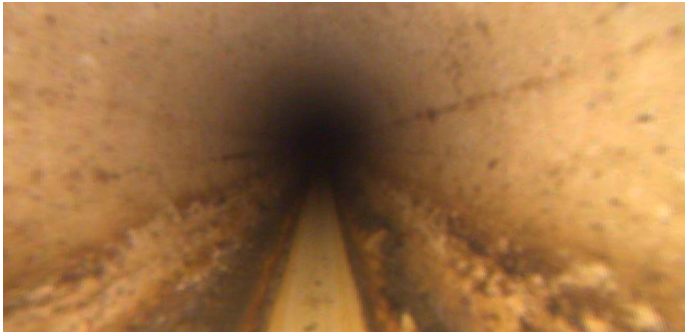
Code:	MWL
Description:	Water Level

Distance (ft):	.0
Structural Grade:	0
O&M Grade:	0
Clock Start/From:	
Clock To:	
1st Value:	
2nd Value:	
Value Percent:	5.000
Continuous Index:	
Within 8" of Joint:	NO
Remarks:

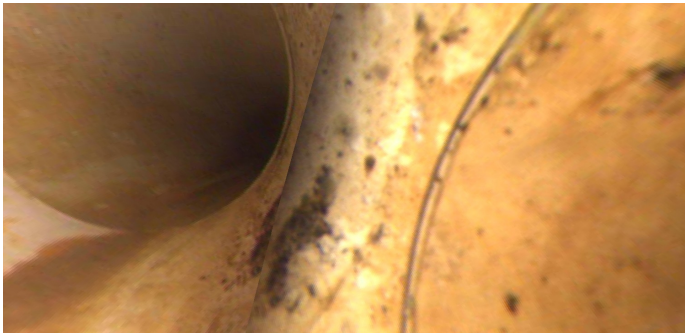
Code:	TF
Description:	Tap Factory

Distance (ft):	9.8
Structural Grade:	0
O&M Grade:	0
Clock Start/From:	11
Clock To:	
1st Value:	4.000
2nd Value:	
Value Percent:	
Continuous Index:	
Within 8" of Joint:	YES
Remarks:

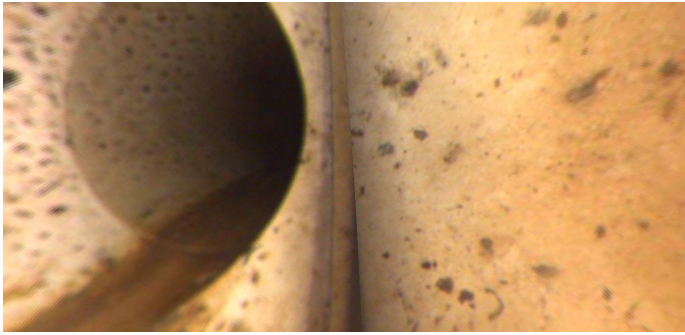
Code: **TF**
Description: **Tap Factory**

Distance (ft): **11.0**
Structural Grade: **0**
O&M Grade: **0**
Clock Start/From: **1**
Clock To:
1st Value: **4.000**
2nd Value:
Value Percent:
Continuous Index:
Within 8" of Joint: **YES**
Remarks:

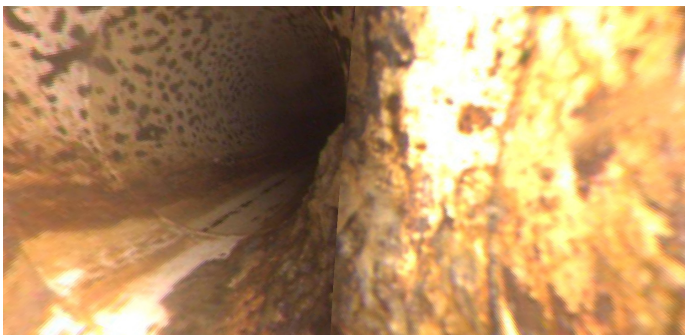
Code: **TF**
Description: **Tap Factory**

Distance (ft): **102.8**
Structural Grade: **0**
O&M Grade: **0**
Clock Start/From: **11**
Clock To:
1st Value: **4.000**
2nd Value:
Value Percent:
Continuous Index:
Within 8" of Joint: **YES**
Remarks:

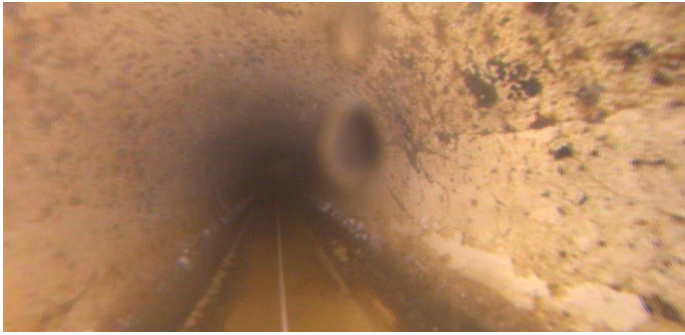
Code: **MGO**
Description: **General Observation**

Distance (ft): **179.0**
Structural Grade: **0**
O&M Grade: **0**
Clock Start/From:
Clock To:
1st Value:
2nd Value:
Value Percent:
Continuous Index:
Within 8" of Joint: **NO**
Remarks: **rear camera/cob webs**

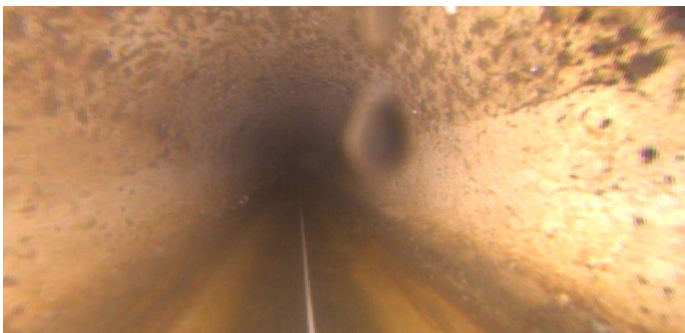
Code: **DAZ**
Description: **Deposits Attached Other**

Distance (ft): **182.4**
Structural Grade: **0**
O&M Grade: **2**
Clock Start/From: **10**
Clock To: **2**
1st Value:
2nd Value:
Value Percent: **5.000**
Continuous Index: **S01**
Within 8" of Joint: **NO**
Remarks: **wandering**

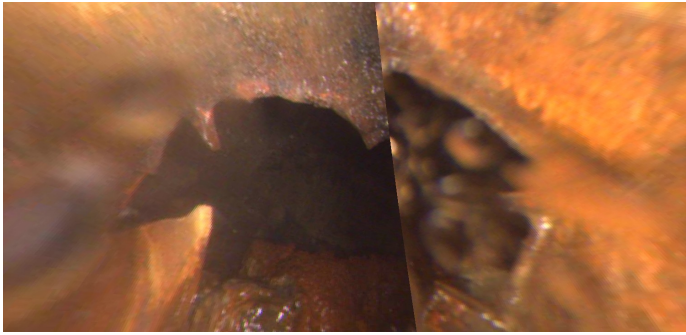
Code: **HVV**
Description: **Hole Void Visible**

Distance (ft): **194.6**
Structural Grade: **5**
O&M Grade: **0**
Clock Start/From: **8**
Clock To: **10**
1st Value:
2nd Value:
Value Percent:
Continuous Index:
Within 8" of Joint:
Remarks: **huge**

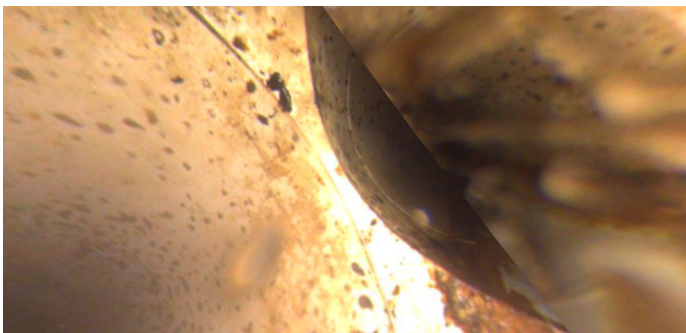
Code: **TF**
Description: **Tap Factory**

Distance (ft): **201.3**
Structural Grade: **0**
O&M Grade: **0**
Clock Start/From: **11**
Clock To:
1st Value: **4.000**
2nd Value:
Value Percent:
Continuous Index:
Within 8" of Joint: **YES**
Remarks:

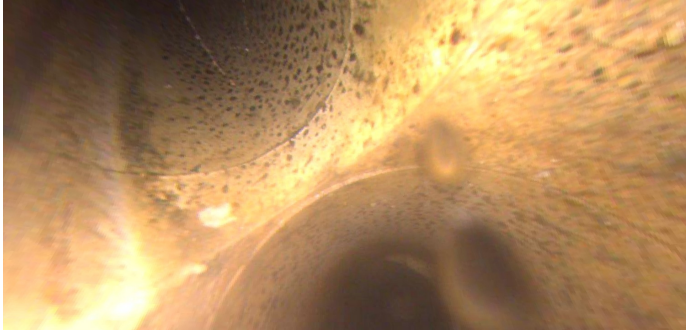
Code: **TF**
Description: **Tap Factory**

Distance (ft): **203.2**
Structural Grade: **0**
O&M Grade: **0**
Clock Start/From: **1**
Clock To:
1st Value: **4.000**
2nd Value:
Value Percent:
Continuous Index:
Within 8" of Joint: **YES**
Remarks:

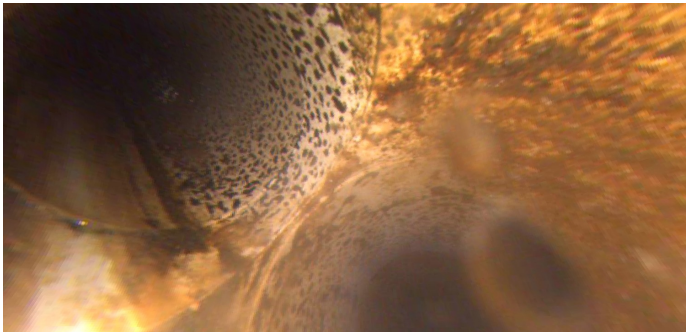
Code: **TF**
Description: **Tap Factory**

Distance (ft): **301.1**
Structural Grade: **0**
O&M Grade: **0**
Clock Start/From: **1**
Clock To:
1st Value: **4.000**
2nd Value:
Value Percent:
Continuous Index:
Within 8" of Joint: **YES**
Remarks:

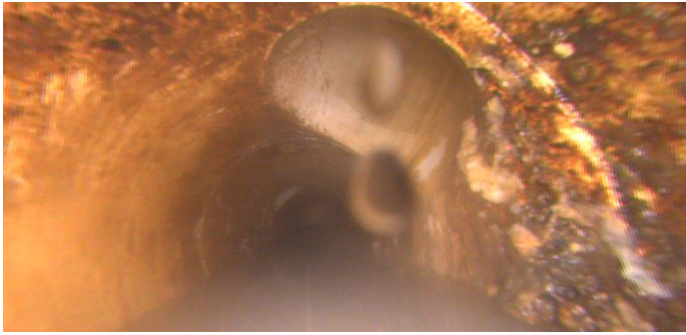
Code: **TF**
Description: **Tap Factory**

Distance (ft): **303.2**
Structural Grade: **0**
O&M Grade: **0**
Clock Start/From: **11**
Clock To:
1st Value: **4.000**
2nd Value:
Value Percent:
Continuous Index:
Within 8" of Joint: **YES**
Remarks:

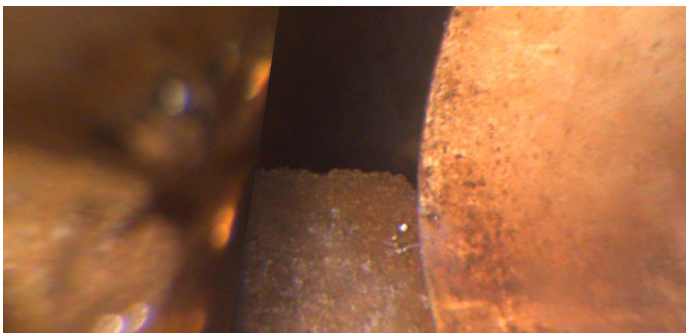
Code: **DAZ**
Description: **Deposits Attached Other**

Distance (ft): **353.5**
Structural Grade: **0**
O&M Grade: **2**
Clock Start/From: **10**
Clock To: **2**
1st Value:
2nd Value:
Value Percent: **5.000**
Continuous Index: **F01**
Within 8" of Joint: **NO**
Remarks: **wandering**

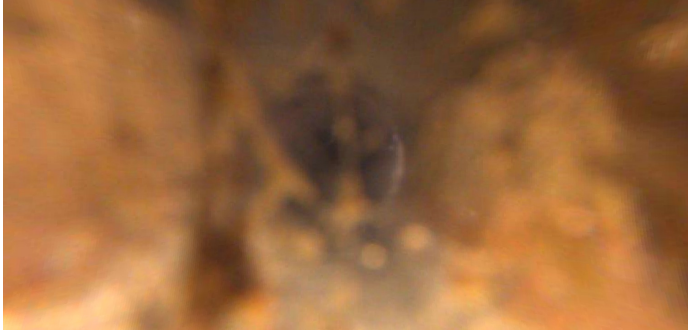
Code:	AMH
Description:	Manhole
Distance (ft):	355.1
Structural Grade:	0
O&M Grade:	0
Clock Start/From:	
Clock To:	
1st Value:	
2nd Value:	
Value Percent:	
Continuous Index:	
Within 8" of Joint:	NO
Remarks:	M-809-053
