Profile/Photo Observation Report

Date:	10/20/2021	Weather:		Coding:	PACP 6.0
Pipe Length (ft):		Owner:	Hobart, IN	Pre Clean:	Not Known
P.O.#:	923_1	Surveyor:	M. Pielacha	PSR:	P-809-053-054
Customer:	Hobart, IN	Clean Date:		Shape:	C

Street:	Off Bracken Parkway	Flow Control:	
City:	Hobart, IN	Year Renewed:	
Location:	Sidewalk	Tape/Media #:	923
Purpose:	Routine Assessment	Dia/Height:	8"
Use:	Sanitary	Material:	PVC
Drain Area:		Lining:	
Category:	NA		
Comment:

Location Details:		Direction of Survey:	Upstream
US MH:	M-809-53	DS MH:	M-809-54
		Total Length Surveyed (ft):	344.5

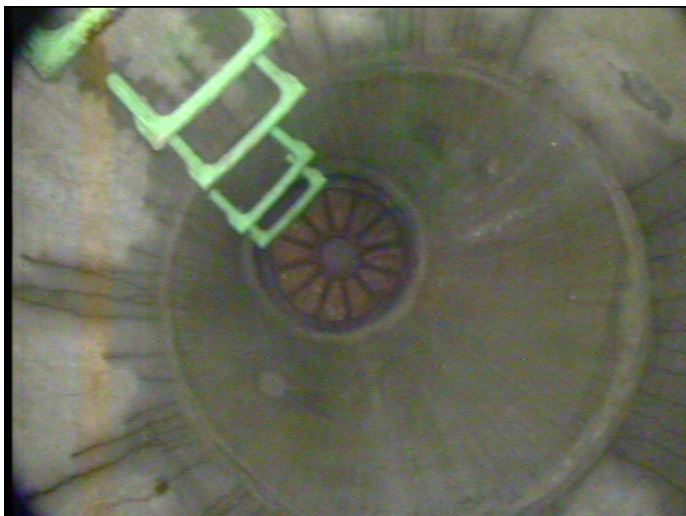
The diagram illustrates a vertical pipe structure with inspection points. A red arrow on the left indicates the 'Camera Direction' pointing downwards. The pipe is labeled with 'M-809-54' at the top and 'M-809-53' at the bottom. A table on the right provides data for the inspection points.

Position	Code	Observation	Video (sec)	Grade
.0	AMH	Manhole	0	NA
.0	MWL	Water Level	14	NA
40.6	TF	Tap Factory	71	NA
127.9	TF	Tap Factory	199	NA
148.4	TF	Tap Factory	234	NA
227.8	TF	Tap Factory	335	NA
344.5	AMH	Manhole	504	NA

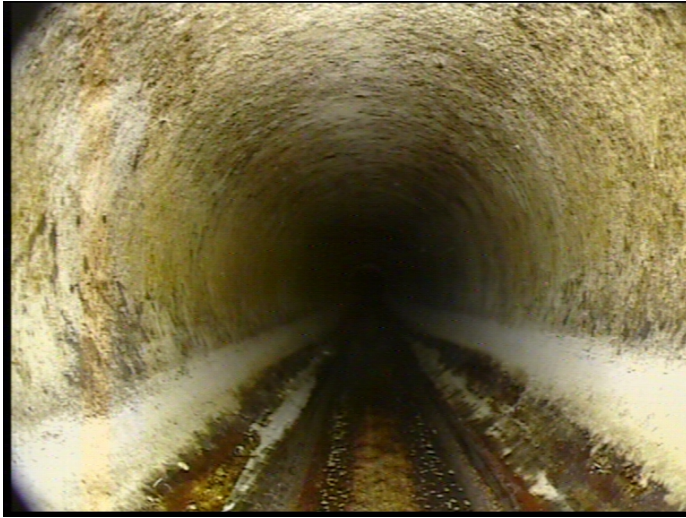
Code:	MWL
Description:	Water Level
Distance (ft):	.0
Structural Grade:	0
O&M Grade:	0
Clock Start/From:	
Clock To:	
1st Value:	
2nd Value:	
Value Percent:	5.000
Continuous Index:	
Within 8" of Joint:	NO
Remarks:

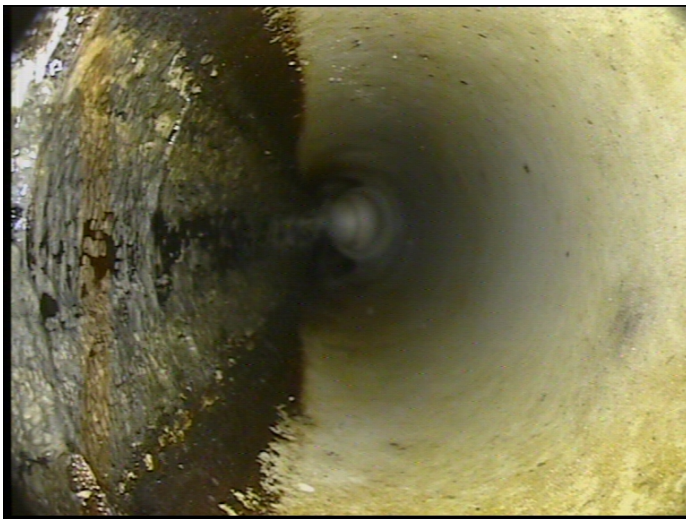
Code:	TF
Description:	Tap Factory
Distance (ft):	40.6
Structural Grade:	0
O&M Grade:	0
Clock Start/From:	10
Clock To:	
1st Value:	4.000
2nd Value:	
Value Percent:	
Continuous Index:	
Within 8" of Joint:	NO
Remarks:

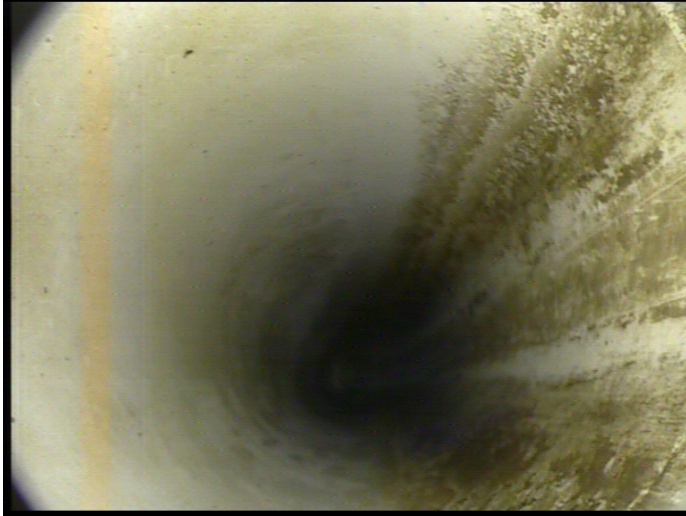
Code: **TF**
Description: **Tap Factory**

Distance (ft): **127.9**
Structural Grade: **0**
O&M Grade: **0**
Clock Start/From: **2**
Clock To:
1st Value: **4.000**
2nd Value:
Value Percent:
Continuous Index:
Within 8" of Joint: **NO**
Remarks:

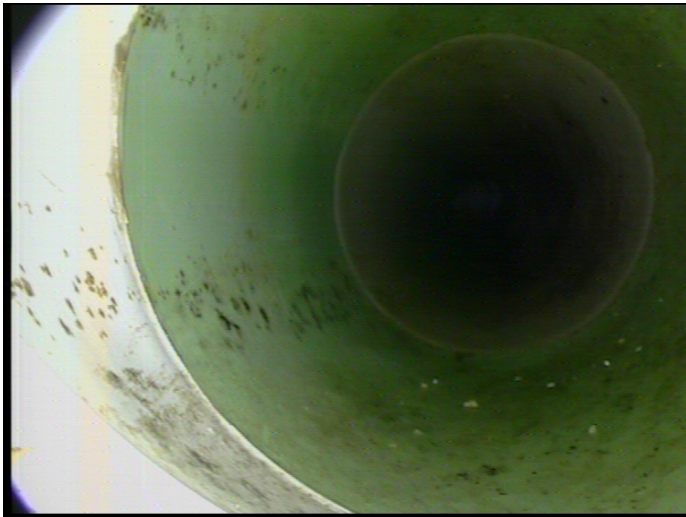
Code: **TF**
Description: **Tap Factory**

Distance (ft): **148.4**
Structural Grade: **0**
O&M Grade: **0**
Clock Start/From: **10**
Clock To:
1st Value: **4.000**
2nd Value:
Value Percent:
Continuous Index:
Within 8" of Joint: **NO**
Remarks:

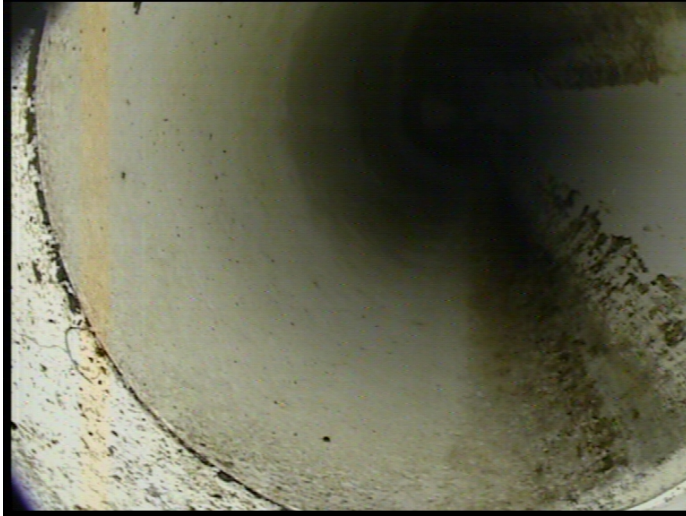
Code:	TF
Description:	Tap Factory
Distance (ft):	227.8
Structural Grade:	0
O&M Grade:	0
Clock Start/From:	2
Clock To:	
1st Value:	4.000
2nd Value:	
Value Percent:	
Continuous Index:	
Within 8" of Joint:	NO
Remarks:

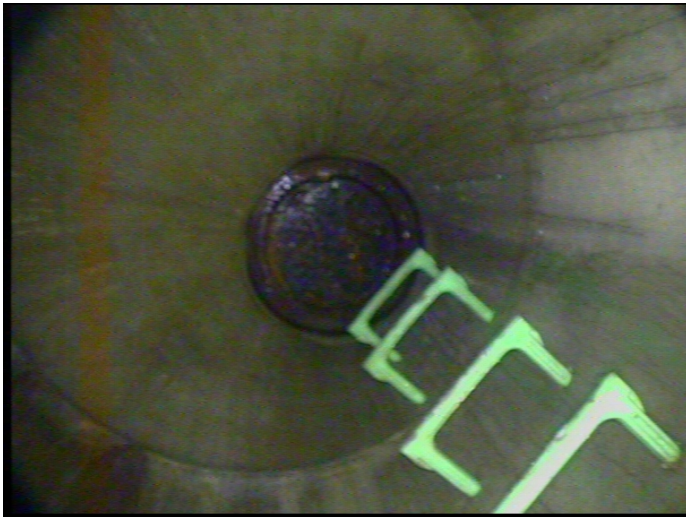
Code:	AMH
Description:	Manhole
Distance (ft):	344.5
Structural Grade:	0
O&M Grade:	0
Clock Start/From:	
Clock To:	
1st Value:	
2nd Value:	
Value Percent:	
Continuous Index:	
Within 8" of Joint:	NO
Remarks:	M-809-53
