Profile/Photo Observation Report

Street:	SORA ST & WILLET AVE	Flow Control:	Not Controlled
City:	Hobart, IN	Year Renewed:	
Location:	Sidewalk	Tape/Media #:	
Purpose:	Maintenance Related	Dia/Height:	8"
Use:	Sanitary	Material:	PVC
Drain Area:	NA	Lining:	
Category:	NA		
Comment:	flow is incorrect.

Location Details:		Direction of Survey:	Downstream
US MH:	M-809-056	DS MH:	M-809-057
		Total Length Surveyed (ft):	159.0

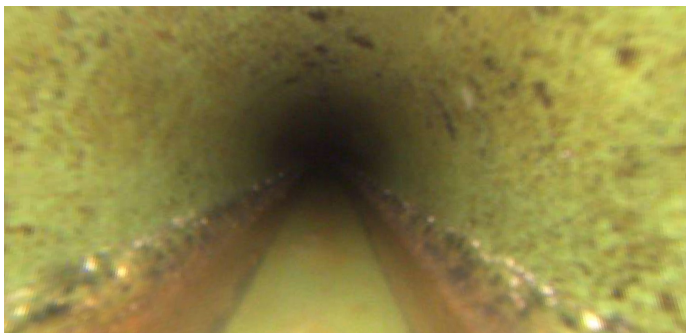
Code: **AMH**
Description: **Manhole**

Distance (ft): **.0**
Structural Grade: **0**
O&M Grade: **0**
Clock Start/From:
Clock To:
1st Value:
2nd Value:
Value Percent:
Continuous Index:
Within 8" of Joint: **NO**
Remarks: **M-809-056**

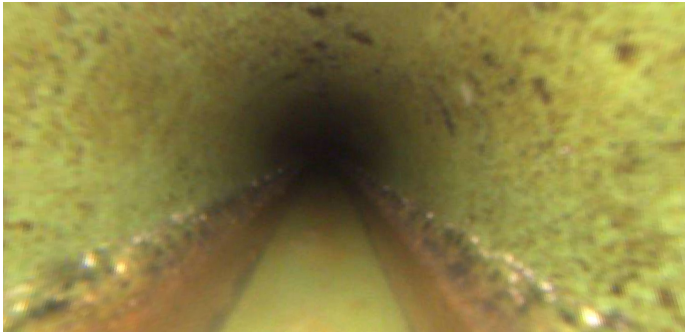
Code:	MWL
Description:	Water Level

Distance (ft):	.0
Structural Grade:	0
O&M Grade:	0
Clock Start/From:	
Clock To:	
1st Value:	
2nd Value:	
Value Percent:	5.000
Continuous Index:	
Within 8" of Joint:	NO
Remarks:

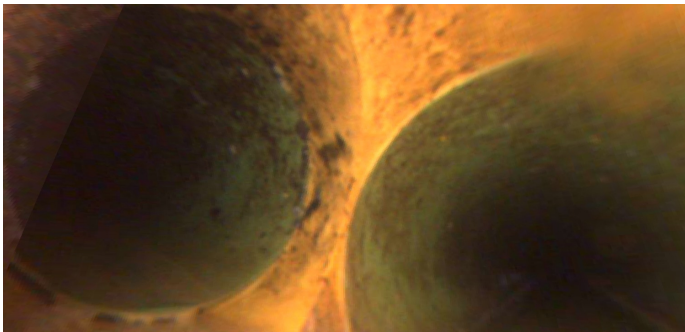
Code:	TF
Description:	Tap Factory

Distance (ft):	30.6
Structural Grade:	0
O&M Grade:	0
Clock Start/From:	9
Clock To:	
1st Value:	4.000
2nd Value:	
Value Percent:	
Continuous Index:	
Within 8" of Joint:	
Remarks:

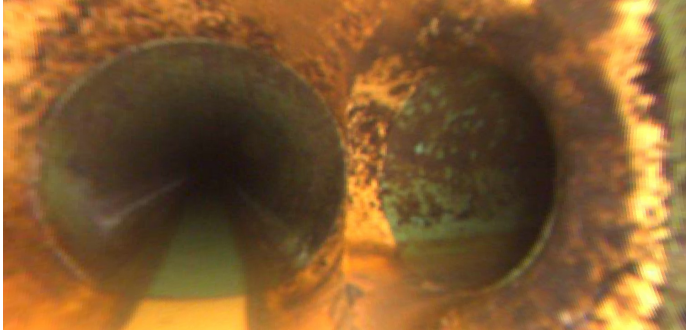
Code: **TF**
Description: **Tap Factory**

Distance (ft): **45.2**
Structural Grade: **0**
O&M Grade: **0**
Clock Start/From: **3**
Clock To:
1st Value: **4.000**
2nd Value:
Value Percent:
Continuous Index:
Within 8" of Joint:
Remarks:

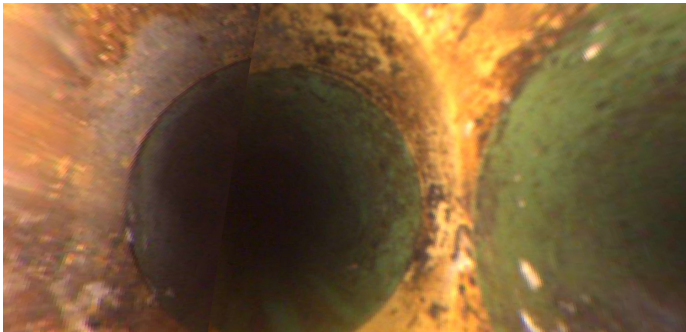
Code: **TF**
Description: **Tap Factory**

Distance (ft): **105.4**
Structural Grade: **0**
O&M Grade: **0**
Clock Start/From: **9**
Clock To:
1st Value: **4.000**
2nd Value:
Value Percent:
Continuous Index:
Within 8" of Joint:
Remarks:

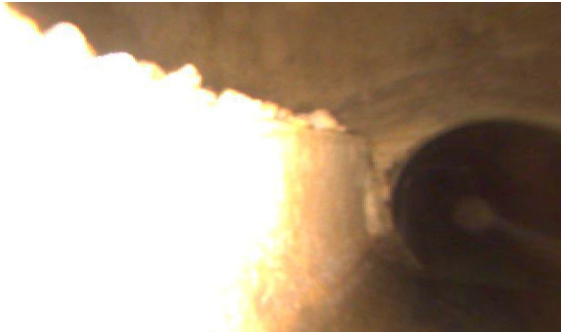
Code:	AMH
Description:	Manhole
Distance (ft):	159.0
Structural Grade:	0
O&M Grade:	0
Clock Start/From:	
Clock To:	
1st Value:	
2nd Value:	
Value Percent:	
Continuous Index:	
Within 8" of Joint:	NO
Remarks:	M-809-057
