Profile/Photo Observation Report

Street:	Oak	Flow Control:	Not Controlled
City:	Hobart, IN	Year Renewed:	
Location:	Sidewalk	Tape/Media #:	
Purpose:	Maintenance Related	Dia/Height:	8"
Use:	Sanitary	Material:	PVC
Drain Area:	NA	Lining:	
Category:	NA		
Comment:	new mh found at 42'.

Location Details:		Direction of Survey:	Downstream
US MH:	M-809-059	DS MH:	M-809-059A
		Total Length Surveyed (ft):	43.7

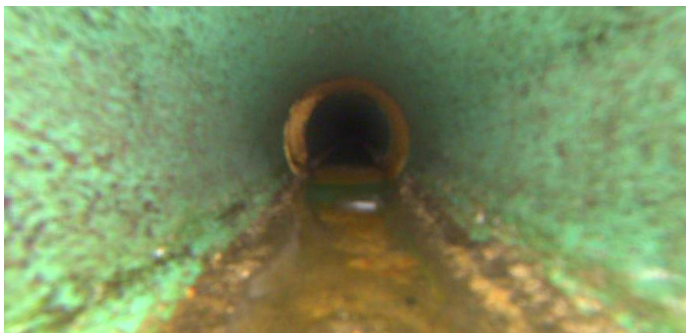
Code: **AMH**
Description: **Manhole**

Distance (ft): **.0**
Structural Grade: **0**
O&M Grade: **0**
Clock Start/From:
Clock To:
1st Value:
2nd Value:
Value Percent:
Continuous Index:
Within 8" of Joint: **NO**
Remarks: **M-809-059**

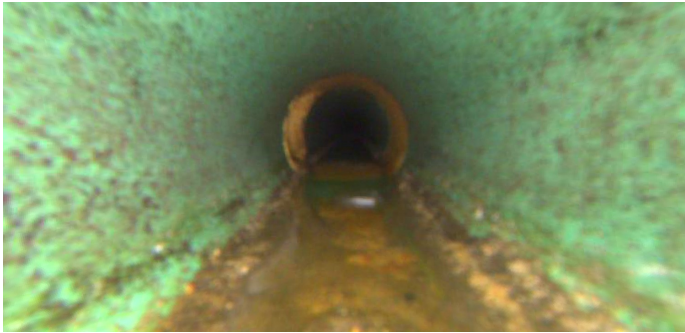
Code:	MWL
Description:	Water Level

Distance (ft):	.0
Structural Grade:	0
O&M Grade:	0
Clock Start/From:	
Clock To:	
1st Value:	
2nd Value:	
Value Percent:	5.000
Continuous Index:	
Within 8" of Joint:	NO
Remarks:

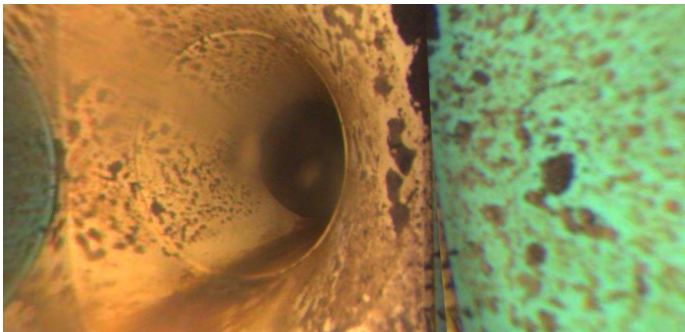
Code:	TF
Description:	Tap Factory

Distance (ft):	2.9
Structural Grade:	0
O&M Grade:	0
Clock Start/From:	9
Clock To:	
1st Value:	4.000
2nd Value:	
Value Percent:	
Continuous Index:	
Within 8" of Joint:	
Remarks:

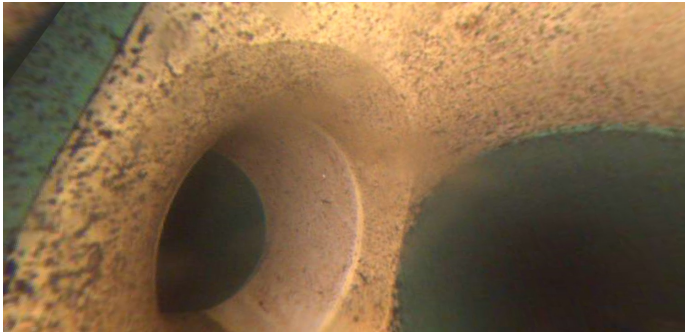
Code: **TF**
Description: **Tap Factory**

Distance (ft): **24.1**
Structural Grade: **0**
O&M Grade: **0**
Clock Start/From: **3**
Clock To:
1st Value: **4.000**
2nd Value:
Value Percent:
Continuous Index:
Within 8" of Joint:
Remarks:

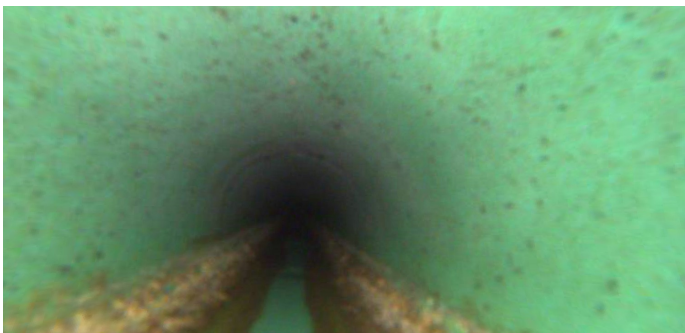
Code: **DAGS**
Description: **Deposits Attached Grease**

Distance (ft): **27.1**
Structural Grade: **0**
O&M Grade: **2**
Clock Start/From: **8**
Clock To: **4**
1st Value:
2nd Value:
Value Percent: **5.000**
Continuous Index: **S01**
Within 8" of Joint: **NO**
Remarks:

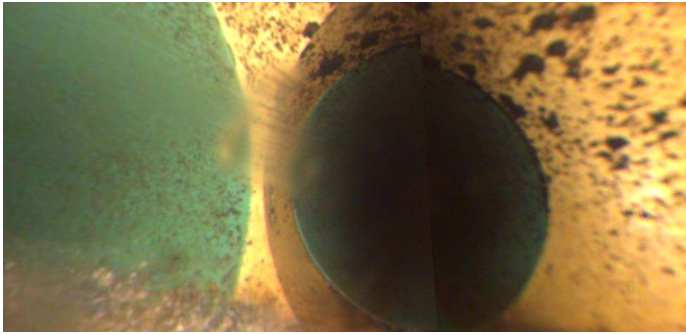
Code: **TF**
Description: **Tap Factory**

Distance (ft): **36.8**
Structural Grade: **0**
O&M Grade: **0**
Clock Start/From: **9**
Clock To:
1st Value: **4.000**
2nd Value:
Value Percent:
Continuous Index:
Within 8" of Joint:
Remarks:

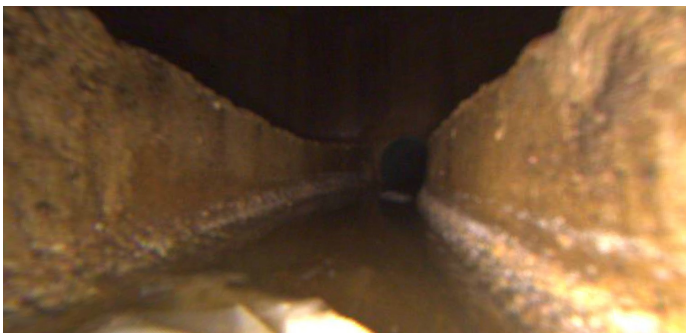
Code: **DAGS**
Description: **Deposits Attached Grease**

Distance (ft): **41.8**
Structural Grade: **0**
O&M Grade: **2**
Clock Start/From: **8**
Clock To: **4**
1st Value:
2nd Value:
Value Percent: **5.000**
Continuous Index: **F01**
Within 8" of Joint: **NO**
Remarks:

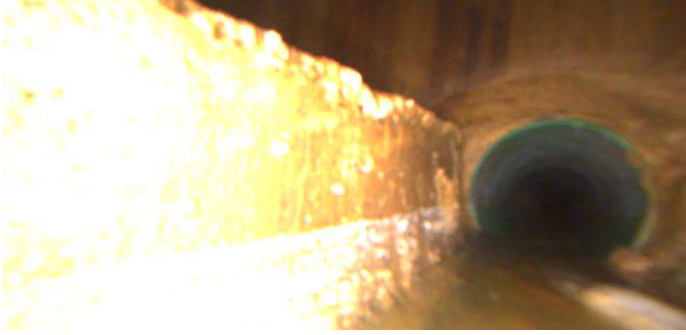
Code:	AMH
Description:	Manhole
Distance (ft):	43.7
Structural Grade:	0
O&M Grade:	0
Clock Start/From:	
Clock To:	
1st Value:	
2nd Value:	
Value Percent:	
Continuous Index:	
Within 8" of Joint:	NO
Remarks:	M-809-059A
