## Profile/Photo Observation Report

Street:	<b>SORA ST &amp; WILLET AVE</b>	Flow Control:	<b>Not Controlled</b>
City:	<b>Hobart, IN</b>	Year Renewed:	
Location:	<b>Sidewalk</b>	Tape/Media #:	
Purpose:	<b>Maintenance Related</b>	Dia/Height:	<b>8"</b>
Use:	<b>Sanitary</b>	Material:	<b>PVC</b>
Drain Area:	<b>NA</b>	Lining:	
Category:	<b>NA</b>		
Comment:

Location Details:		Direction of Survey:	<b>Upstream</b>
US MH:	<b>M-809-060</b>	DS MH:	<b>M-809-056</b>
		Total Length Surveyed (ft):	<b>266.2</b>

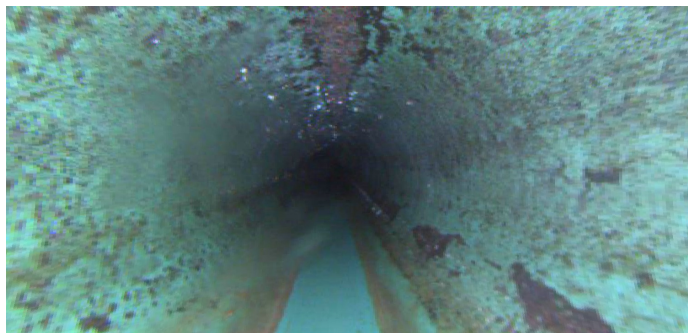
Code: **AMH**  
Description: **Manhole**

Distance (ft): **.0**  
Structural Grade: **0**  
O&M Grade: **0**  
Clock Start/From:  
Clock To:  
1st Value:  
2nd Value:  
Value Percent:  
Continuous Index:  
Within 8" of Joint: **NO**  
Remarks: **M-809-056**

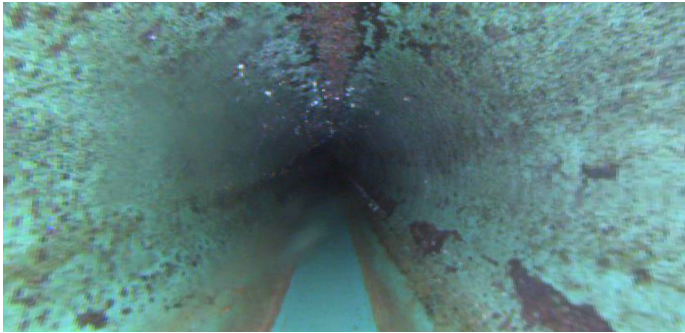
Code:	<b>MWL</b>
Description:	<b>Water Level</b>

Distance (ft):	<b>.0</b>
Structural Grade:	<b>0</b>
O&M Grade:	<b>0</b>
Clock Start/From:	
Clock To:	
1st Value:	
2nd Value:	
Value Percent:	<b>5.000</b>
Continuous Index:	
Within 8" of Joint:	<b>NO</b>
Remarks:

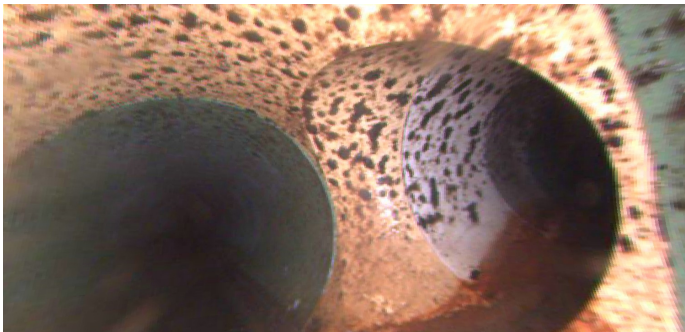
Code:	<b>TF</b>
Description:	<b>Tap Factory</b>

Distance (ft):	<b>140.9</b>
Structural Grade:	<b>0</b>
O&M Grade:	<b>0</b>
Clock Start/From:	<b>3</b>
Clock To:	
1st Value:	<b>4.000</b>
2nd Value:	
Value Percent:	
Continuous Index:	
Within 8" of Joint:	
Remarks:

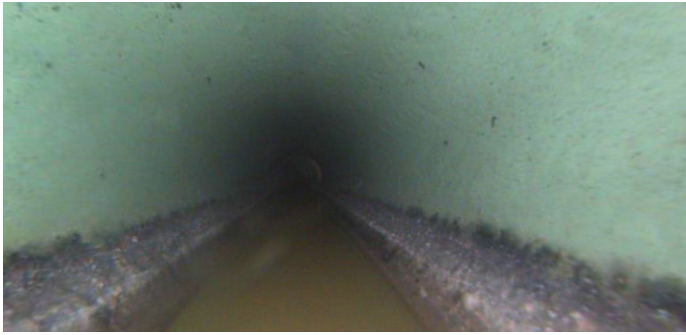
Code: **DAGS**  
Description: **Deposits Attached Grease**

Distance (ft): **222.1**  
Structural Grade: **0**  
O&M Grade: **2**  
Clock Start/From: **7**  
Clock To: **5**  
1st Value:  
2nd Value:  
Value Percent: **5.000**  
Continuous Index: **S01**  
Within 8" of Joint: **NO**  
Remarks:

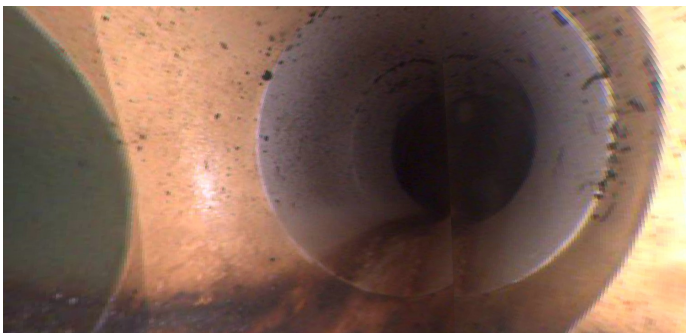
Code: **TF**  
Description: **Tap Factory**

Distance (ft): **226.5**  
Structural Grade: **0**  
O&M Grade: **0**  
Clock Start/From: **3**  
Clock To:  
1st Value: **4.000**  
2nd Value:  
Value Percent:  
Continuous Index:  
Within 8" of Joint:  
Remarks:

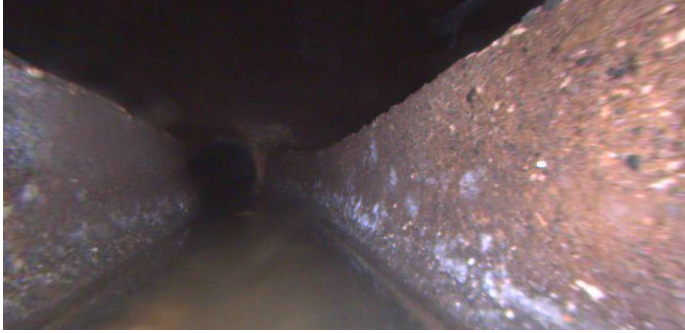
Code: **DAGS**  
Description: **Deposits Attached Grease**

Distance (ft): **264.3**  
Structural Grade: **0**  
O&M Grade: **2**  
Clock Start/From: **7**  
Clock To: **5**  
1st Value:  
2nd Value:  
Value Percent: **5.000**  
Continuous Index: **F01**  
Within 8" of Joint: **NO**  
Remarks:

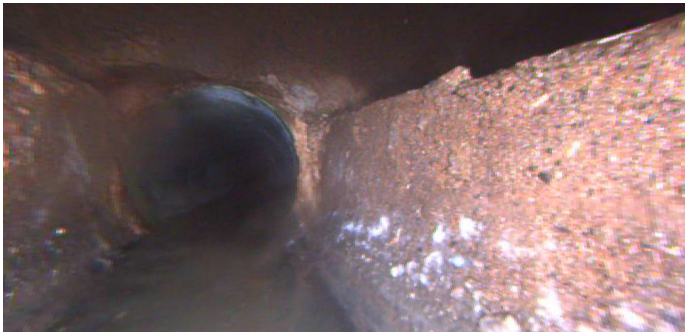
Code: **AMH**  
Description: **Manhole**

Distance (ft): **266.2**  
Structural Grade: **0**  
O&M Grade: **0**  
Clock Start/From:  
Clock To:  
1st Value:  
2nd Value:  
Value Percent:  
Continuous Index:  
Within 8" of Joint: **NO**  
Remarks: **M-809-060**
