Profile/Photo Observation Report

Date:	03/23/2018	Weather:		Coding:	PACP 6.0
Pipe Length (ft):	400.6	Owner:	NA	Pre Clean:	Not Known
P.O.#:		Surveyor:	Justin Gonzales	PSR:	P-809-062-019
Customer:		Clean Date:	01/01/1900	Shape:	C

Street:	BRACKEN PKWY & EIDER ST	Flow Control:	Not Controlled
City:	Hobart, IN	Year Renewed:	
Location:	Sidewalk	Tape/Media #:	
Purpose:	Maintenance Related	Dia/Height:	10"
Use:	Sanitary	Material:	PVC
Drain Area:	NA	Lining:	
Category:	NA		
Comment:	Reverse setup. debris rollover at 389'.		
Location Details:		Direction of Survey:	Upstream
US MH:	M-809-062	DS MH:	M-809-019
		Total Length Surveyed (ft):	391.0

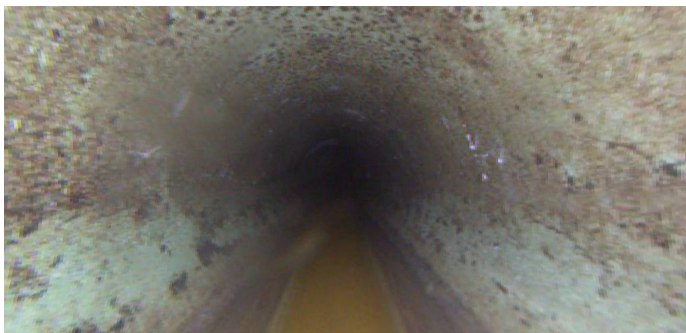
Code: **AMH**
Description: **Manhole**

Distance (ft): **.0**
Structural Grade: **0**
O&M Grade: **0**
Clock Start/From:
Clock To:
1st Value:
2nd Value:
Value Percent:
Continuous Index:
Within 8" of Joint: **NO**
Remarks: **M-809-019**

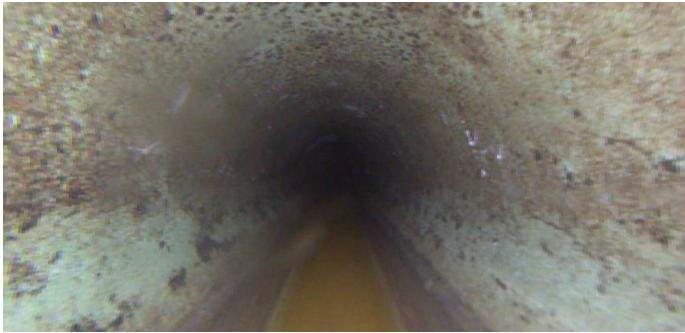
Code:	MWL
Description:	Water Level

Distance (ft):	.0
Structural Grade:	0
O&M Grade:	0
Clock Start/From:	
Clock To:	
1st Value:	
2nd Value:	
Value Percent:	5.000
Continuous Index:	
Within 8" of Joint:	NO
Remarks:

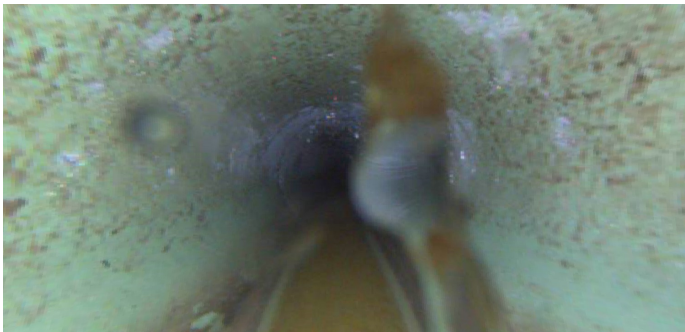
Code:	MGO
Description:	General Observation

Distance (ft):	15.5
Structural Grade:	0
O&M Grade:	0
Clock Start/From:	
Clock To:	
1st Value:	
2nd Value:	
Value Percent:	
Continuous Index:	
Within 8" of Joint:	NO
Remarks:	LARVAE

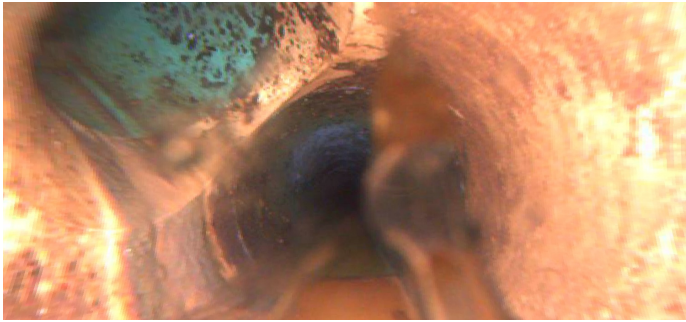
Code: **TF**
Description: **Tap Factory**

Distance (ft): **43.6**
Structural Grade: **0**
O&M Grade: **0**
Clock Start/From: **10**
Clock To:
1st Value: **4.000**
2nd Value:
Value Percent:
Continuous Index:
Within 8" of Joint:
Remarks:

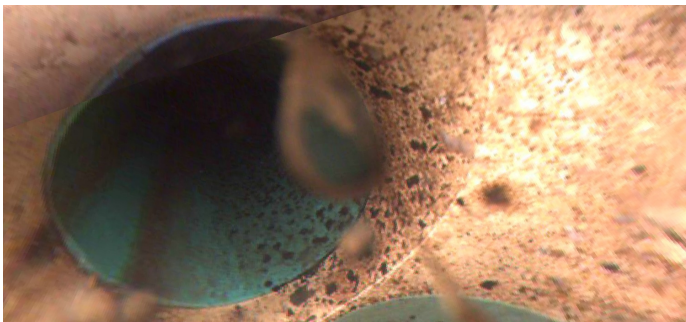
Code: **TF**
Description: **Tap Factory**

Distance (ft): **125.9**
Structural Grade: **0**
O&M Grade: **0**
Clock Start/From: **11**
Clock To:
1st Value: **4.000**
2nd Value:
Value Percent:
Continuous Index:
Within 8" of Joint:
Remarks:

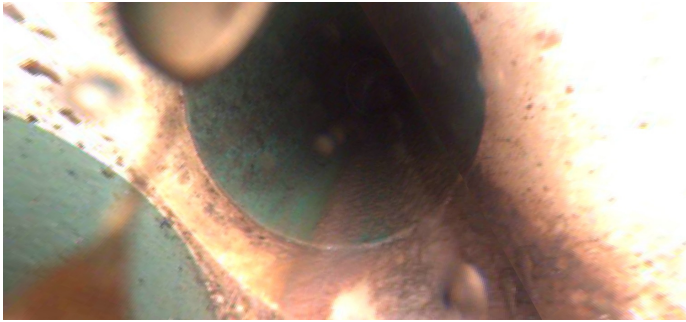
Code: **TF**
Description: **Tap Factory**

Distance (ft): **132.6**
Structural Grade: **0**
O&M Grade: **0**
Clock Start/From: **1**
Clock To:
1st Value: **4.000**
2nd Value:
Value Percent:
Continuous Index:
Within 8" of Joint:
Remarks:

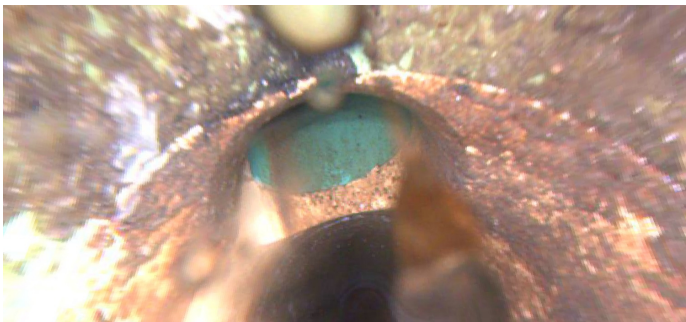
Code: **TF**
Description: **Tap Factory**

Distance (ft): **200.6**
Structural Grade: **0**
O&M Grade: **0**
Clock Start/From: **11**
Clock To:
1st Value: **4.000**
2nd Value:
Value Percent:
Continuous Index:
Within 8" of Joint:
Remarks:

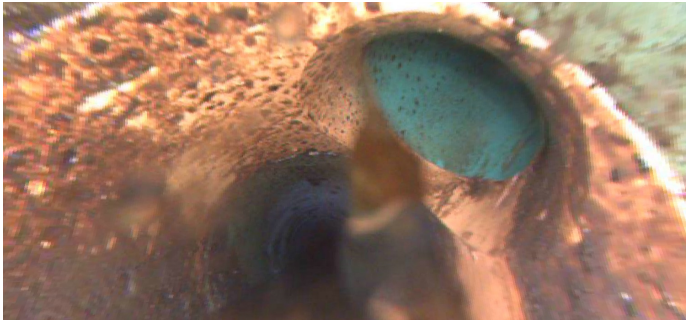
Code: **TF**
Description: **Tap Factory**

Distance (ft): **205.8**
Structural Grade: **0**
O&M Grade: **0**
Clock Start/From: **2**
Clock To:
1st Value: **4.000**
2nd Value:
Value Percent:
Continuous Index:
Within 8" of Joint:
Remarks:

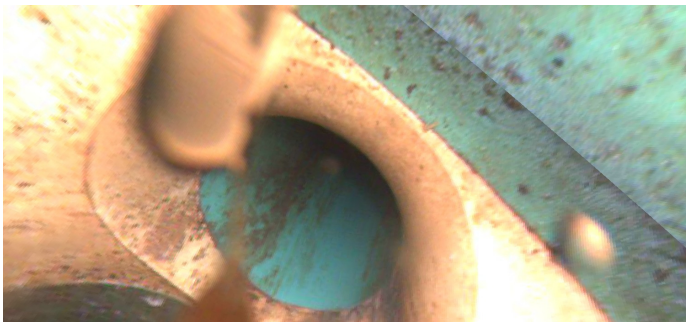
Code: **TF**
Description: **Tap Factory**

Distance (ft): **284.8**
Structural Grade: **0**
O&M Grade: **0**
Clock Start/From: **2**
Clock To:
1st Value: **4.000**
2nd Value:
Value Percent:
Continuous Index:
Within 8" of Joint:
Remarks:

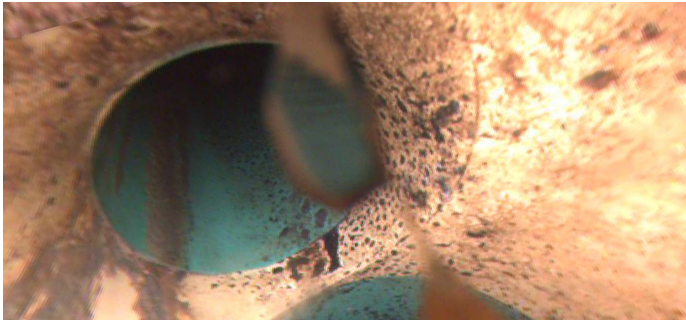
Code: **TF**
Description: **Tap Factory**

Distance (ft): **290.3**
Structural Grade: **0**
O&M Grade: **0**
Clock Start/From: **11**
Clock To:
1st Value: **4.000**
2nd Value:
Value Percent:
Continuous Index:
Within 8" of Joint:
Remarks:

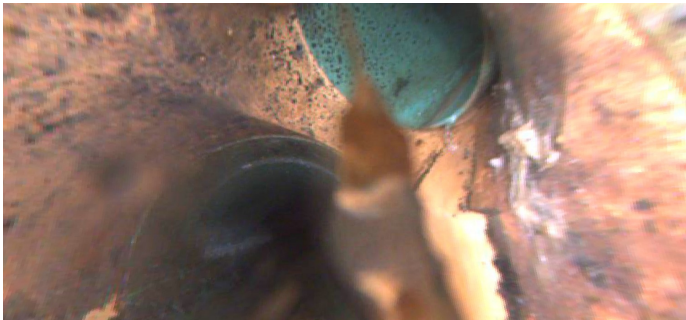
Code: **TF**
Description: **Tap Factory**

Distance (ft): **351.2**
Structural Grade: **0**
O&M Grade: **0**
Clock Start/From: **1**
Clock To:
1st Value: **4.000**
2nd Value:
Value Percent:
Continuous Index:
Within 8" of Joint:
Remarks:

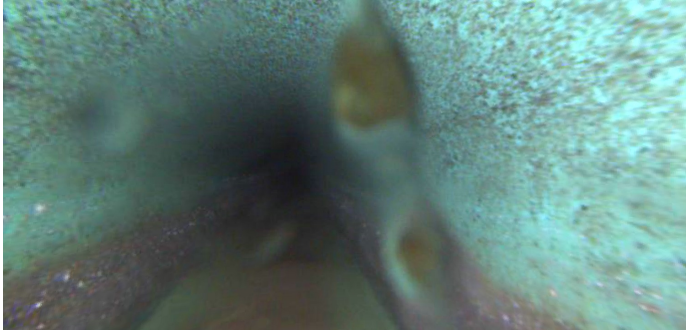
Code: **DAGS**
Description: **Deposits Attached Grease**

Distance (ft): **356.8**
Structural Grade: **0**
O&M Grade: **2**
Clock Start/From: **8**
Clock To: **4**
1st Value:
2nd Value:
Value Percent: **5.000**
Continuous Index: **S01**
Within 8" of Joint: **NO**
Remarks:

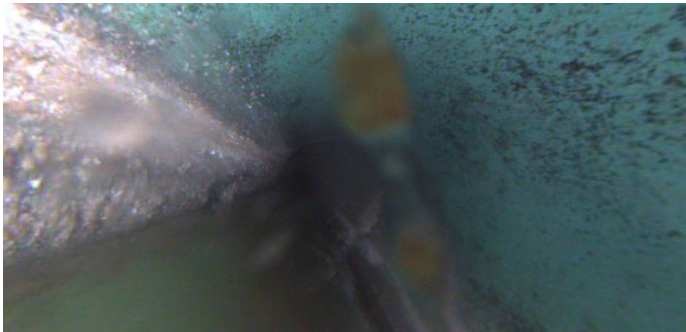
Code: **DAGS**
Description: **Deposits Attached Grease**

Distance (ft): **391.0**
Structural Grade: **0**
O&M Grade: **2**
Clock Start/From: **8**
Clock To: **4**
1st Value:
2nd Value:
Value Percent: **5.000**
Continuous Index: **F01**
Within 8" of Joint: **NO**
Remarks:

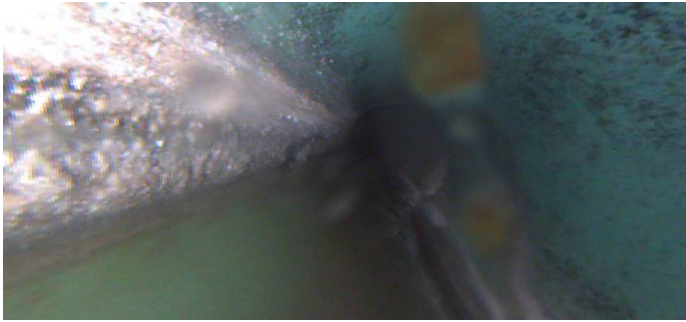
Code:	MSA
Description:	Abandoned Survey
Distance (ft):	391.0
Structural Grade:	0
O&M Grade:	0
Clock Start/From:	
Clock To:	
1st Value:	
2nd Value:	
Value Percent:	
Continuous Index:	
Within 8" of Joint:	NO
Remarks:	ROBOT TURNED OVER
