Profile/Photo Observation Report

Date:	03/22/2018	Weather:		Coding:	PACP 6.0
Pipe Length (ft):	154.6	Owner:	NA	Pre Clean:	Not Known
P.O.#:		Surveyor:	Selasie Honu	PSR:	P-902-002-003
Customer:		Clean Date:	01/01/1900	Shape:	C

Street:	OFF SAINT JOSEPH PL	Flow Control:	Not Controlled
City:	Hobart, IN	Year Renewed:	
Location:	Other	Tape/Media #:	
Purpose:	Not Known	Dia/Height:	10"
Use:	Sanitary	Material:	VCP
Drain Area:	NA	Lining:	
Category:	NA		
Comment:

Location Details:		Direction of Survey:	Upstream
US MH:	M-902-002	DS MH:	M-902-003
		Total Length Surveyed (ft):	52.9

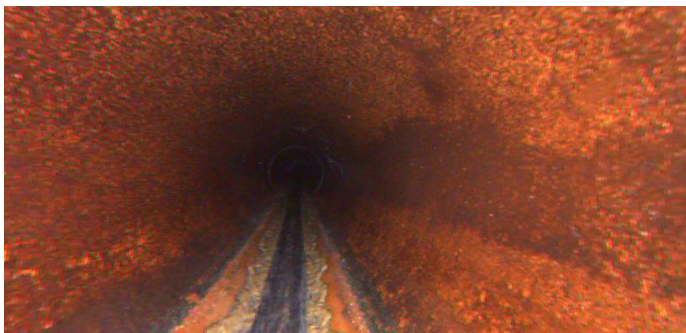
Code: **AMH**
Description: **Manhole**

Distance (ft): **.0**
Structural Grade: **0**
O&M Grade: **0**
Clock Start/From:
Clock To:
1st Value:
2nd Value:
Value Percent:
Continuous Index:
Within 8" of Joint: **NO**
Remarks: **M-902-003**

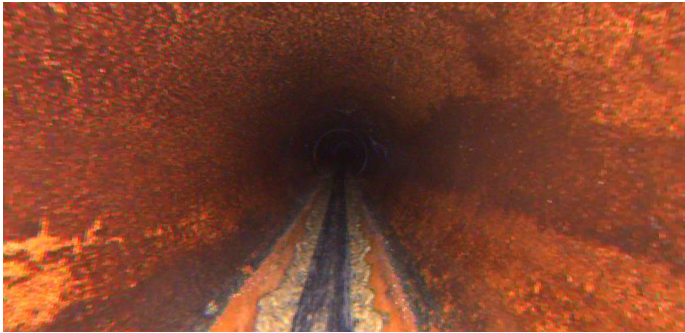
Code:	MWL
Description:	Water Level

Distance (ft):	.0
Structural Grade:	0
O&M Grade:	0
Clock Start/From:	
Clock To:	
1st Value:	
2nd Value:	
Value Percent:	5.000
Continuous Index:	
Within 8" of Joint:	NO
Remarks:

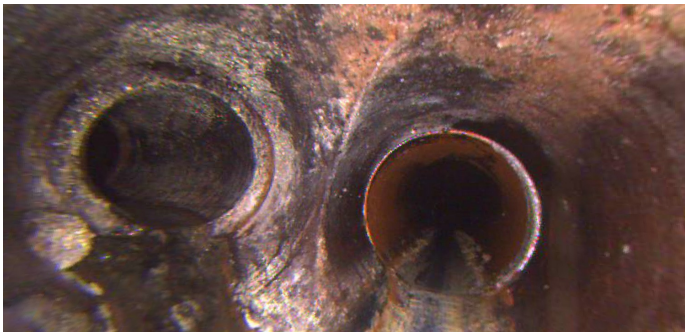
Code:	TF
Description:	Tap Factory

Distance (ft):	35.3
Structural Grade:	0
O&M Grade:	0
Clock Start/From:	9
Clock To:	
1st Value:	4.000
2nd Value:	
Value Percent:	
Continuous Index:	
Within 8" of Joint:	
Remarks:

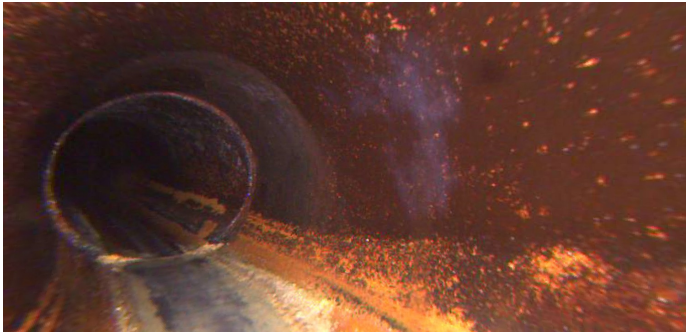
Code: **LL**
Description: **Alignment Left**

Distance (ft): **51.5**
Structural Grade: **0**
O&M Grade: **1**
Clock Start/From:
Clock To:
1st Value:
2nd Value:
Value Percent: **10.000**
Continuous Index:
Within 8" of Joint: **NO**
Remarks:

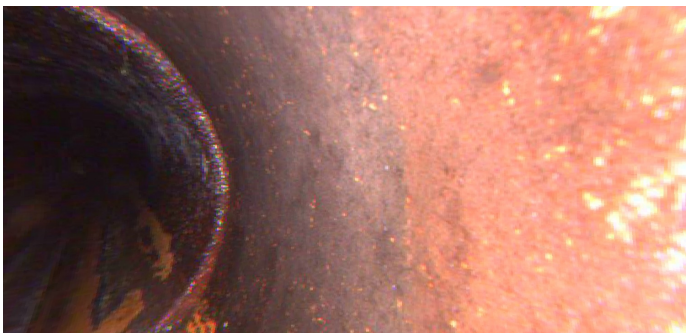
Code: **MSA**
Description: **Abandoned Survey**

Distance (ft): **52.9**
Structural Grade: **0**
O&M Grade: **0**
Clock Start/From:
Clock To:
1st Value:
2nd Value:
Value Percent:
Continuous Index:
Within 8" of Joint: **NO**
Remarks: **camera stopped**
