Profile/Photo Observation Report

Date:	03/22/2018	Weather:		Coding:	PACP 6.0
Pipe Length (ft):	154.6	Owner:	NA	Pre Clean:	Not Known
P.O.#:		Surveyor:	Selasie Honu	PSR:	P-902-002-003
Customer:		Clean Date:	01/01/1900	Shape:	C

Street:	saint joesph pl	Flow Control:	Not Controlled
City:	Hobart, IN	Year Renewed:	
Location:	Other	Tape/Media #:	
Purpose:	Not Known	Dia/Height:	10"
Use:	Sanitary	Material:	VCP
Drain Area:	NA	Lining:	
Category:	NA		
Comment:

Location Details:		Direction of Survey:	Upstream
US MH:	M-902-002	DS MH:	M-902-003
		Total Length Surveyed (ft):	52.9

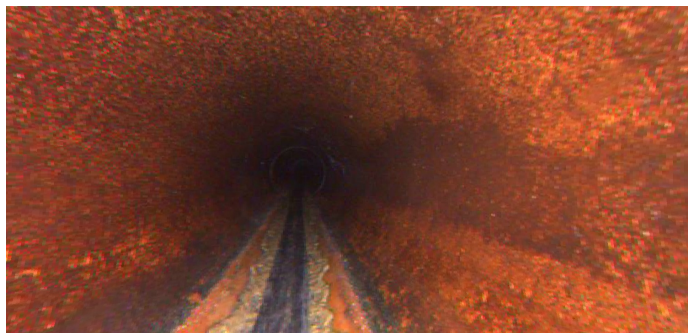
Code: **AMH**
Description: **Manhole**

Distance (ft): **.0**
Structural Grade: **0**
O&M Grade: **0**
Clock Start/From:
Clock To:
1st Value:
2nd Value:
Value Percent:
Continuous Index:
Within 8" of Joint: **NO**
Remarks: **M-902-003**

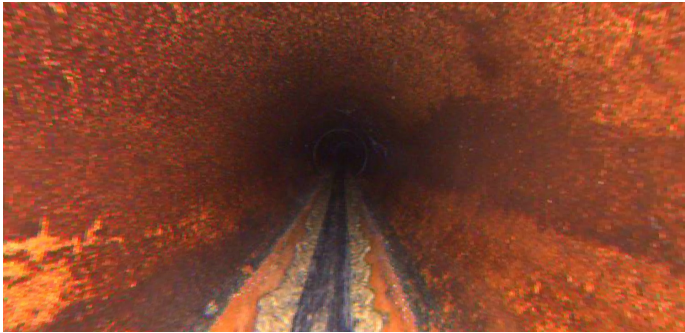
Code:	MWL
Description:	Water Level

Distance (ft):	.0
Structural Grade:	0
O&M Grade:	0
Clock Start/From:	
Clock To:	
1st Value:	
2nd Value:	
Value Percent:	5.000
Continuous Index:	
Within 8" of Joint:	NO
Remarks:

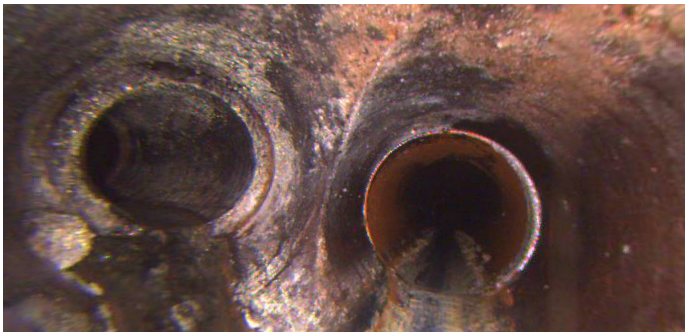
Code:	TF
Description:	Tap Factory

Distance (ft):	35.3
Structural Grade:	0
O&M Grade:	0
Clock Start/From:	9
Clock To:	
1st Value:	4.000
2nd Value:	
Value Percent:	
Continuous Index:	
Within 8" of Joint:	
Remarks:

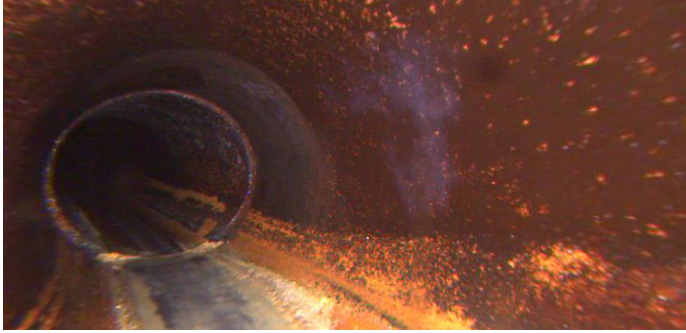
Code: **LL**
Description: **Alignment Left**

Distance (ft): **51.5**
Structural Grade: **0**
O&M Grade: **1**
Clock Start/From:
Clock To:
1st Value:
2nd Value:
Value Percent: **10.000**
Continuous Index:
Within 8" of Joint: **NO**
Remarks:

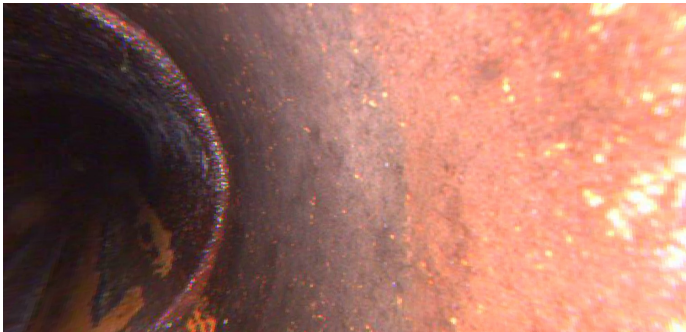
Code: **MSA**
Description: **Abandoned Survey**

Distance (ft): **52.9**
Structural Grade: **0**
O&M Grade: **0**
Clock Start/From:
Clock To:
1st Value:
2nd Value:
Value Percent:
Continuous Index:
Within 8" of Joint: **NO**
Remarks: **camera stopped**
