Profile/Photo Observation Report

Date:	03/22/2018	Weather:		Coding:	PACP 6.0
Pipe Length (ft):	59.3	Owner:	NA	Pre Clean:	Not Known
P.O.#:		Surveyor:	Selasie Honu	PSR:	P-902-003-003.5
Customer:		Clean Date:	01/01/1900	Shape:	C

Street:	OFF SAINT JOSEPH PL	Flow Control:	Not Controlled
City:	Hobart, IN	Year Renewed:	
Location:	Other	Tape/Media #:	
Purpose:	Not Known	Dia/Height:	10"
Use:	Sanitary	Material:	VCP
Drain Area:	NA	Lining:	
Category:	NA		
Comment:

Location Details:		Direction of Survey:	Upstream
US MH:	M-902-003.5	DS MH:	M-902-003
		Total Length Surveyed (ft):	57.1

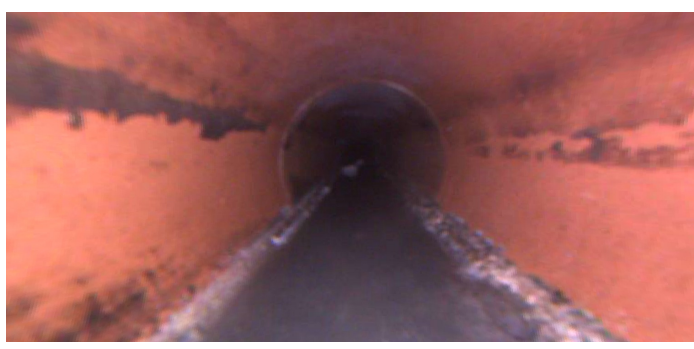
Code: **AMH**
Description: **Manhole**

Distance (ft): **.0**
Structural Grade: **0**
O&M Grade: **0**
Clock Start/From:
Clock To:
1st Value:
2nd Value:
Value Percent:
Continuous Index:
Within 8" of Joint: **NO**
Remarks: **M-902-003**

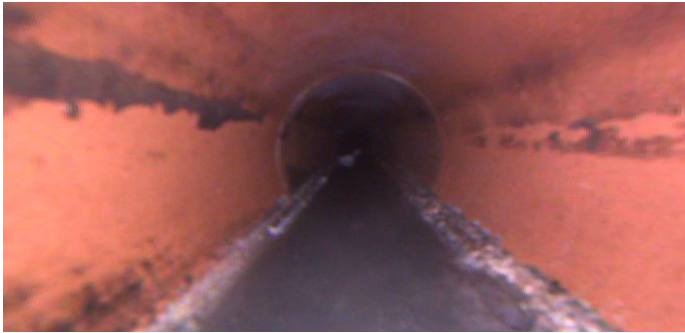
Code:	MWL
Description:	Water Level

Distance (ft):	.0
Structural Grade:	0
O&M Grade:	0
Clock Start/From:	
Clock To:	
1st Value:	
2nd Value:	
Value Percent:	5.000
Continuous Index:	
Within 8" of Joint:	NO
Remarks:

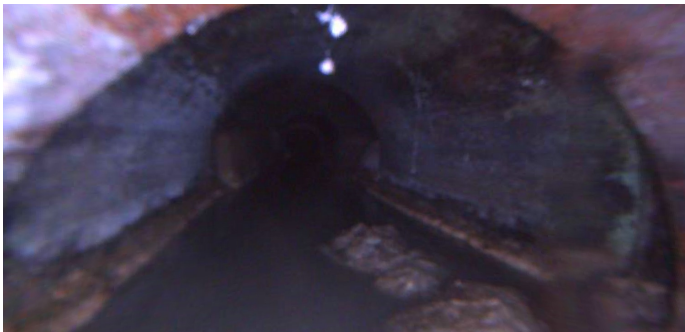
Code:	MMC
Description:	Material Change

Distance (ft):	52.8
Structural Grade:	0
O&M Grade:	0
Clock Start/From:	
Clock To:	
1st Value:	
2nd Value:	
Value Percent:	
Continuous Index:	
Within 8" of Joint:	NO
Remarks:	pvc

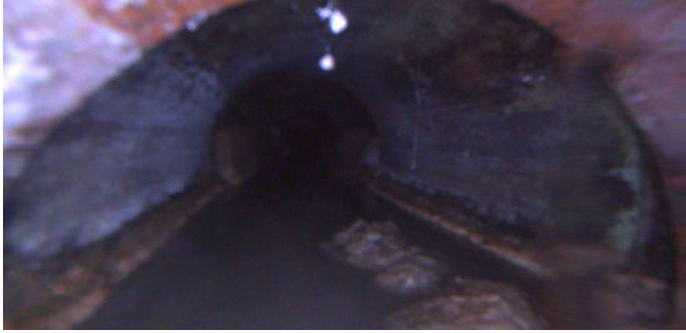
Code: **JOM**
Description: **Joint Offset Medium**

Distance (ft): **52.8**
Structural Grade: **1**
O&M Grade: **0**
Clock Start/From:
Clock To:
1st Value:
2nd Value:
Value Percent:
Continuous Index:
Within 8" of Joint: **NO**
Remarks:

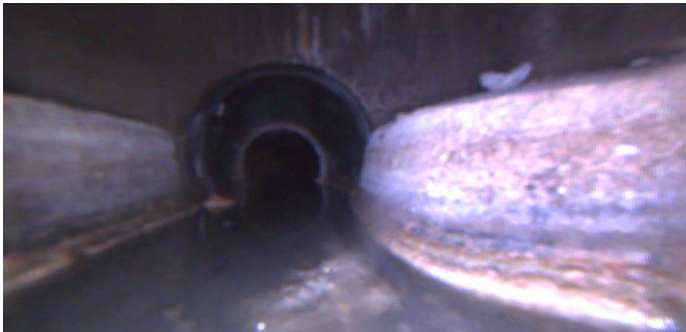
Code: **AMH**
Description: **Manhole**

Distance (ft): **57.1**
Structural Grade: **0**
O&M Grade: **0**
Clock Start/From:
Clock To:
1st Value:
2nd Value:
Value Percent:
Continuous Index:
Within 8" of Joint: **NO**
Remarks: **M-902-003.5**
