Profile/Photo Observation Report

Location Details:		Direction of Survey:	Upstream
US MH:	M-902-003.5	DS MH:	M-902-003
		Total Length Surveyed (ft):	57.1

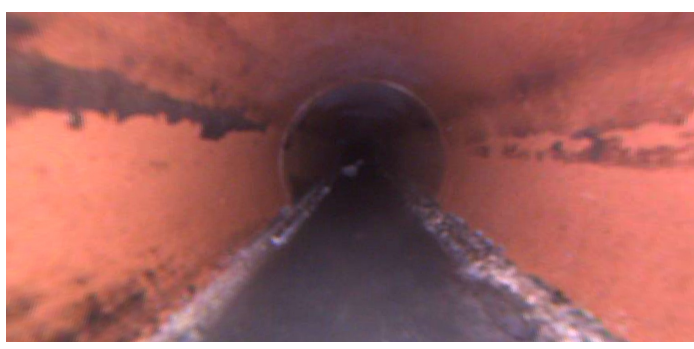
Code: **AMH**
Description: **Manhole**

Distance (ft): **.0**
Structural Grade: **0**
O&M Grade: **0**
Clock Start/From:
Clock To:
1st Value:
2nd Value:
Value Percent:
Continuous Index:
Within 8" of Joint: **NO**
Remarks: **M-902-003**

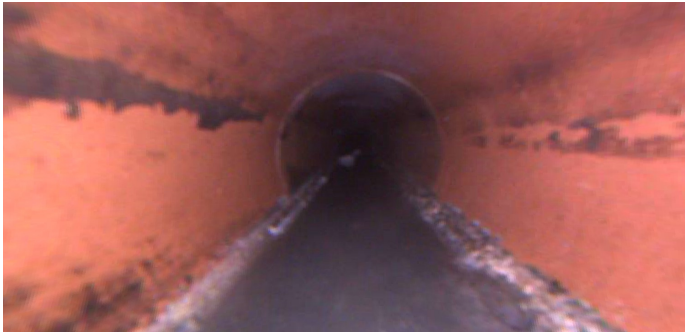
Code:	MWL
Description:	Water Level

Distance (ft):	.0
Structural Grade:	0
O&M Grade:	0
Clock Start/From:	
Clock To:	
1st Value:	
2nd Value:	
Value Percent:	5.000
Continuous Index:	
Within 8" of Joint:	NO
Remarks:

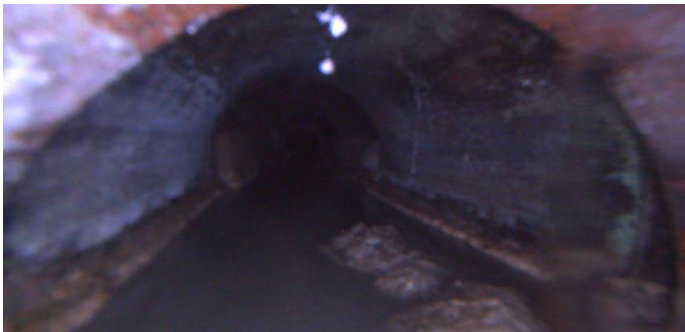
Code:	MMC
Description:	Material Change

Distance (ft):	52.8
Structural Grade:	0
O&M Grade:	0
Clock Start/From:	
Clock To:	
1st Value:	
2nd Value:	
Value Percent:	
Continuous Index:	
Within 8" of Joint:	NO
Remarks:	pvc

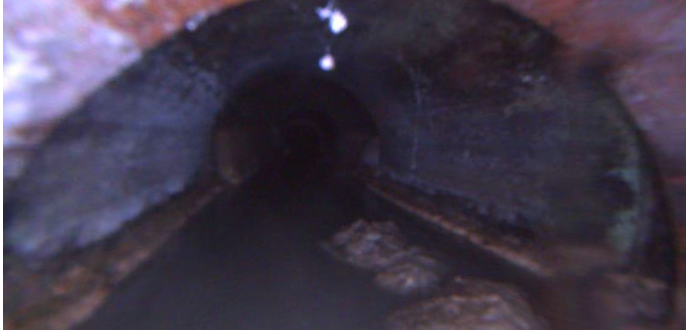
Code: **JOM**
Description: **Joint Offset Medium**

Distance (ft): **52.8**
Structural Grade: **1**
O&M Grade: **0**
Clock Start/From:
Clock To:
1st Value:
2nd Value:
Value Percent:
Continuous Index:
Within 8" of Joint: **NO**
Remarks:

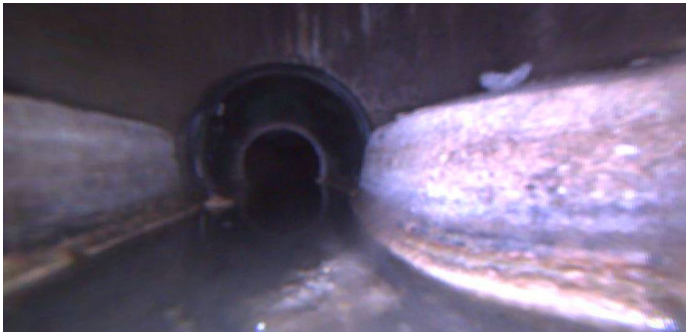
Code: **AMH**
Description: **Manhole**

Distance (ft): **57.1**
Structural Grade: **0**
O&M Grade: **0**
Clock Start/From:
Clock To:
1st Value:
2nd Value:
Value Percent:
Continuous Index:
Within 8" of Joint: **NO**
Remarks: **M-902-003.5**
