Profile/Photo Observation Report

Date:	03/23/2018	Weather:		Coding:	PACP 6.0
Pipe Length (ft):	101.1	Owner:	NA	Pre Clean:	Not Known
P.O.#:		Surveyor:	Jen Costello	PSR:	P-902-006-007
Customer:		Clean Date:	01/01/1900	Shape:	C

Street:	E 34TH LN	Flow Control:	Not Controlled
City:	Hobart, IN	Year Renewed:	
Location:	Other	Tape/Media #:	
Purpose:	Not Known	Dia/Height:	10"
Use:	Sanitary	Material:	VCP
Drain Area:	NA	Lining:	
Category:	NA		
Comment:

Location Details:		Direction of Survey:	Upstream
US MH:	M-902-007	DS MH:	M-902-006
		Total Length Surveyed (ft):	5.5

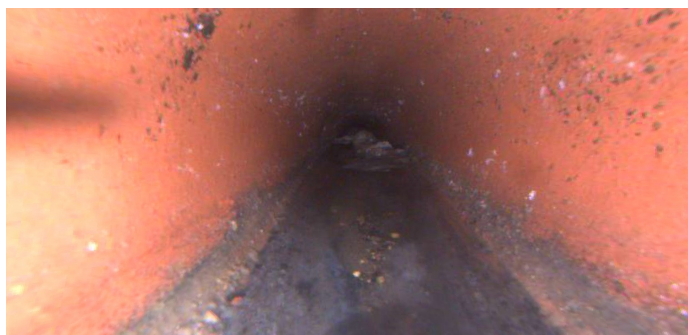
Code: **AMH**
Description: **Manhole**

Distance (ft): **.0**
Structural Grade: **0**
O&M Grade: **0**
Clock Start/From:
Clock To:
1st Value:
2nd Value:
Value Percent:
Continuous Index:
Within 8" of Joint: **NO**
Remarks: **M-902-006**

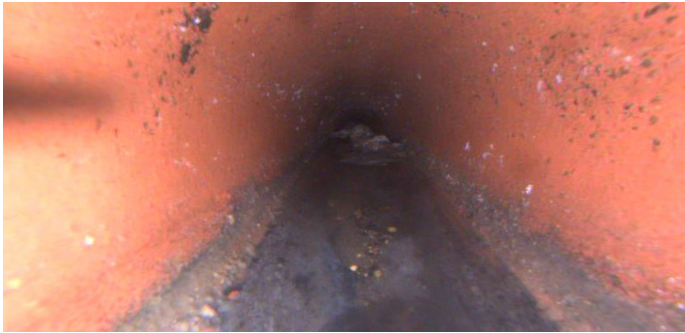
Code:	MWL
Description:	Water Level

Distance (ft):	.0
Structural Grade:	0
O&M Grade:	0
Clock Start/From:	
Clock To:	
1st Value:	
2nd Value:	
Value Percent:	10.000
Continuous Index:	
Within 8" of Joint:	NO
Remarks:

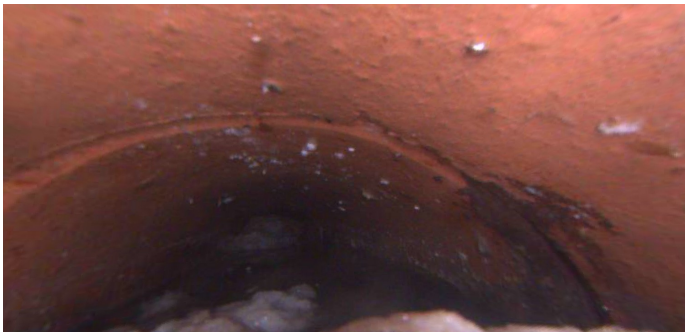
Code:	MSA
Description:	Abandoned Survey

Distance (ft):	5.5
Structural Grade:	0
O&M Grade:	0
Clock Start/From:	
Clock To:	
1st Value:	
2nd Value:	
Value Percent:	
Continuous Index:	
Within 8" of Joint:	NO
Remarks:	DEBRIS UNDER WATER
