Profile/Photo Observation Report

Date:	03/23/2018	Weather:		Coding:	PACP 6.0
Pipe Length (ft):	101.1	Owner:	NA	Pre Clean:	Not Known
P.O.#:		Surveyor:	Jen Costello	PSR:	P-902-006-007
Customer:		Clean Date:	01/01/1900	Shape:	C

Street:	e 34th In	Flow Control:	Not Controlled
City:	Hobart, IN	Year Renewed:	
Location:	Other	Tape/Media #:	
Purpose:	Not Known	Dia/Height:	10"
Use:	Sanitary	Material:	VCP
Drain Area:	NA	Lining:	
Category:	NA		
Comment:

Location Details:		Direction of Survey:	Upstream
US MH:	M-902-007	DS MH:	M-902-006
		Total Length Surveyed (ft):	5.5

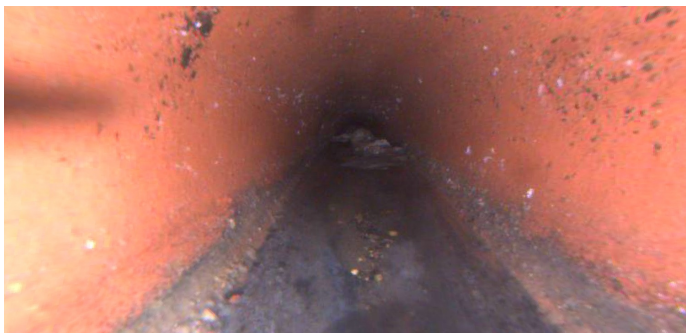
Code: **AMH**
Description: **Manhole**

Distance (ft): **.0**
Structural Grade: **0**
O&M Grade: **0**
Clock Start/From:
Clock To:
1st Value:
2nd Value:
Value Percent:
Continuous Index:
Within 8" of Joint: **NO**
Remarks: **M-902-006**

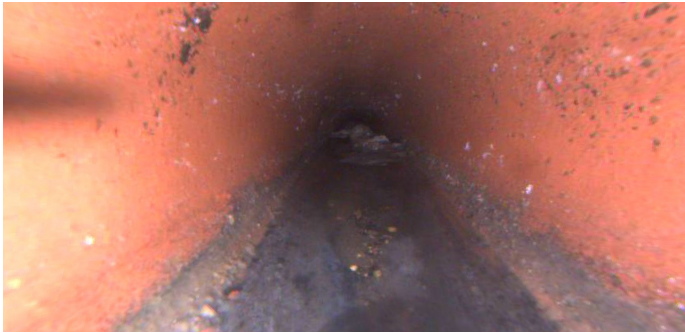
Code:	MWL
Description:	Water Level

Distance (ft):	.0
Structural Grade:	0
O&M Grade:	0
Clock Start/From:	
Clock To:	
1st Value:	
2nd Value:	
Value Percent:	10.000
Continuous Index:	
Within 8" of Joint:	NO
Remarks:

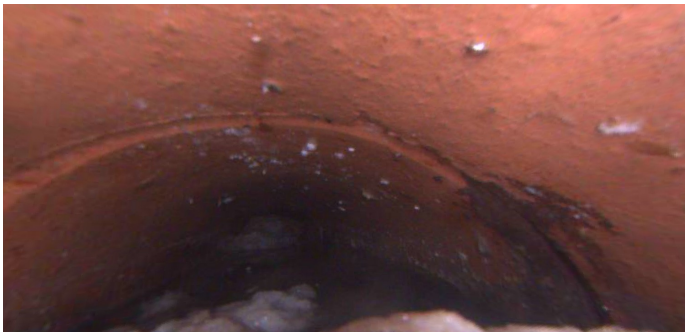
Code:	MSA
Description:	Abandoned Survey

Distance (ft):	5.5
Structural Grade:	0
O&M Grade:	0
Clock Start/From:	
Clock To:	
1st Value:	
2nd Value:	
Value Percent:	
Continuous Index:	
Within 8" of Joint:	NO
Remarks:	DEBRIS UNDER WATER
